## **Question 10: What causes metal-catalyzed coking (MCC) that obstructs catalyst circulation in CCR reformers? What actions do you take to mitigate MCC formation?**

### **DAVINDER MITTAL (HPCL Mittal Energy)**

Our Continuous Catalytic Regeneration Reformer Unit was commissioned in May'2012. However, within one year of operation, the unit started experiencing several performance issues including restriction of catalyst flow in some of the spider legs of all 04 reactors , higher pressure drop and lower endotherm in reactors (more severe in 2nd Reactor, 60-70% of design value) and lower RON than design.

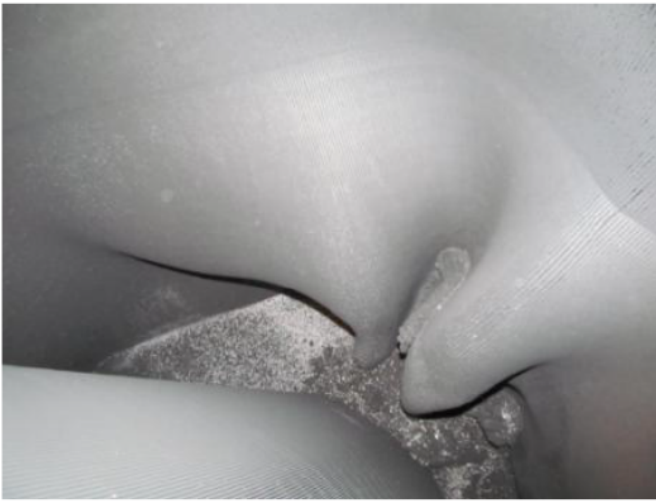
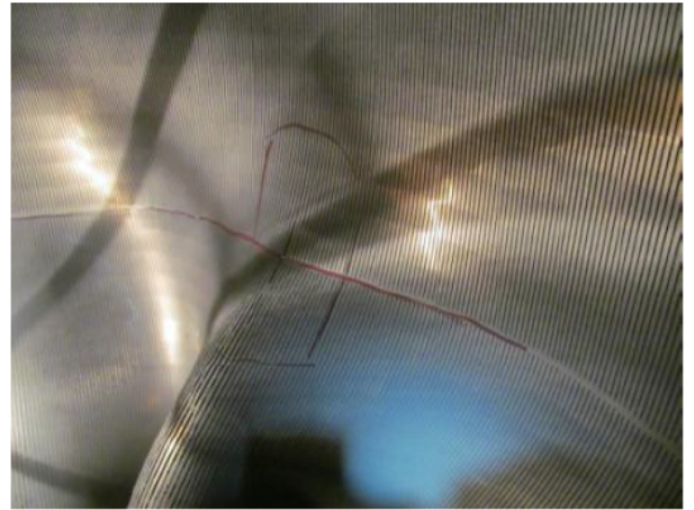
**Picture-2(a):** Last panel of outside reactor grid found fully bulged with huge coke build up

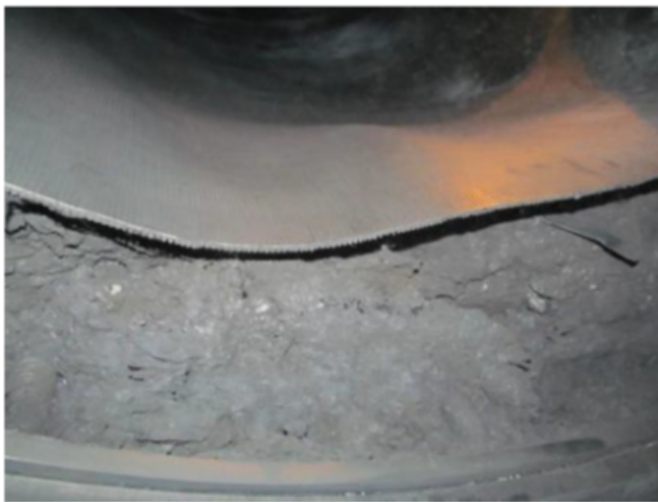
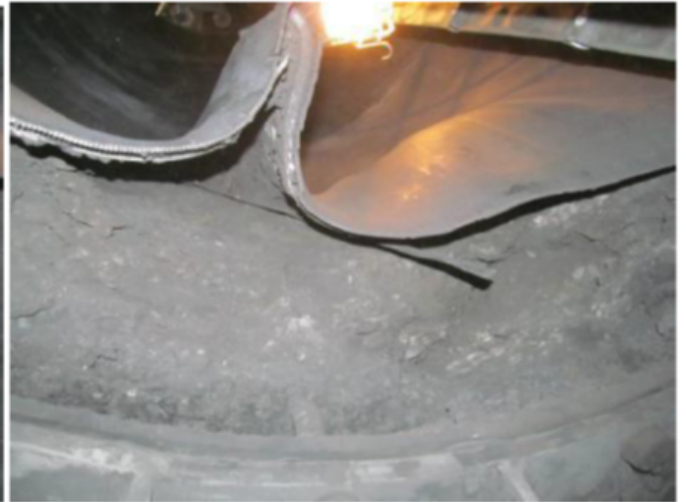
**Picture-2(b):** Last panel of outside reactor grid found fully bulged with huge coke build up

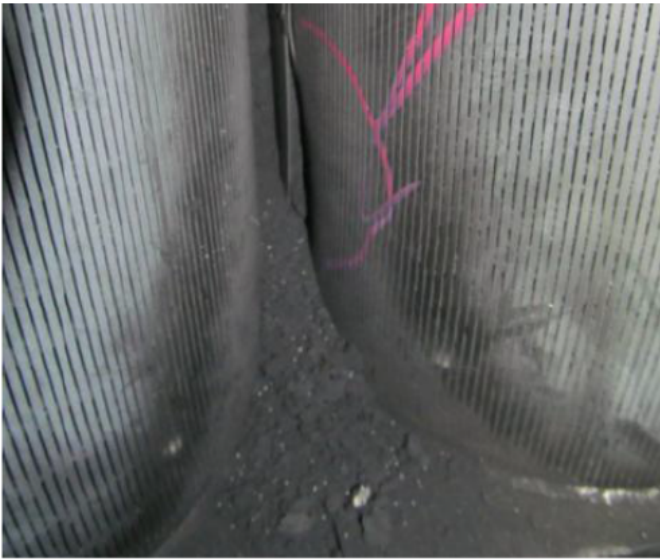
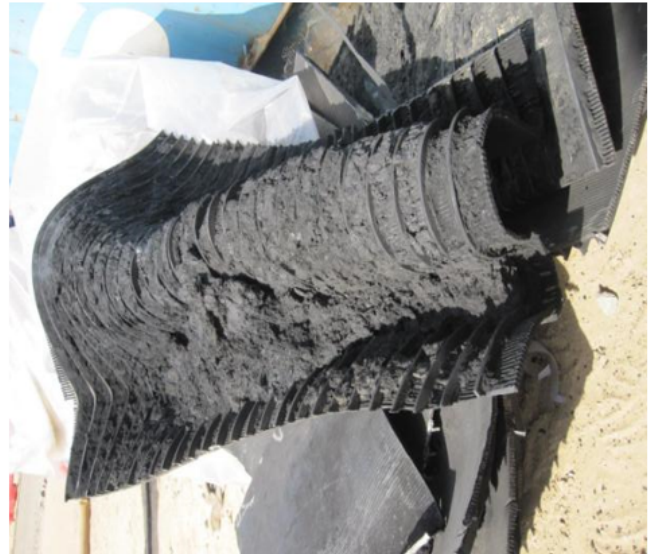
**Picture-3(a):** Shiny coke between and inside scallops leading to bulging and fish mouth cracks

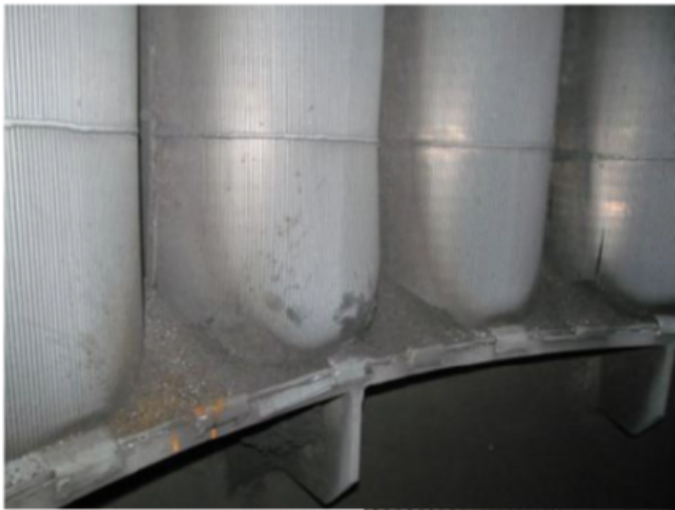
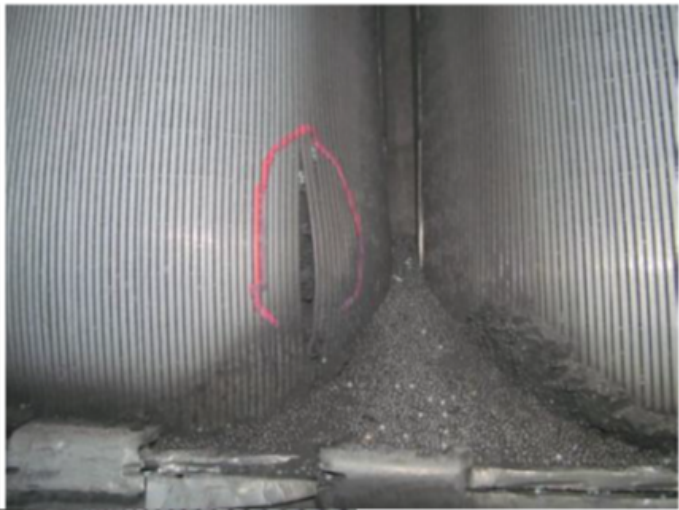
**Picture-3(b):** Shiny coke between and inside scallops leading to bulging and fish mouth cracks  
A joint root cause analysis with Licensor confirmed presence of Fe and carbon graphite (high carbon content) in the coke samples. During cleaning of the scallops, presence of lot of hard shining coke (metallic coke) was observed along with soft coke. It was concluded that coke build up in reactors/scallops/grids may have taken place due to metal catalyzed coking considering problem with DMDS dosing pump during initial year of commissioning as well as due to other reliability issues like frequent trip of recycle gas compressor. The presence of metallic coke in reactors may have acted as nuclei and further catalyzed the coke growth during recycle gas failure.

The heater tube thickness measurements also indicated some loss of thickness indicating metal catalyzed coking in addition to other forms of coke. The level of thickness loss was fortunately not alarming to inhibit future operation.

Maintain sulfur level 0.3 to 0.5 ppmw on CCR feed to be substantiated by presence of detectable amount of H<sub>2</sub>S in recycles gas and 100-150 ppmw of 'S' on catalyst sample.

Operate Naphtha Hydro-treating (NHT) unit to remove essentially all of the sulfur and other contaminants in the feed. Inject DMDS in CCR feed through dedicated facility to maintain recommended range of sulfur.

Maximum Tube Metal Temperature (TMT) to be restricted below 620oC.

Carry out emergency catalyst circulation in case of unplanned trip of the Recycle Gas compressor to relieve the mechanical stress built up due to difference in the thermal expansion coefficient between catalyst and reactors internals.
