Question 10: What causes metal-catalyzed coking (MCC) that obstructs catalyst circulation in CCR reformers? What actions do you take to mitigate MCC formation?

DAVINDER MITTAL (HPCL Mittal Energy)

Our Continuous Catalytic Regeneration Reformer Unit was commissioned in May'2012. However, within one year of operation, the unit started experiencing several performance issues including restriction of catalyst flow in some of the spider legs of all 04 reactors , higher pressure drop and lower endotherm in reactors (more severe in 2nd Reactor, 60-70% of design value) and lower RON than design.

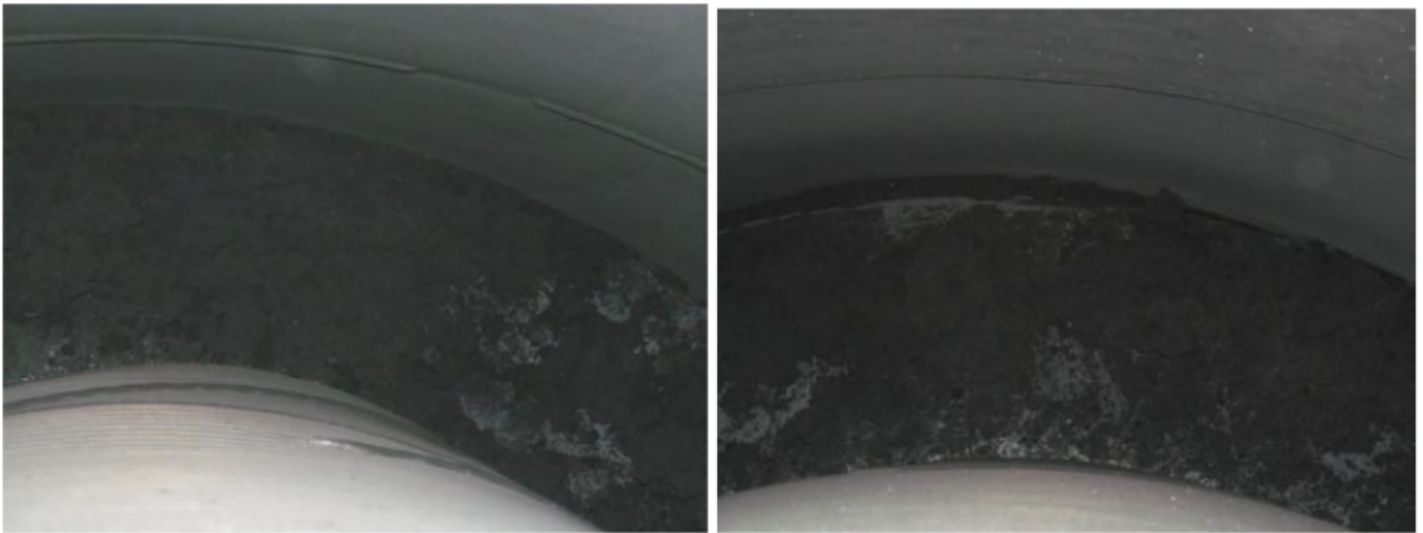
Picture-1: Huge quantity of coke in annular space between reactor grid and shell

Picture-3(b): Shiny coke between and inside scallops leading to bulging and fish mouth cracks
A joint root cause analysis with Licensor confirmed presence of Fe and carbon graphite (high carbon content) in the coke samples. During cleaning of the scallops, presence of lot of hard shining coke (metallic coke) was observed along with soft coke. It was concluded that coke build up in reactors/scallops/grids may have taken place due to metal catalyzed coking considering problem with DMDS dosing pump during initial year of commissioning as well as due to other reliability issues like frequent trip of recycle gas compressor. The presence of metallic coke in reactors may have acted as nuclei and further catalyzed the coke growth during recycle gas failure.

The heater tube thickness measurements also indicated some loss of thickness indicating metal catalyzed coking in addition to other forms of coke. The level of thickness loss was fortunately not alarming to inhibit future operation.

Maintain sulfur level 0.3 to 0.5 ppmw on CCR feed to be substantiated by presence of detectable amount of H₂S in recycles gas and 100-150 ppmw of 'S' on catalyst sample.

Operate Naphtha Hydro-treating (NHT) unit to remove essentially all of the sulfur and other contaminants in the feed. Inject DMDS in CCR feed through dedicated facility to maintain recommended range of sulfur.

No flame sweeping/scattering on the furnace coils.

Maximum Tube Metal Temperature (TMT) to be restricted below 620oC.

Operation of heater burners within the design regime (maximum allowable process absorbed duty per burner: 1.0 Gcal/h).

Perform positive material identification of tube metal to confirm P9 (confirmed).
