Question 67: Have you experienced coking or other fouling of reboilers in naphtha distillation service (splitter, debutanizer, etc.)? If so, what operational or design changes did you implement to eliminate this problem?

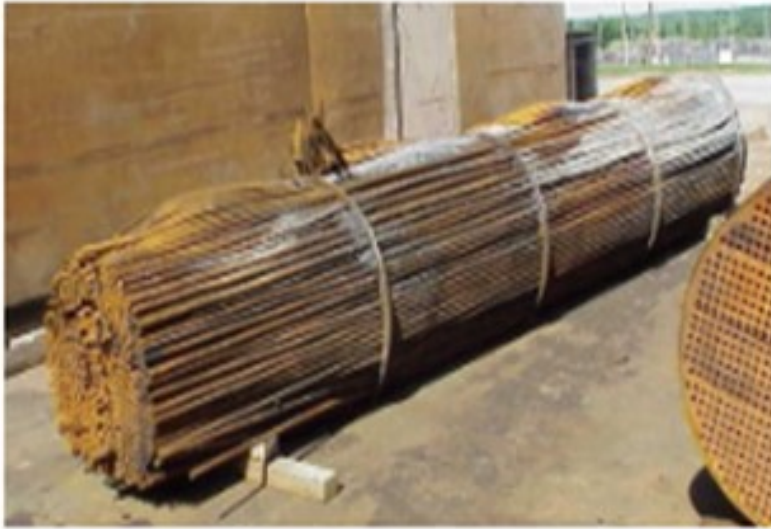
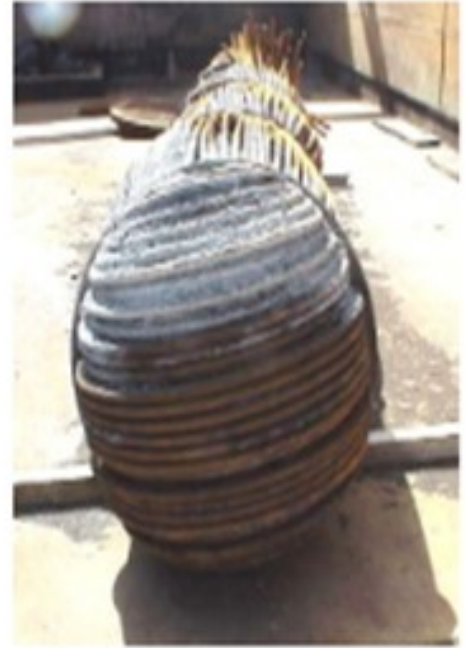
- The Debutanizer Reboilers are two kettle reboilers with U-tube bundles.
- Debutanizer bottoms flows through the shell side and is heated with Heavy Cycle Oil on the tube side.
- The shells and original bundles were carbon steel.
- History of tube leaks, but no records of significant shell-side fouling.
- Due to leak history purchased new chrome bundles for installation.
- At shutdown, very difficult bundle extraction.
- Extensive coke formation within the bundles bulged the tops rows of tubes into the shell cavity. •Shell-side fouling was found largely in the top 1/3 of the bundles.

- Fouling was believed to be caused by iron-catalyzed diolefin polymerization that eventually became coke and was a function of ·Reboiler tube wall temperature

- Diolefin concentration

- Iron concentration

- We eliminated issue by lowering HCO temperature some and changing metallurgy to 9Cr bundles. It has been four years since bundle replacement without performance problems. We will confirm during next year's turnaround.
