Question 86: With more refiners upgrading to packing in the reactor stripper, what has been your experience with reliability? When do you consider removing packing for inspection during turnaround? How much of the packing does one spare?

2015 FCC Q&A Session

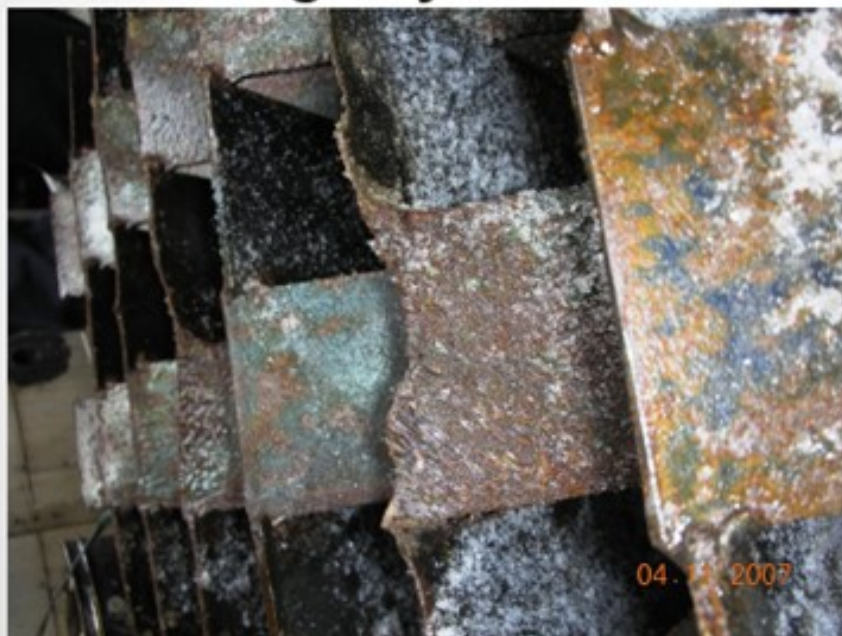
Damaged Packing Layer

In the first run from 2003 to 2007, we ended up replacing the bottom two layers just due to general thinning. There was about a 60% metal loss. There was one caveat to this run: The steam distributor underneath the packing failed during the run; so, most of the time, we ran with poor steam distribution. The adjacent layers moving up from the bottom of the bed had 20 to 30% loss as well, but we deemed them okay and reused them.

I have included some pictures. The first one is from the first run in 2007. You can see that there are some knife edges and it is worn out. What I like about this picture is that it is from April. The white stuff is not a catalyst. This is snow. [Laughter] You can guess which part of the country this refinery is in.

Just the lower one. The one that is damaged is at the bottom. The damage has been worst at the bottom and progressively better going up.

In the next run, from 2007 to 2012, we ended up replacing the bottom six layers. Some of that damage was on two of the layers that had not been replaced on the previous run. We could have reused the two top layers that were replaced; but since we already had them out of the vessel and had new packing sitting right there, we replaced the lower six of eight layers, as well as the support grid underneath the packing. It was knife-edged and had some thinning. Going forward, we plan to keep four layers on hand just for turnarounds.

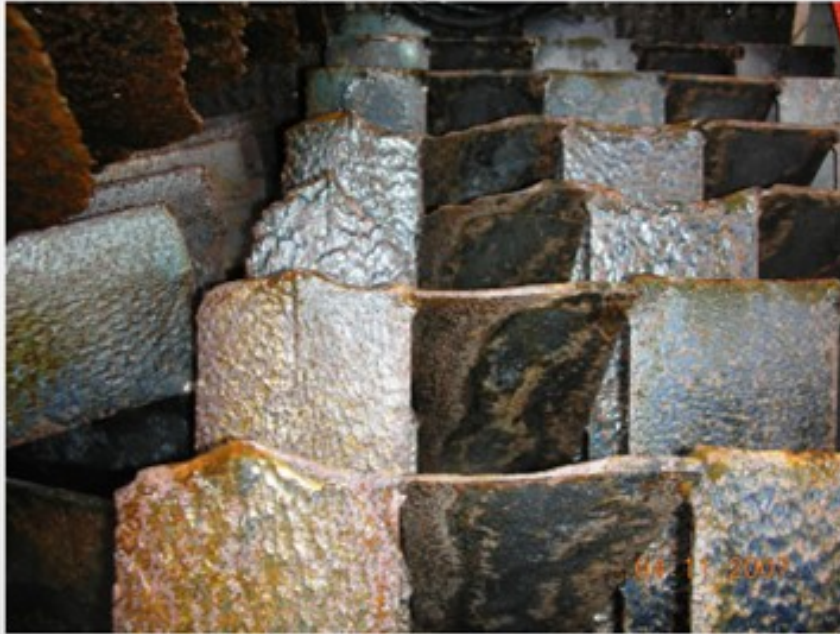
Damaged Packing Layer

On the next slide, you can see another picture of that damage. There are erosion patterns in this wear. You can that see it is just worn down.

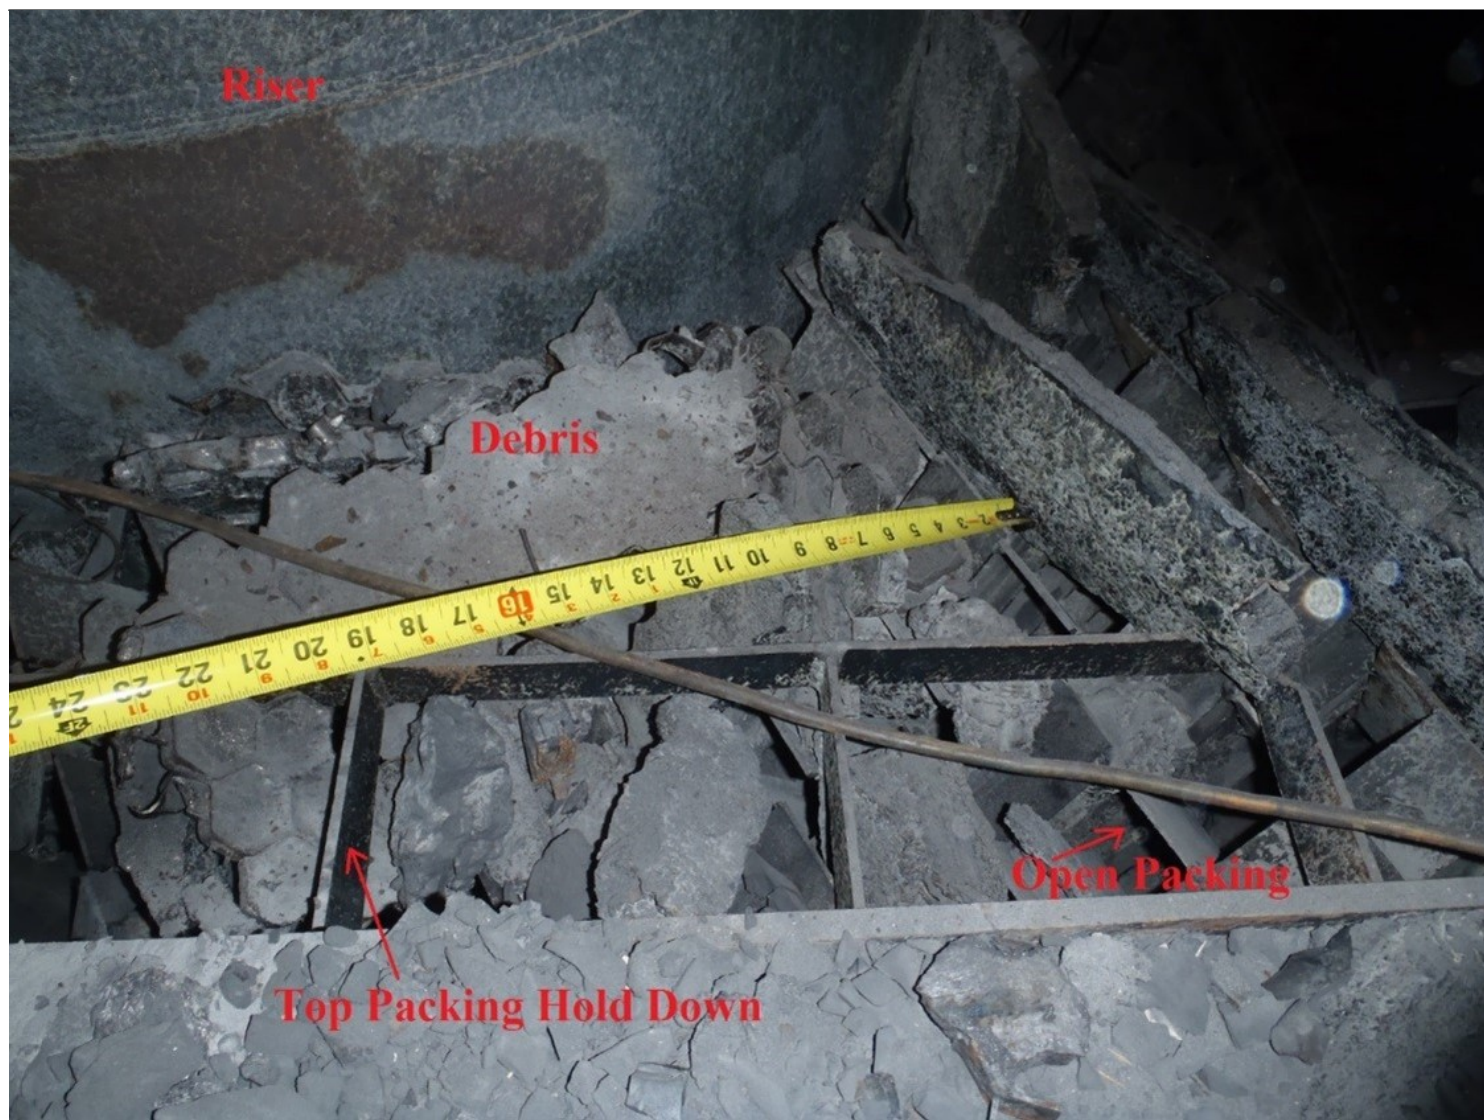
We installed packing in our reactor stripper in 2006. So far, the only issue we have seen was in 2012. When we went into the reactor, we had refractory and coke debris from various areas of the reactor that had fallen onto the top of the packing and partially clogged and blocked a portion of the packing. We had already made the decision to remove all of the packing to evaluate whether there was any erosion with the new configuration (there was not), but we would have needed to remove at least the top two layers for cleaning anyway due to the debris.

Once removed, we did not see any noticeable erosion on the packing itself; but in anticipation of possible issues, we had ordered one layer of spare packing prior to the outage. I will caution that the price per layer was twice as high when just ordering one or two layers compared to ordering a complete replacement (eight layers for us) and lead time for even just one layer was in the range of 12 weeks. I would also caution that even though our packing was very robust, some sections still got deformed during handling, although not badly enough to need to be replaced. For our next outage (if we did not already need to remove the packing for another reason), we would have suggested having one layer on hand and simply inspecting from the top and bottom and determining whether cleaning or replacement was needed from there.

The following pictures are of the as-found condition and the packing, and some pictures of it once it had been removed and then cleaned.
