**Question 86: With more refiners upgrading to packing in the reactor stripper, what has been your experience with reliability? When do you consider removing packing for inspection during turnaround? How much of the packing does one spare?**

## Stripper Packing

2015 FCC Q&A Session

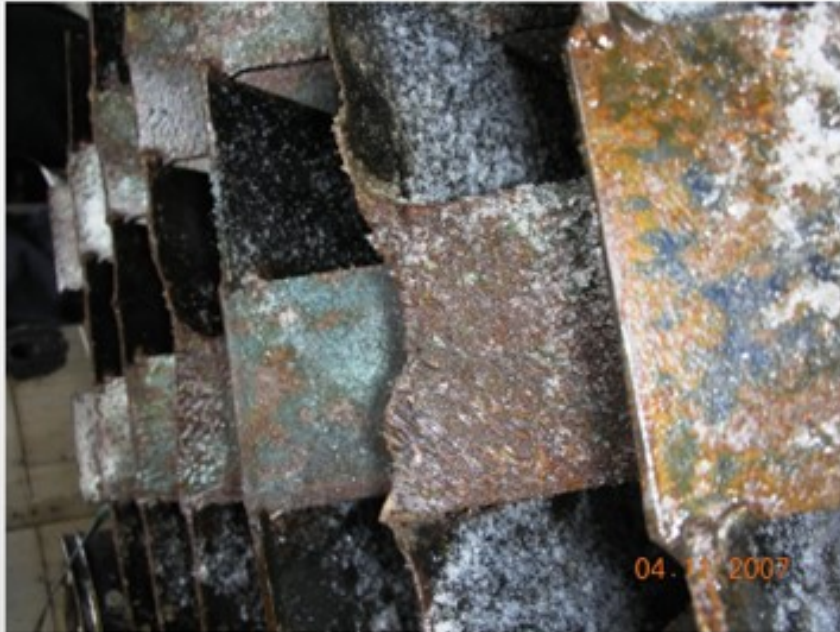
## Damaged Packing Layer

In the first run from 2003 to 2007, we ended up replacing the bottom two layers just due to general thinning. There was about a 60% metal loss. There was one caveat to this run: The steam distributor underneath the packing failed during the run; so, most of the time, we ran with poor steam distribution. The adjacent layers moving up from the bottom of the bed had 20 to 30% loss as well, but we deemed them okay and reused them.

In the next run, from 2007 to 2012, we ended up replacing the bottom six layers. Some of that damage was on two of the layers that had not been replaced on the previous run. We could have reused the two top layers that were replaced; but since we already had them out of the vessel and had new packing sitting right there, we replaced the lower six of eight layers, as well as the support grid underneath the packing. It was knife-edged and had some thinning. Going forward, we plan to keep four layers on hand just for turnarounds.

I have included some pictures. The first one is from the first run in 2007. You can see that there are some knife edges and it is worn out. What I like about this picture is that it is from April. The white stuff is not a catalyst. This is snow. [Laughter] You can guess which part of the country this refinery is in.

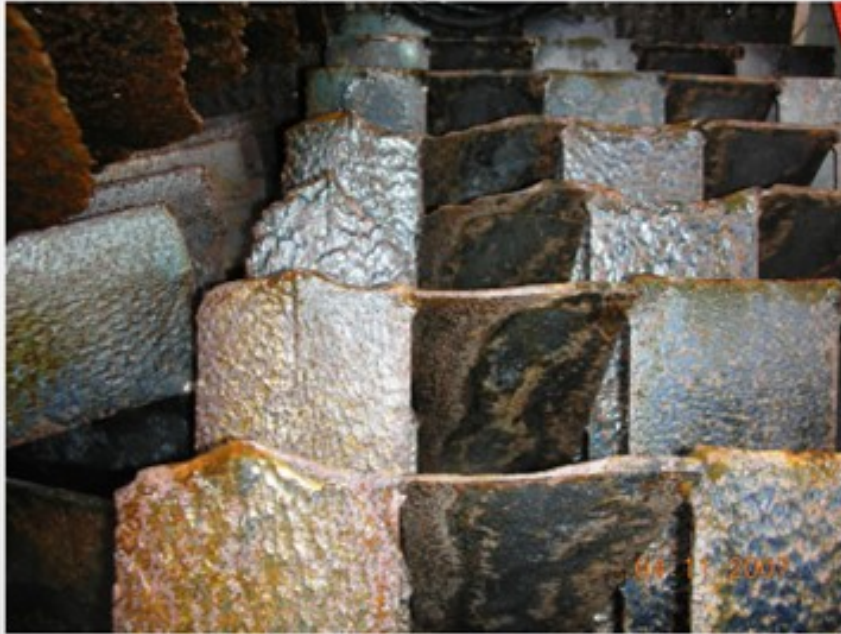
## Damaged Packing Layer

On the next slide, you can see another picture of that damage. There are erosion patterns in this wear. You can that see it is just worn down.

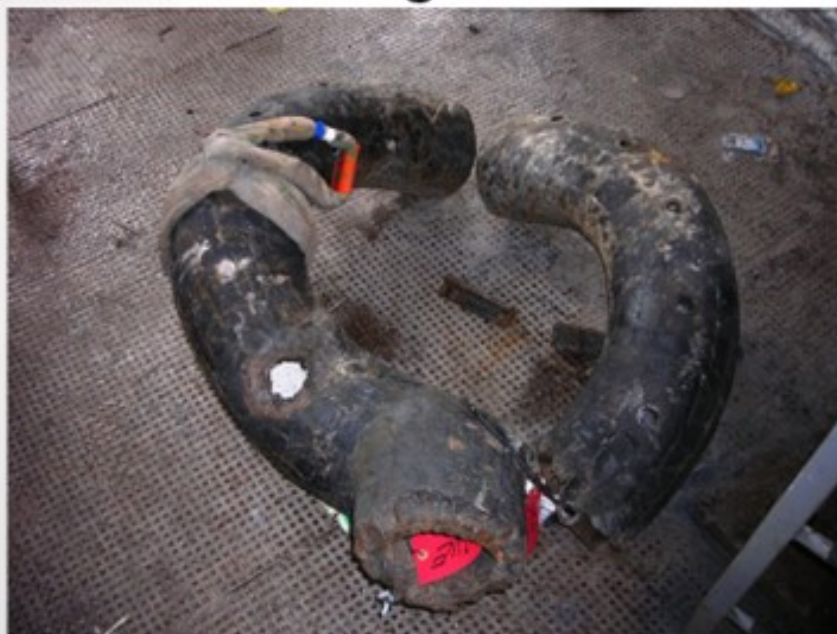
## Damaged Steam Ring

The last slide shows the steam ring. It was C-shaped. It failed in two locations. I believe there were bad welds, as dissimilar welds have failed. So, we put a pipe grid-type distributor in there, and it has done fine since then.

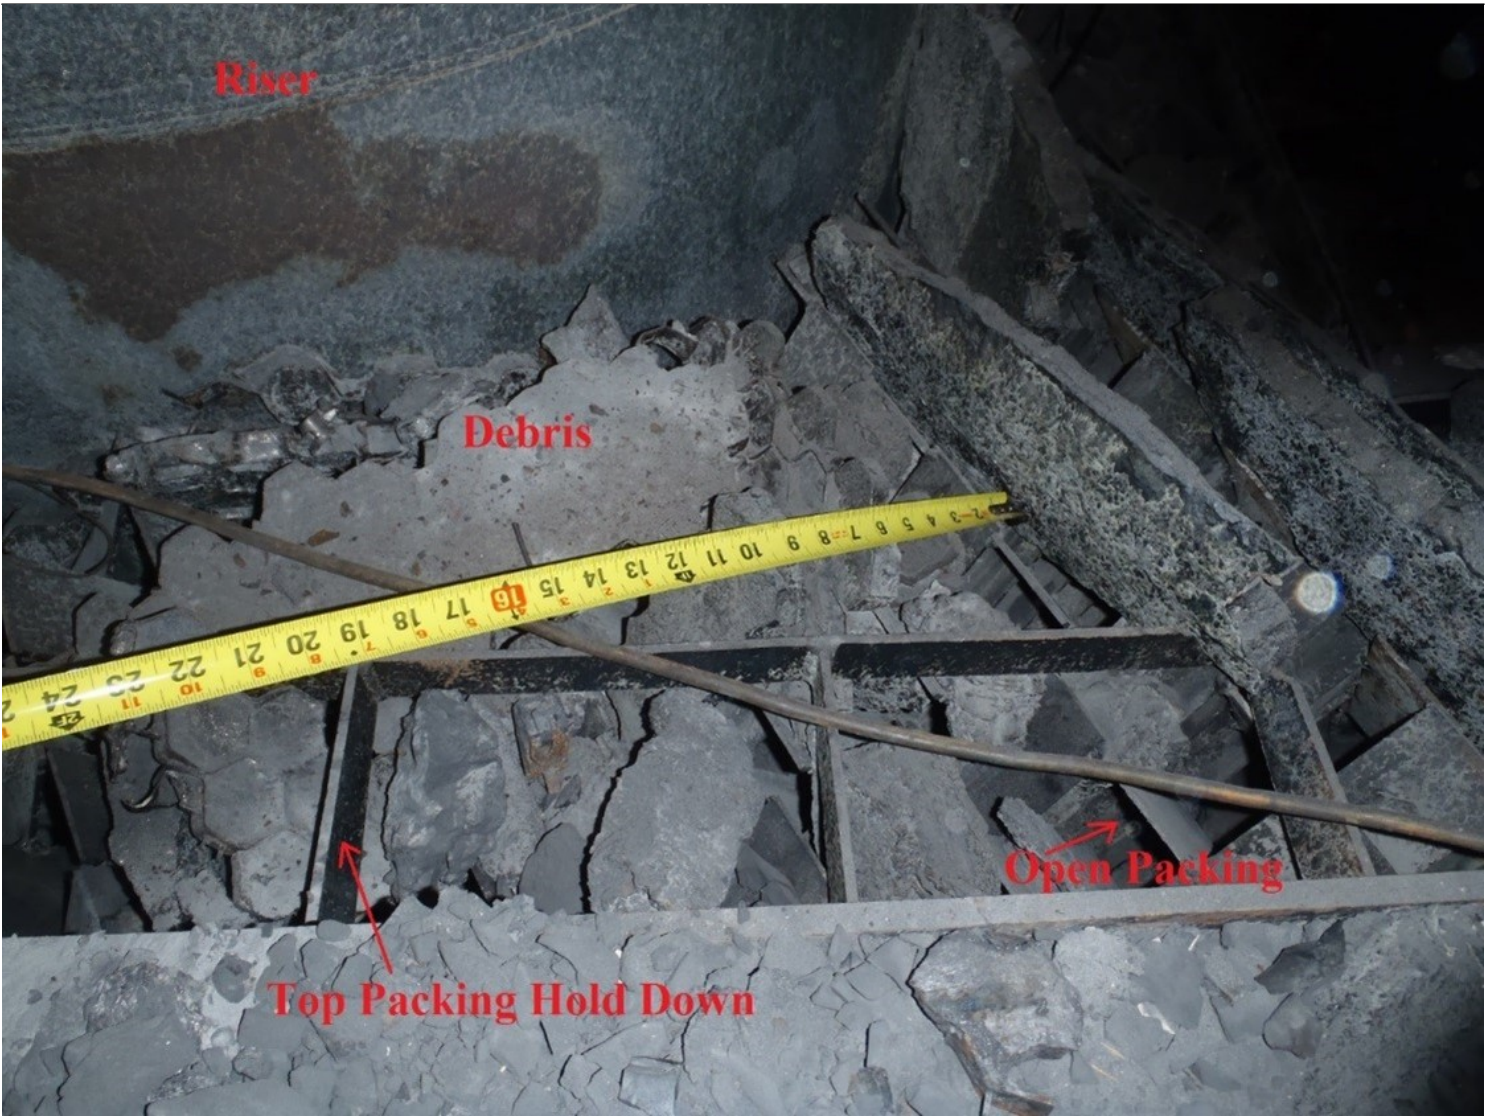
We installed packing in our reactor stripper in 2006. So far, the only issue we have seen was in 2012. When we went into the reactor, we had refractory and coke debris from various areas of the reactor that had fallen onto the top of the packing and partially clogged and blocked a portion of the packing. We had already made the decision to remove all of the packing to evaluate whether there was any erosion with the new configuration (there was not), but we would have needed to remove at least the top two layers for cleaning anyway due to the debris.

Debris

Open Packing

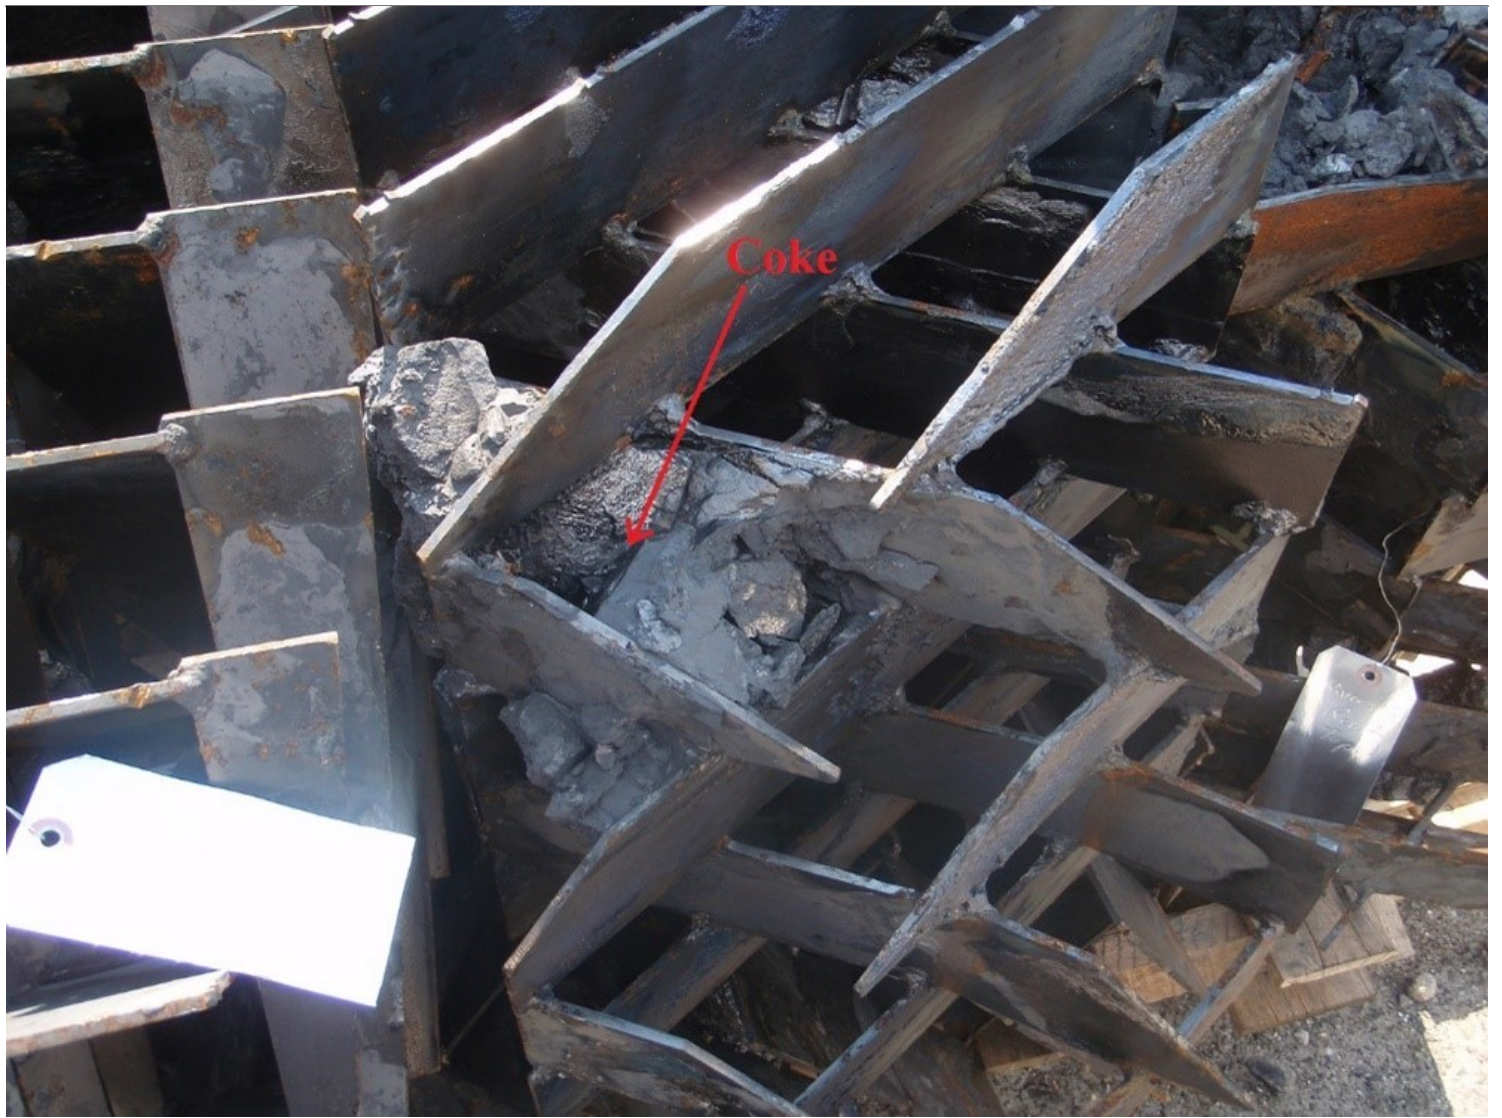
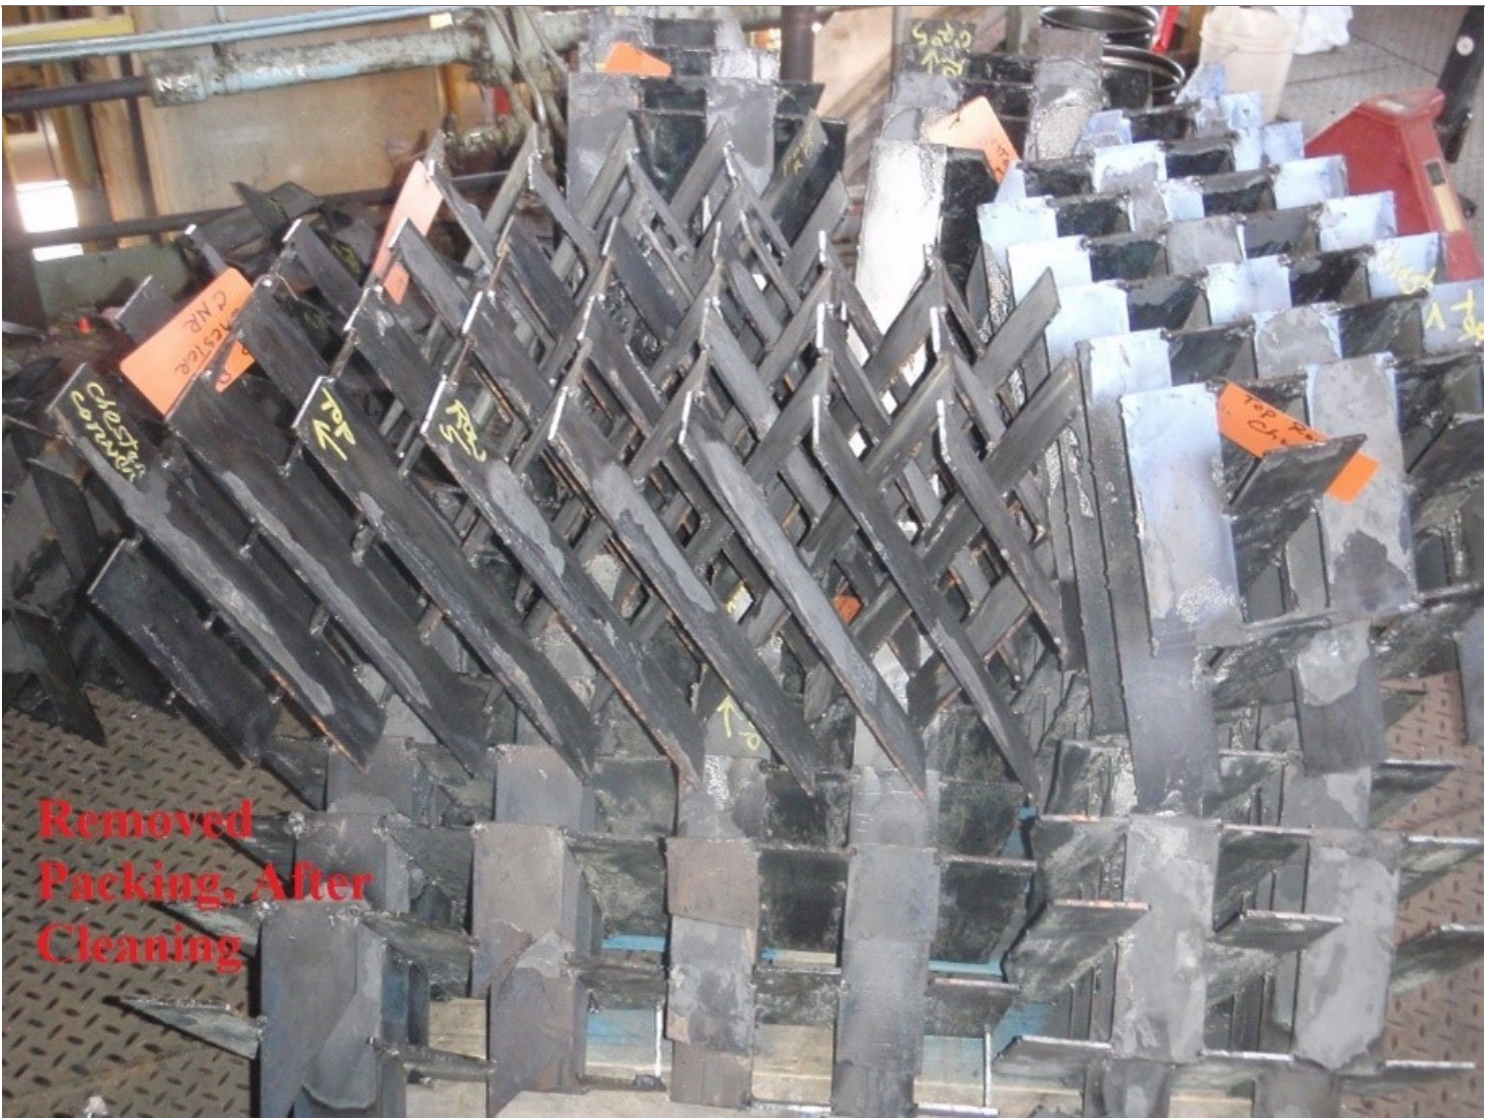
Once removed, we did not see any noticeable erosion on the packing itself; but in anticipation of possible issues, we had ordered one layer of spare packing prior to the outage. I will caution that the price per layer was twice as high when just ordering one or two layers compared to ordering a complete replacement (eight layers for us) and lead time for even just one layer was in the range of 12 weeks. I would also caution that even though our packing was very robust, some sections still got deformed during handling, although not badly enough to need to be replaced. For our next outage (if we did not already need to remove the packing for another reason), we would have suggested having one layer on hand and simply inspecting from the top and bottom and determining whether cleaning or replacement was needed from there.

The following pictures are of the as-found condition and the packing, and some pictures of it once it had been removed and then cleaned.
