Question 71: We have coker/cracked naphtha reboilers which foul on the shell side. How can we minimize the fouling? Are you practicing on-line cleaning in this service?

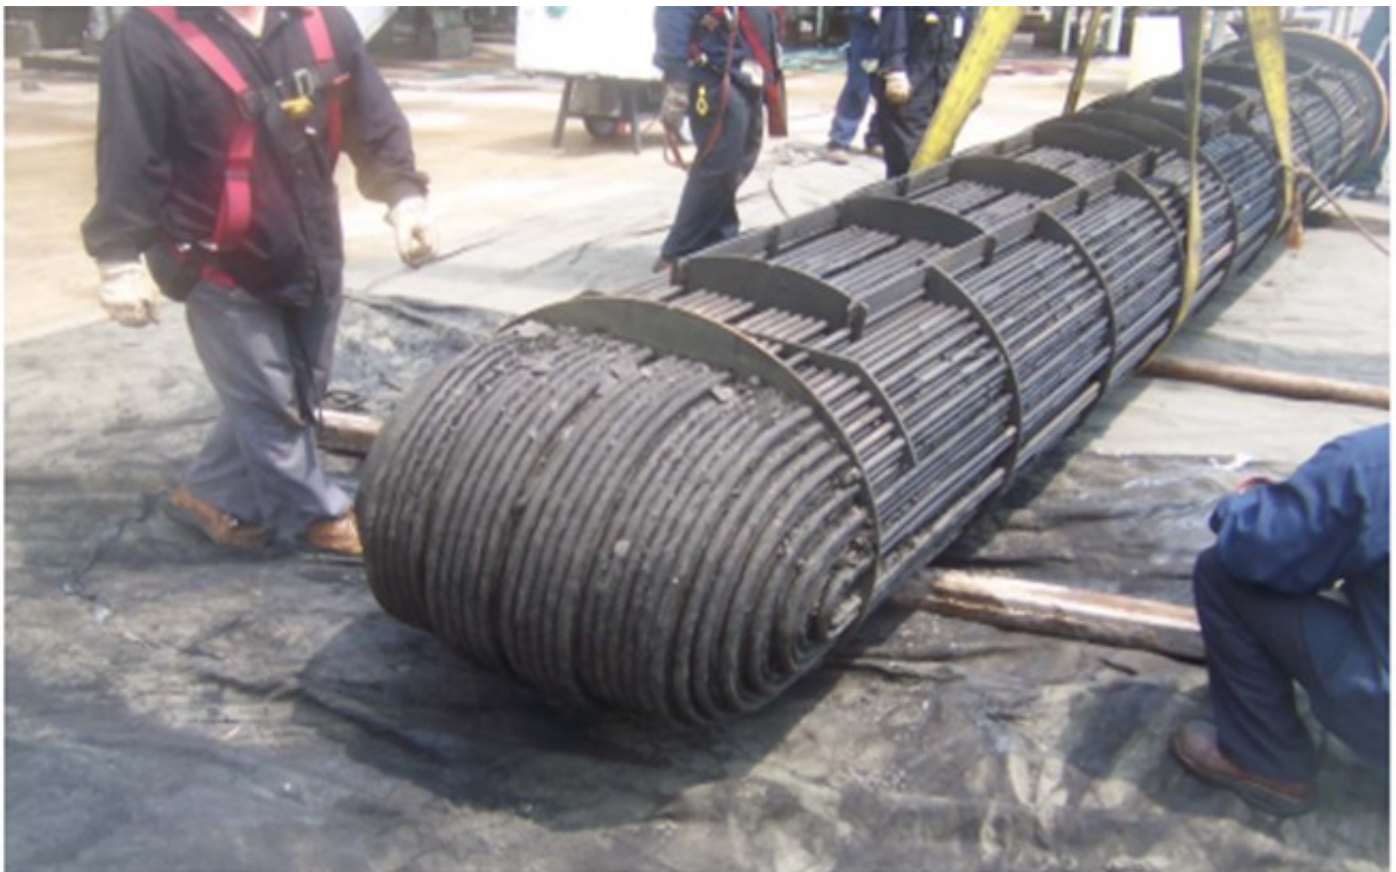
Coker debutanizer fouling is mainly caused by conversion of diolefins to form polymerization material. The polymerization material over time can turn into hard coke. The main cause for polymerization is high temperature of the reboiling media (above 550 F). This issue is more prevalent to units that use hot HCGO pumparound or superheated high pressure steam. If steam is used, make sure that it is desuperheated below 550 F to minimize polymerization. You can also add an inhibitor to the debutanizer feed to prevent polymer formation and reduce exchanger fouling rate. The picture below was from a coker debutanizer reboiler with heating media above 600 F (superheated 600 psig steam).
