Question 31: What is the panel's experience with temperature excursions (regeneration and otherwise) leading to the catalyst or equipment damage in reforming and isomerization units?

STEVES (Norton Engineering Consultants, Inc.)

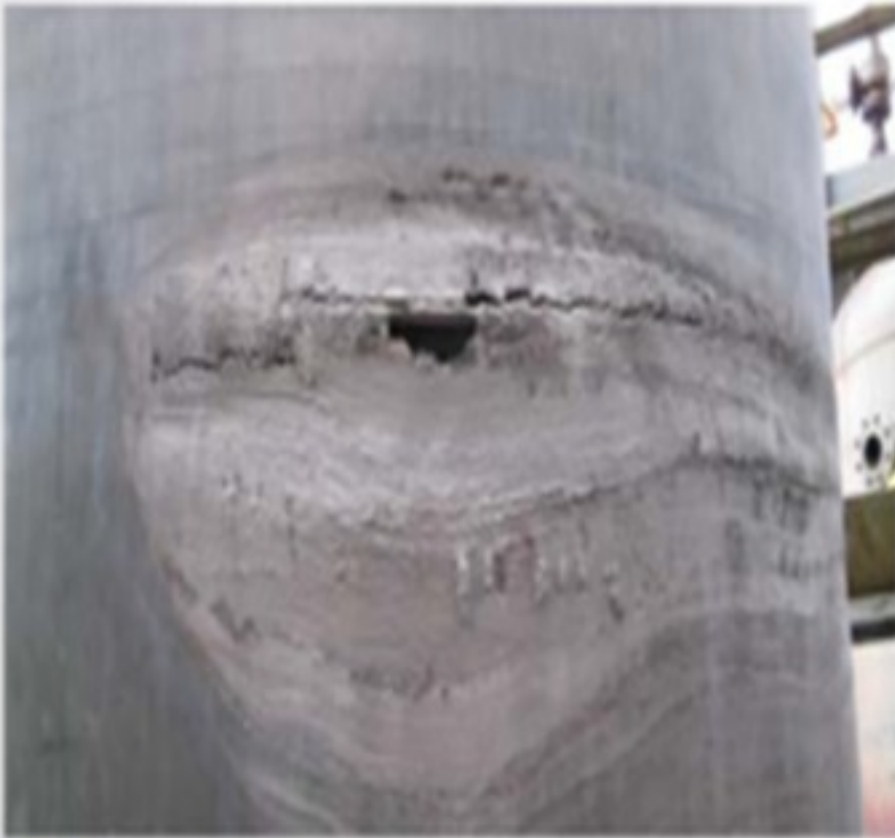
- Severe temperature excursion in chlorination zone of regenerator for moving bed reforming unit.
- Unit put back in “white burn” sooner than what would normally be recommended.
- Drying zone thermocouple indicated temperature spike over 2000° F – believe temperatures exceeded 3600° F.

Upon inspection, it was found that the center screen had failed, as shown on the slide.

- Failed center screen in regenerator

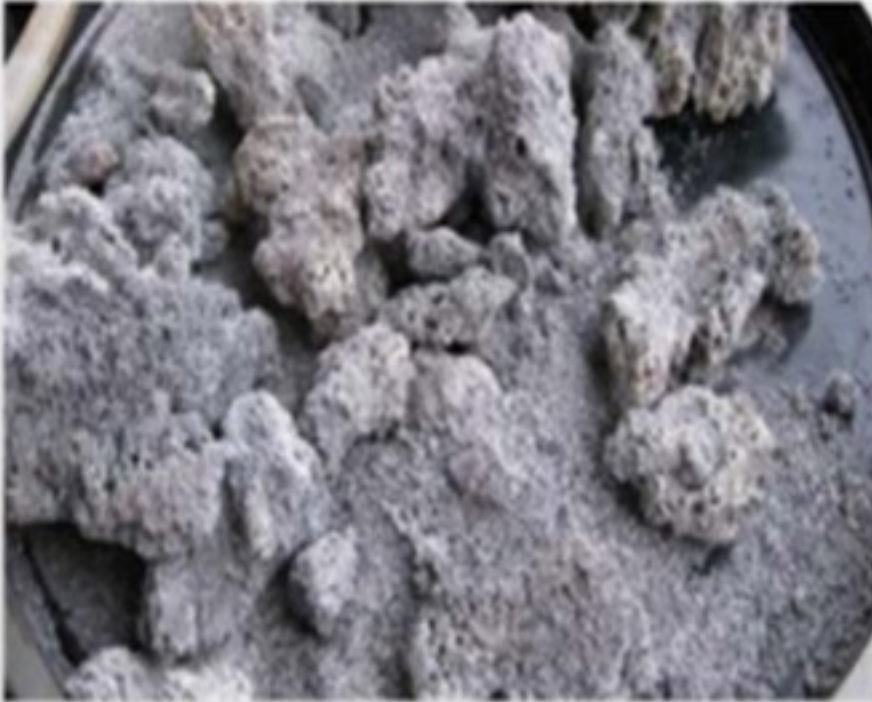
Also, fused catalyst was discovered in the unit. It is believed that temperatures exceeded 3,600°F during the excursion.

- Fused catalyst found in regenerator
