Question 31: What is the panel's experience with temperature excursions (regeneration and otherwise) leading to the catalyst or equipment damage in reforming and isomerization units?

Temperature Excursions

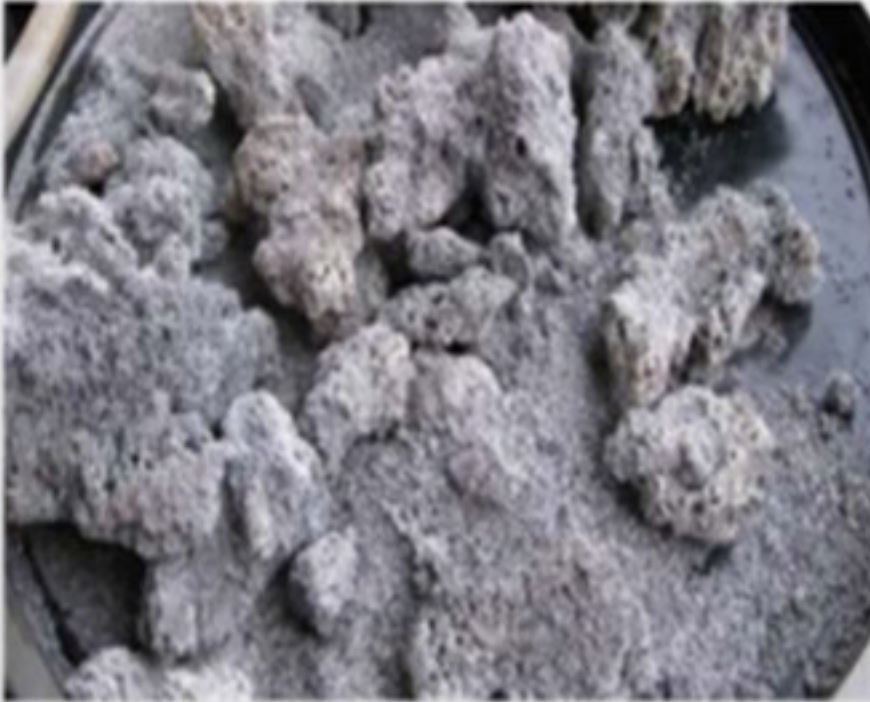
Also, fused catalyst was discovered in the unit. It is believed that temperatures exceeded 3,600°F during the excursion.

- Fused catalyst found in regenerator
