Question 31: What is the panel's experience with temperature excursions (regeneration and otherwise) leading to the catalyst or equipment damage in reforming and isomerization units?

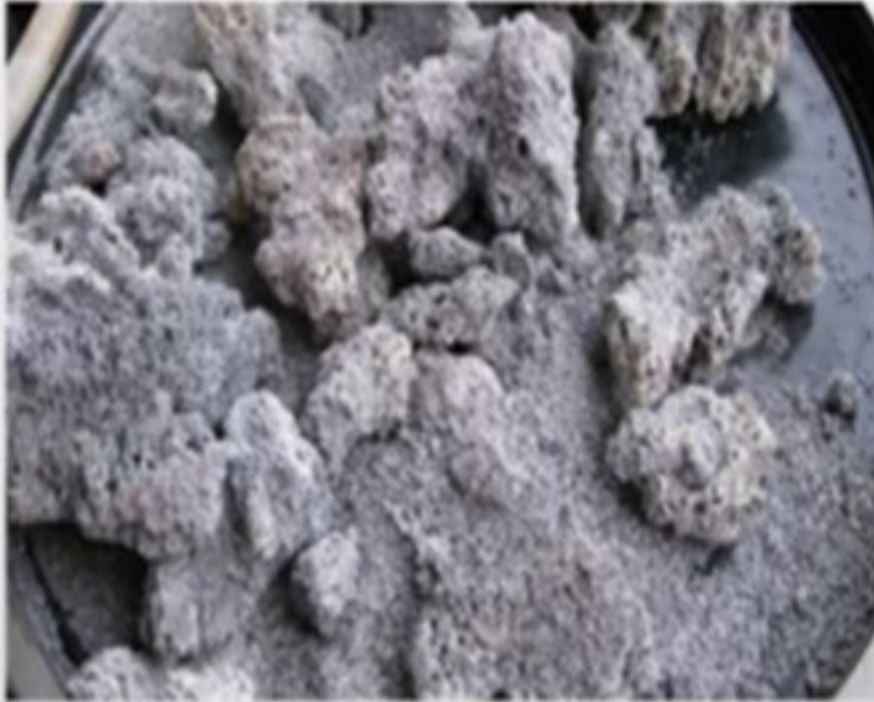
Also, fused catalyst was discovered in the unit. It is believed that temperatures exceeded 3,600°F during the excursion.

- Fused catalyst found in regenerator
