## **Question 65: Please share experiences in crude tower fouling from organic and/or phosphorous-containing deposits.**

**PRIBNOW** (CITGO Petroleum Corporation)

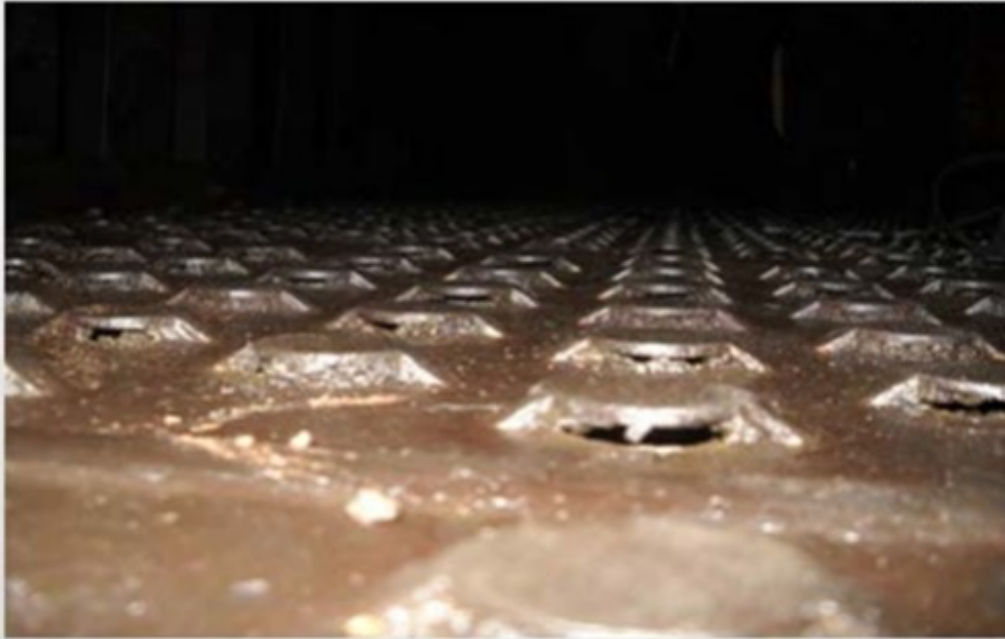
Q-65

Here are two pictures showing observations of what we saw when we went in the tower at turnaround. This first two slides show a portion of the tray above the kerosene draw. Observe the fouled material that was plugging the fixed valves. This fouling material there is substantial.

**Fouled Crude Atmospheric Tower Tray  
above the Kerosene Draw**

The next slide shows some of the samples taken by our engineers. We had it analyzed, and this is what we saw: carbon, oxygen, and that last component: phosphorous. That is really why we believe this was phosphorous organic fouling in this section. At turnaround, we made some modifications. We replaced the trays with some low fouling trays. We also replaced the top pumparound return distributor. Since that startup, we have not seen any degradation in this section. We feel those modifications will get us through the run.

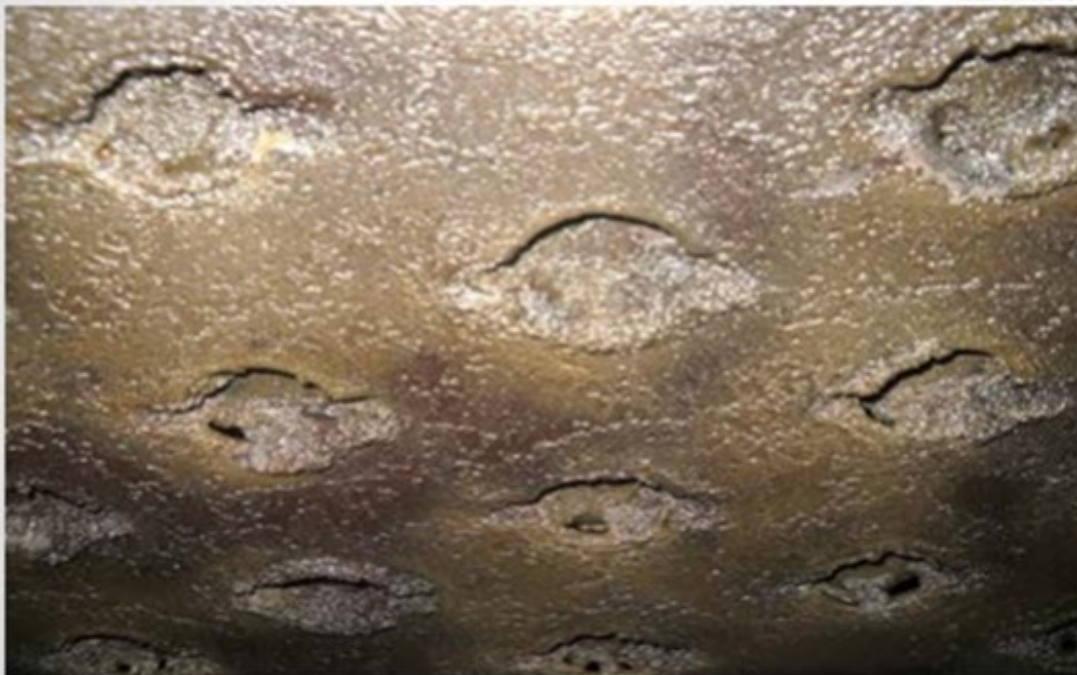
Q-65

**Fouled Crude Atmospheric Tower Tray  
above the Kerosene Draw**

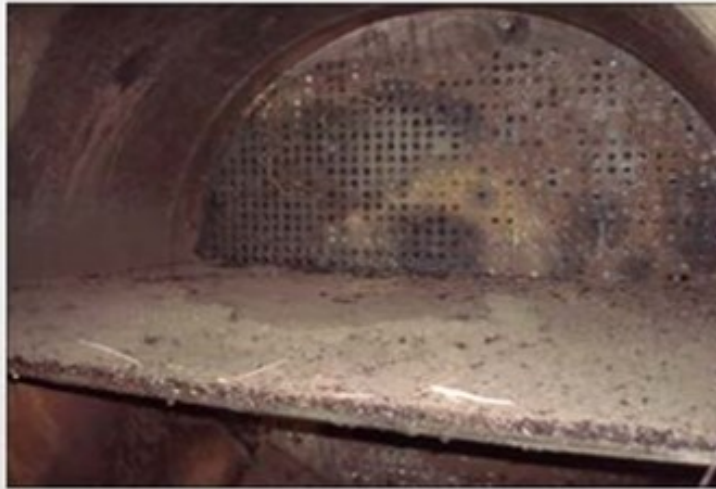
Q-65

On the next slide, you can see how the trays looked when we opened the tower.

# Pumparound Tube Sheet Phosphorous Fouling

As an early online mitigation during the troubleshooting phase, we tried an organic acid wash without success. Long-term mitigation was upgraded in the trays in several sections of the tower to low fouling designs.

- Mitigation
  - Unsuccessful on-line organic acid wash
  - Upgraded kerosene, diesel, and preflash bottom sections to fixed valve trays

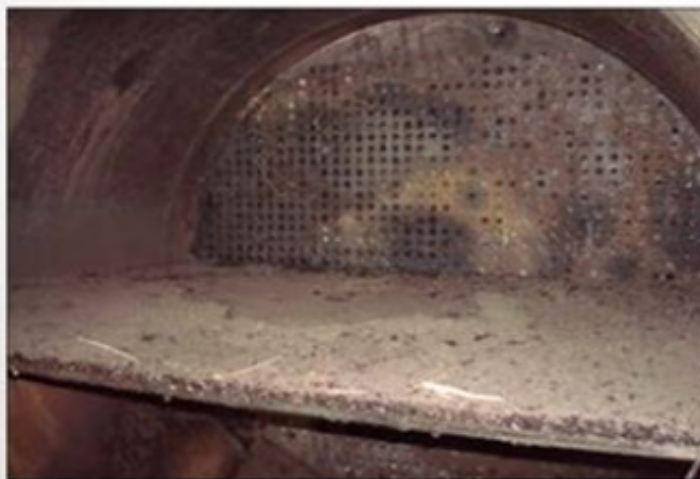
Q-65

The last slide shows fouling in one of the heat exchangers.

# Pumparound Tube Sheet Phosphorous Fouling
