Question 72: What are potential causes of damage to the top section of coker main trays? What mechanical and process considerations are used in designing the top section trays for more reliable operation?

2013 Crude/Alcolum Distillation & Coking Q&A Session

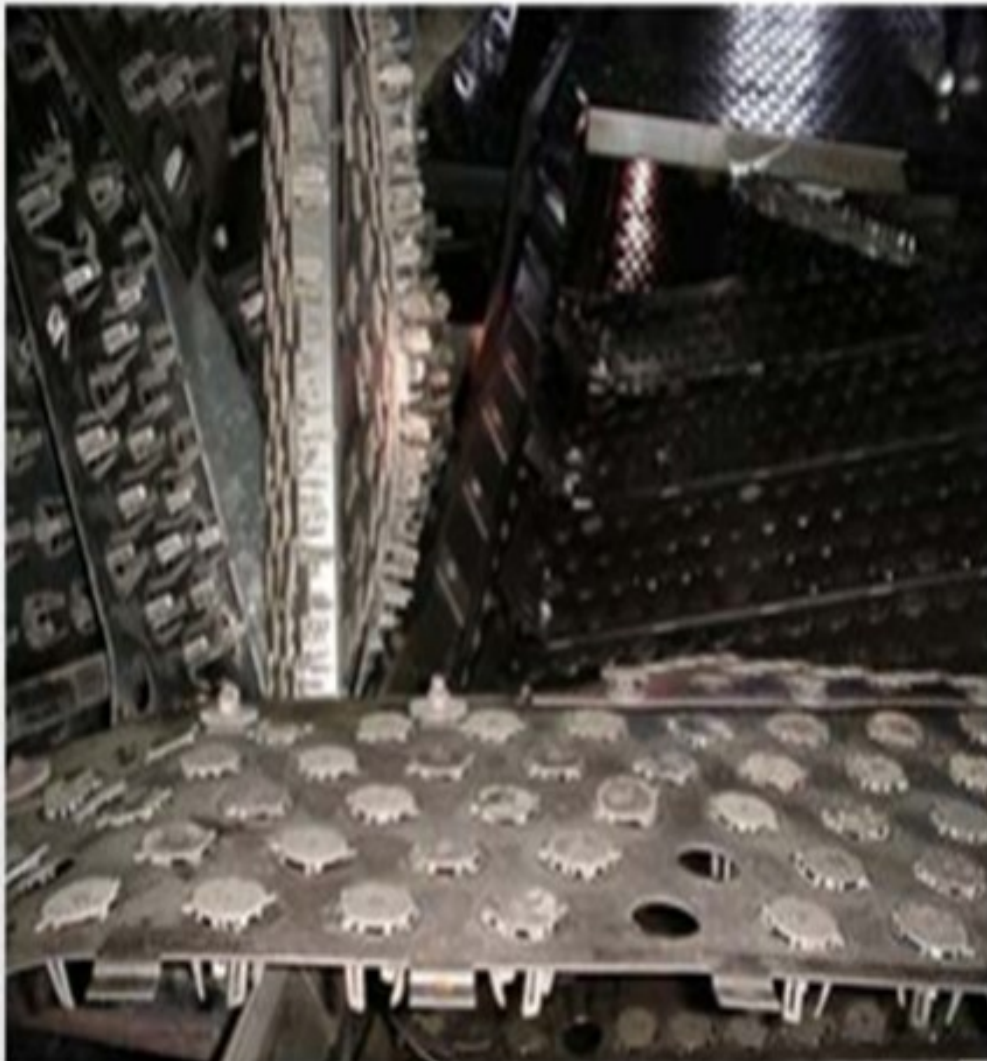
Q-72

Increasing the overhead temperatures is probably one of the better ways to control salt deposition and prevent the salts from precipitating in the trays. You could also balance the heat removal between your overhead condenser and the pumparound streams. If you have a low naphtha endpoint, a backend naphtha splitter could be used. Finally, the fractionator overhead drum has to be designed for adequate hydrocarbon and water separation. Operational issues can occur when water is introduced into the fractionator, which then causes a blowout of the vaporized water. We know of one instance during a startup operation when the spare LCGO pumparound pump, which had not been completely drained of water, was started. The rapid expansion of the vaporized water caused by the high temperature in the fractionator blew the top section of the trays between the LCGO section and the overheads. These slides show that event.

Damage to Fractionator trays

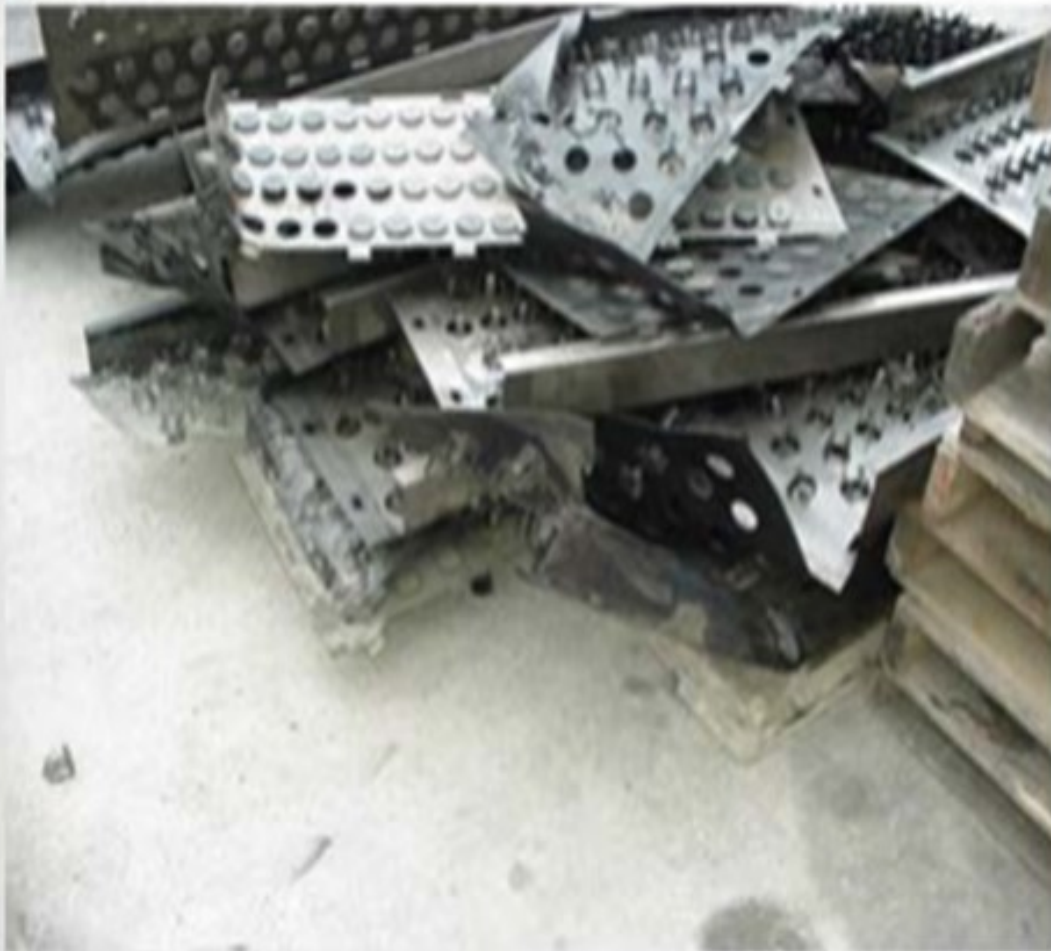
Q-72

Damage to Fractionator trays

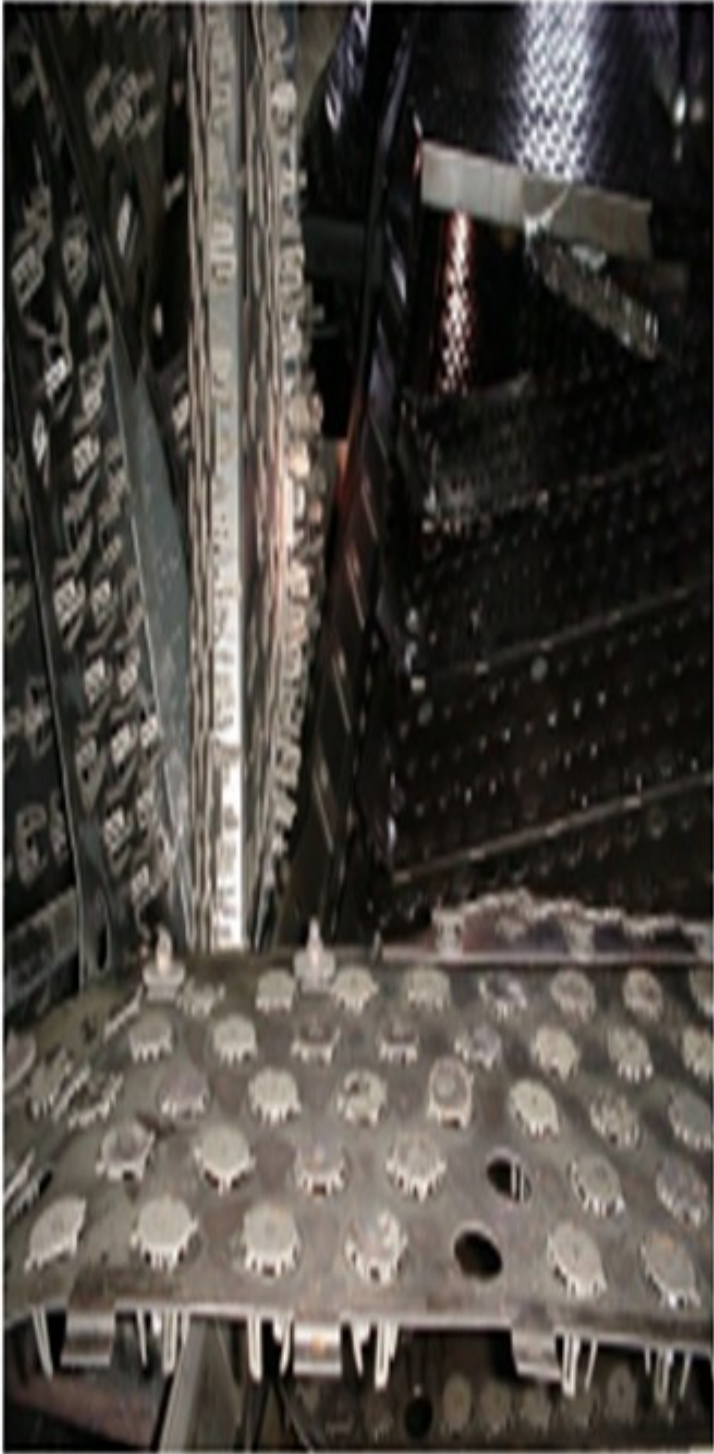
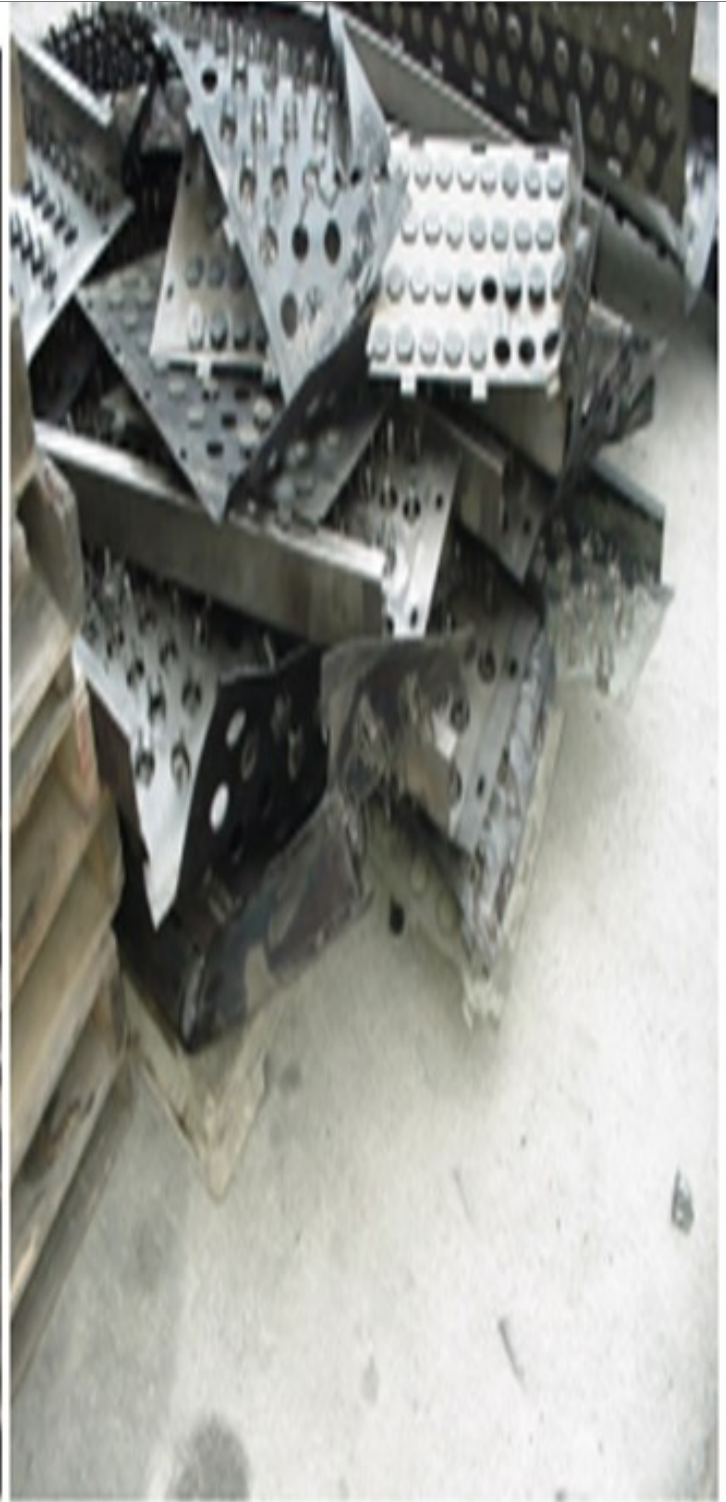
Operational issues occur when water is introduced into the fractionator causing a blowout of the vaporized water. We know of one instance during a startup operation when the spare LCGO pumparound pump, which had not been drained completely of water, was started. The rapid expansion of the vaporized water caused by the high temperature in the fractionator blew the top section of the trays between the naphtha and LCGO sections in the fractionator. Below are photographs showing the damage.
