AFPM PROCESS SAFETY BULLETIN

Flammable Mixture Accumulation in FCC Units During Non-Routine Operations

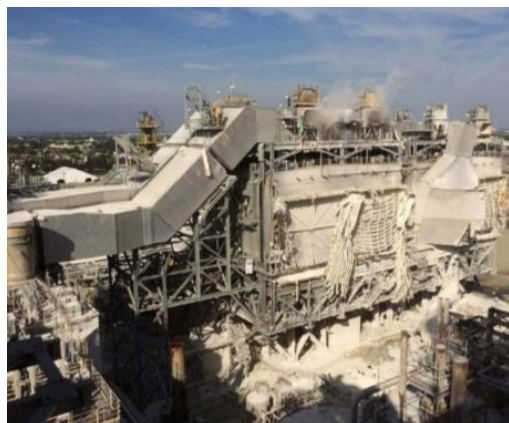
Event # 1 (CSB Report - Refinery Explosion)

An explosion occurred in the FCC's ESP, a pollution control device that removes catalyst particles using charged plates that produce sparks (potential ignition sources) during normal operation. The incident occurred during an attempt to isolate equipment for maintenance while the unit was in a standby mode of operation. Improper pressure balance allowed hydrocarbons to flow to the regenerator and ignite in the ESP. The CSB found that safe operating limits for operating the unit in Safe Park (a standby mode of operation) were not established, and therefore the unit was placed in an unsafe condition when steam flow to the reactor was reduced below a safe level.

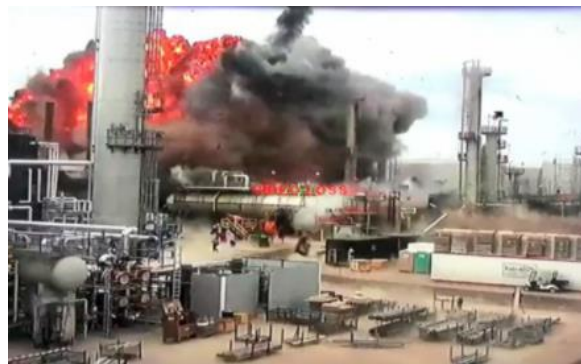
Event # 2 (CSB Report - Refinery Explosion and Fire)

During the shutdown of the refinery in preparation for a 5-week turnaround, an explosion occurred in proximity to the FCC unit. Catalyst de-inventoried into the regenerator and an improper pressure balance resulted in the transfer of air from the regenerator into the reactor. The air accumulated in equipment downstream of the reactor until a flammable mixture was reached and found an ignition source. Projectiles from the resulting explosion punctured an asphalt tank about 200 feet away. The asphalt pouring from the hole flowed beyond the protective berm and began to accumulate in the FCC and crude fractionator processing areas. The asphalt ignited resulting in a smoky fire causing the evacuation of a portion of the nearby community.

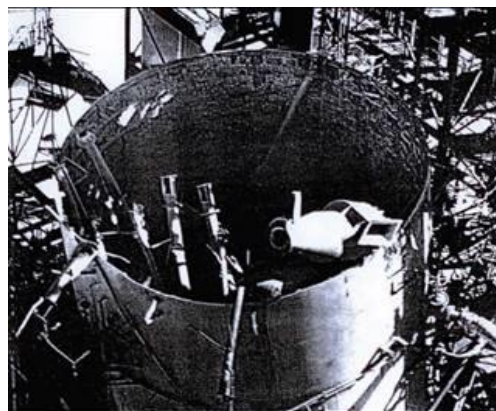
Event # 8

During an FCC unit shutdown, the steam flows to the reactor were gradually reduced over the course of 5 hours for various reasons while catalyst was unloaded from the regenerator. During this time, fuel gas was continuously injected in the top of the main fractionator to maintain the system pressure. Condensation of the steam in the main fractionator overhead and the removal of all significant steam sources in the reactor allowed fuel gas to flow back to the regenerator and form an explosive mixture. A large explosion occurred in the regenerator approximately 2.5 hrs. after the final reductions in steam. The regenerator head, weighing approximately 165 tons was launched approximately 125 ft causing damage to piping in the area. The event took place in 1963, with no casualties or subsequent fires occurring in conjunction with the incident.
