# Question 67: Have you experienced coking or other fouling of reboilers in naphtha distillation service (splitter, debutanizer, etc.)? If so, what operational or design changes did you implement to eliminate this problem?

# Frank Tracy (ConocoPhillips)

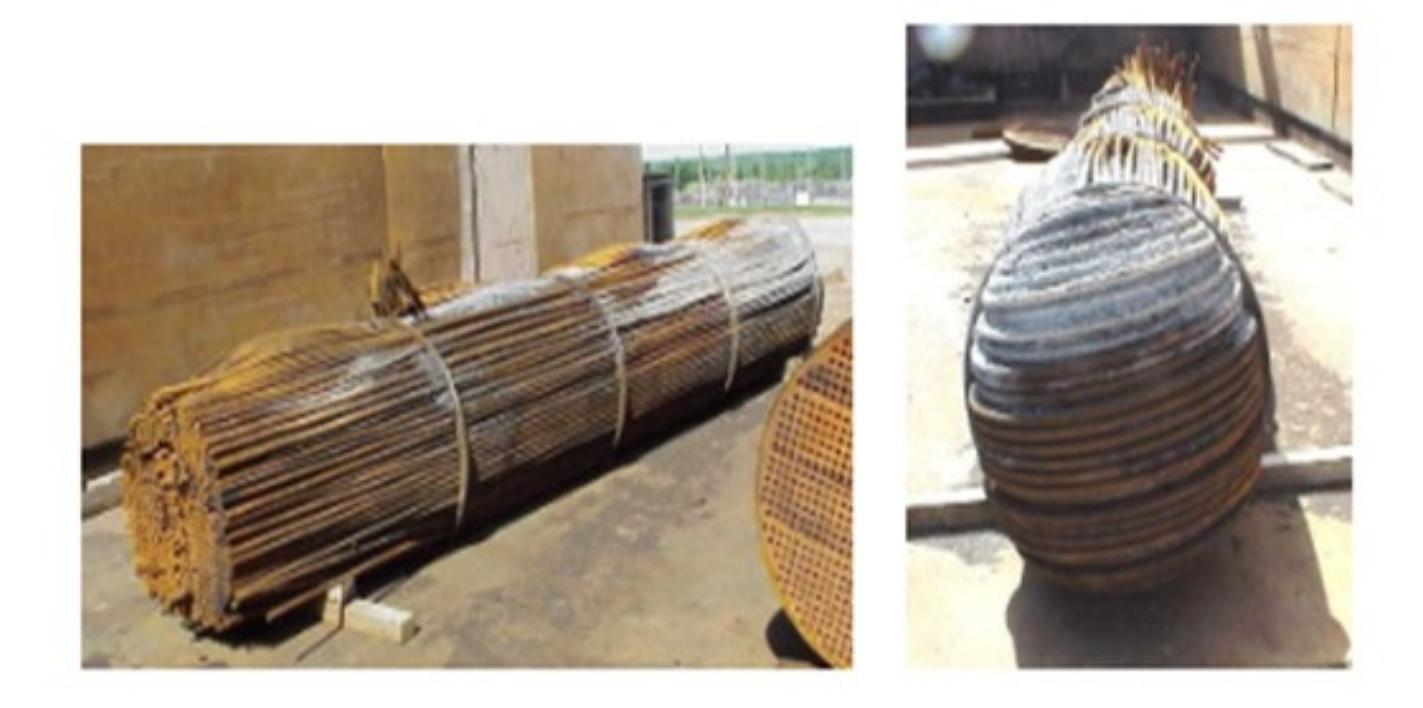
•Extensive coke formation within the bundles bulged the tops rows of tubes into the shell cavity. •Shellside fouling was found largely in the top 1/3 of the bundles.

•Fouling was believed to be caused by iron-catalyzed diolefin polymerization that eventually became coke and was a function of •Reboiler tube wall temperature

- ·Diolefin concentration
- Iron concentration

•We eliminated issue by lowering HCO temperature some and changing metallurgy to 9Cr bundles. It has been four years since bundle replacement without performance problems. We will confirm during next year's turnaround.
