Question 85: What operating practices or technology upgrades are you using to manage coking in the reactor overhead line at the main fractionator inlet?

Coking In Reactor Overhead

2015 FCC Q&A Session

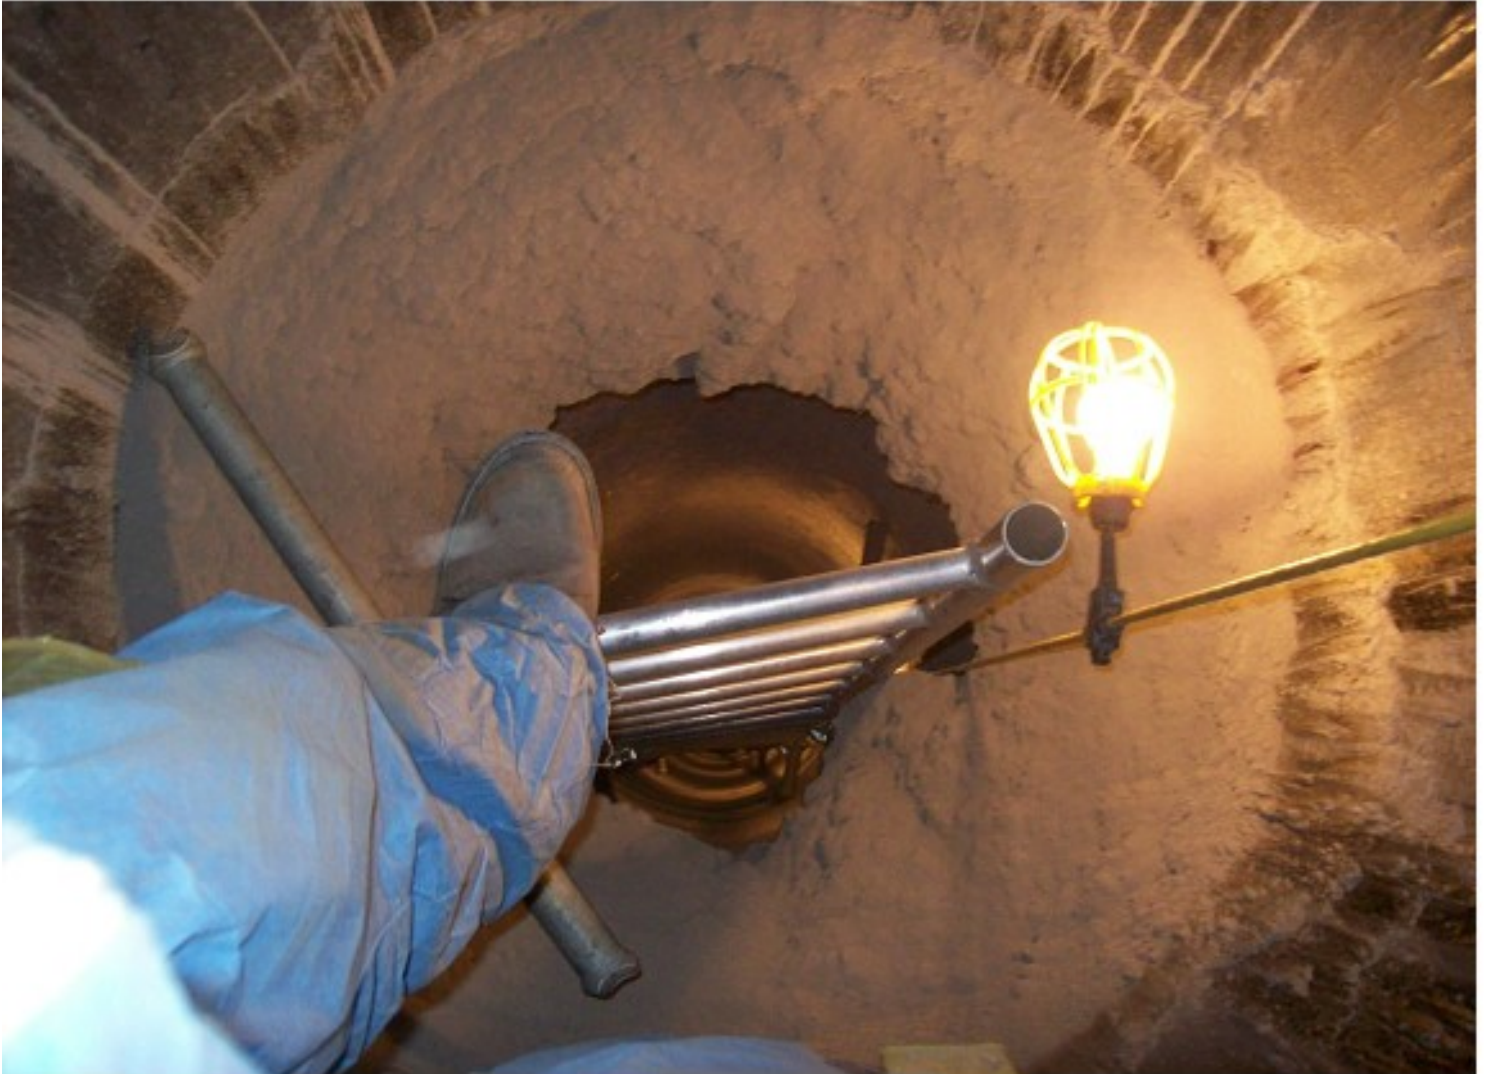
The only vapor line coking incident occurred because of condensation. A portion of a reactor vapor line was replaced during a scheduled unit turnaround. The transition between the hot wall and cold wall components was not properly insulated. This resulted in a cold spot where reactor vapors condensed and formed coke. The coke ring caused a 1.5 psi pressure drop. The problem was diagnosed from regular, single-gauge unit pressure surveys. A picture of the coke deposit is shown below.
