## Question 94: What is your experience regarding corrosion of hexmesh anchorage in regenerators using non-phosphate bonded abrasion resistant lining materials?

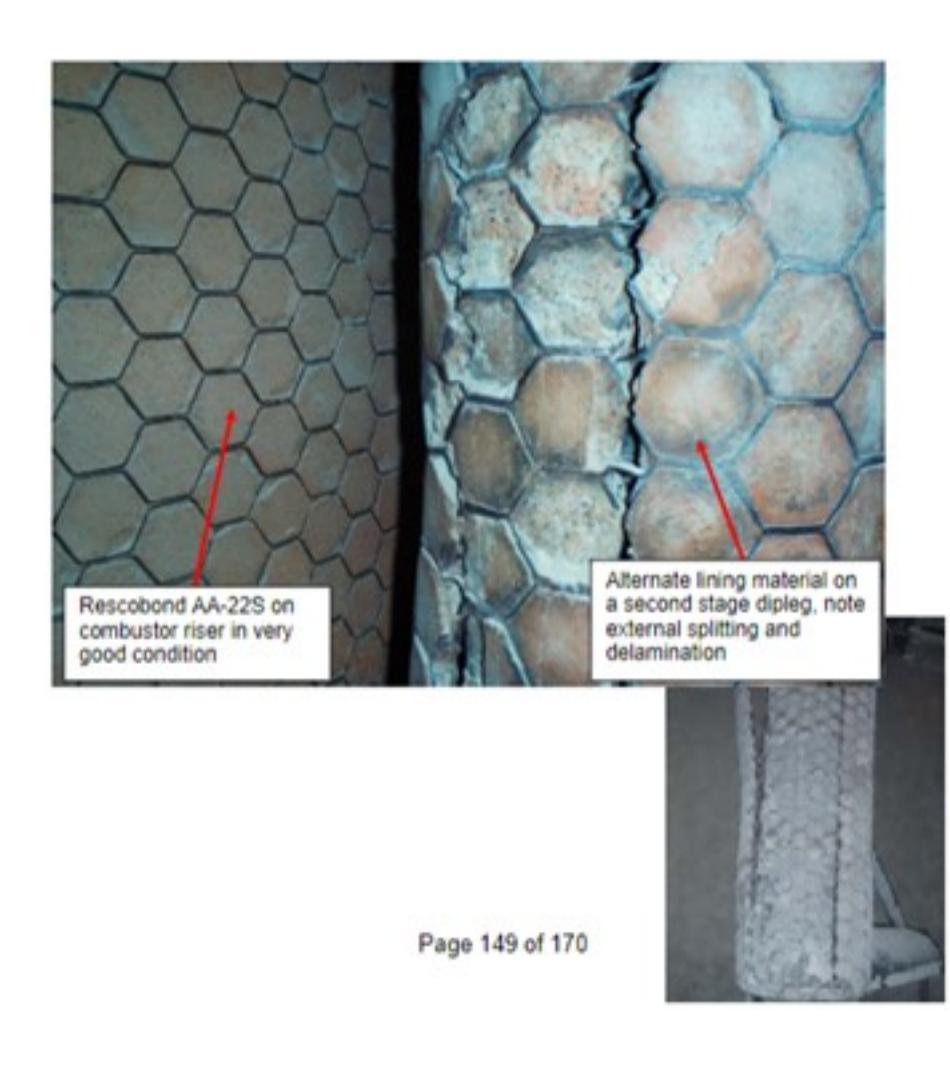
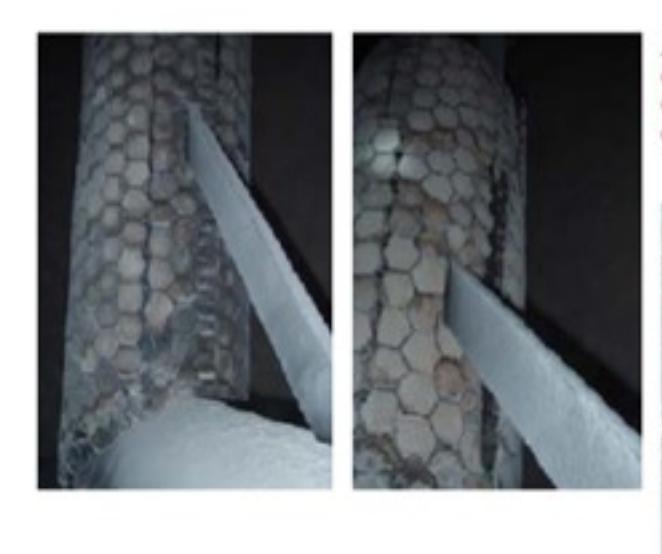
The slide on screen shows both categories of abrasion resistant materials side by side in a new full burn FCC unit. This FCC unit started up in February 2008 and processes virgin HVGO feed containing about 2.5 wt% sulfur. The pictures shown were taken in July 2011 after about 2.5 years of operation. The pictures show Rescobond AA-22S on the exterior of the regenerator combustor riser right next to an Alternate refractory material installed on the exterior of a regenerator second stage cyclone dipleg. The internal refractory linings of the cyclones were also in very poor condition as shown in the second picture.

Alternate refractory lining failure due to under-lining corrosion on exterior of regenerator cyclone diplegs.

On the basis of the strong empirical correlation between lining failures and use of Alternate refractory materials and the lack of a clear solution to the problem, UOP has revised its abrasion resistant lining project specifications and now lists only Rescobond AA-22S for use in regenerator abrasion resistant linings. This under-lining corrosion has not been seen at the lower temperature reducing conditions in the reactor and several Alternate materials are cited as approved for use in FCC reactor abrasion resistant linings.
