Question 42: In your experience, what are the typical causes of damage to the top of the regenerator inner screen?

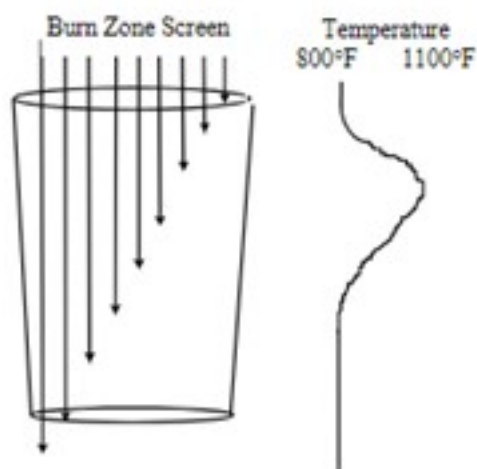
Typical Burn Zone Temperature profile

The typical cause for damage in the top 2-3 ft of inner screen is metal fatigue due to thermal cycling. This is common to all CCR designs, but more critical in early pressurized designs. Catalyst entering the regenerator from the vessel above is relatively cool, from the catalyst lift and elutriation. The cold catalyst enters the regenerator and the regeneration gas at the top of the screen will cool as it passes through this top section of catalyst, then in turn the gas will cool the inner screen.

As the carbon burn begins, catalyst temperature will increase thereby causing the inner screen temperature to rise. Each time catalyst cycles, a thermal cycle at the top of the regenerator inner screen will occur.

TI	Normal Range of temperature
TI-1	800-950°F
TI-2	920-1100°F
TI-3	920-1100°F
TI-4	915-1040°F
TI-5	915-940°F
TI-6	915-940°F
TI-7	915-940°F
TI-8	895-930°F
TI-9	895-930°F

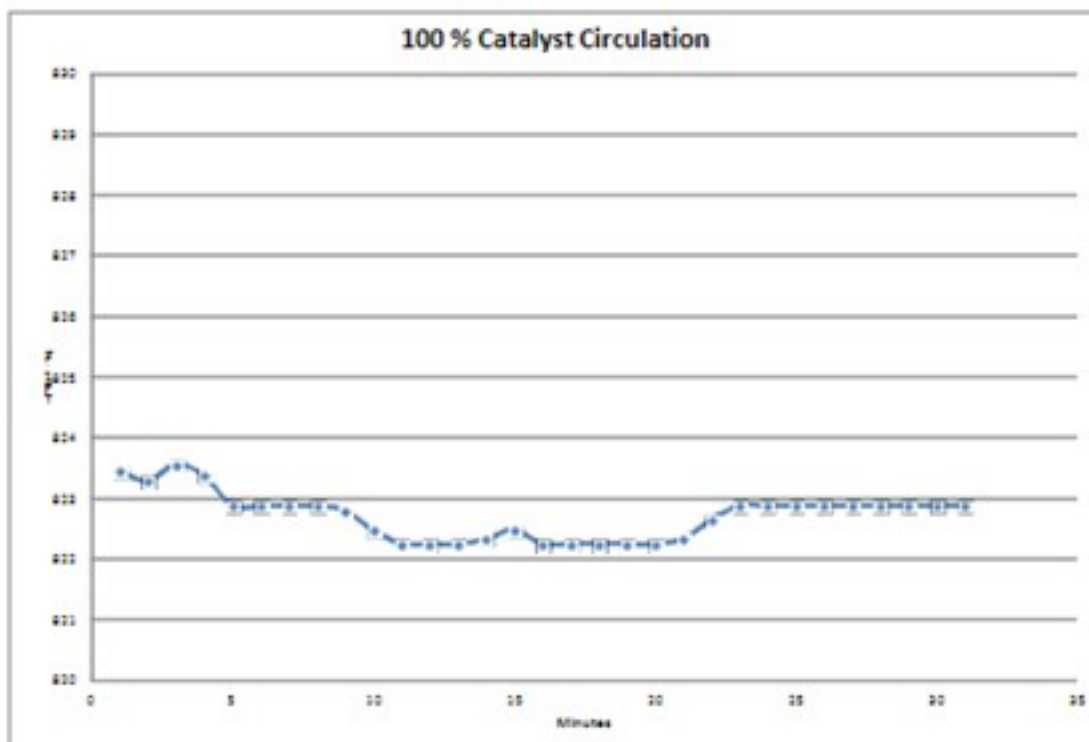
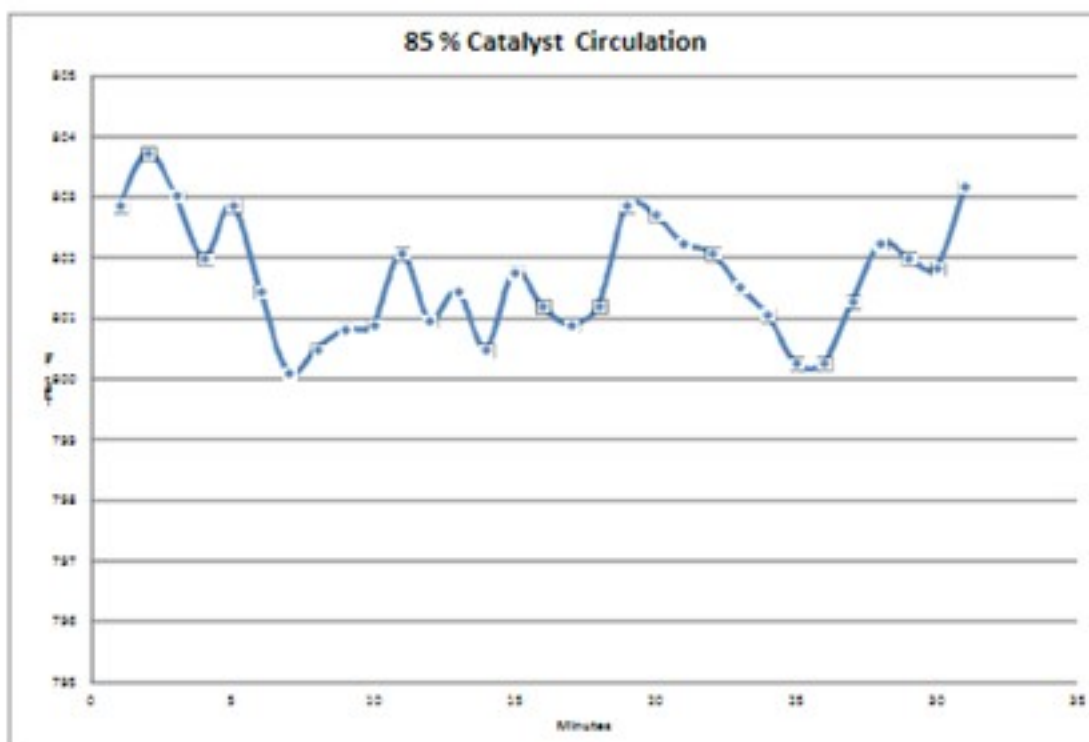
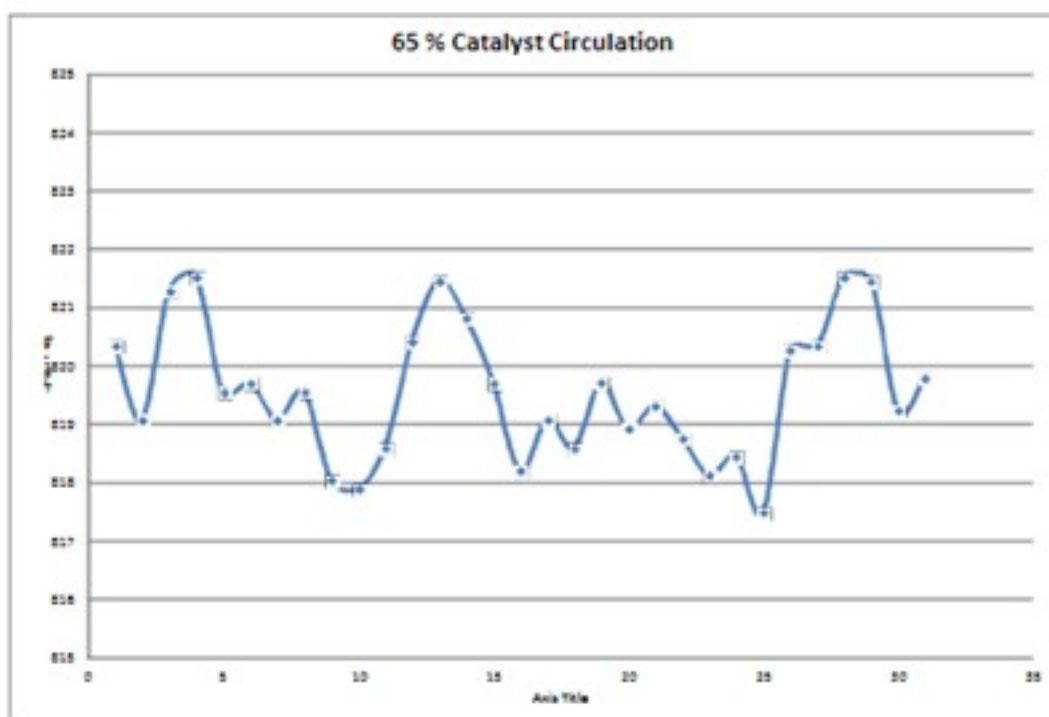
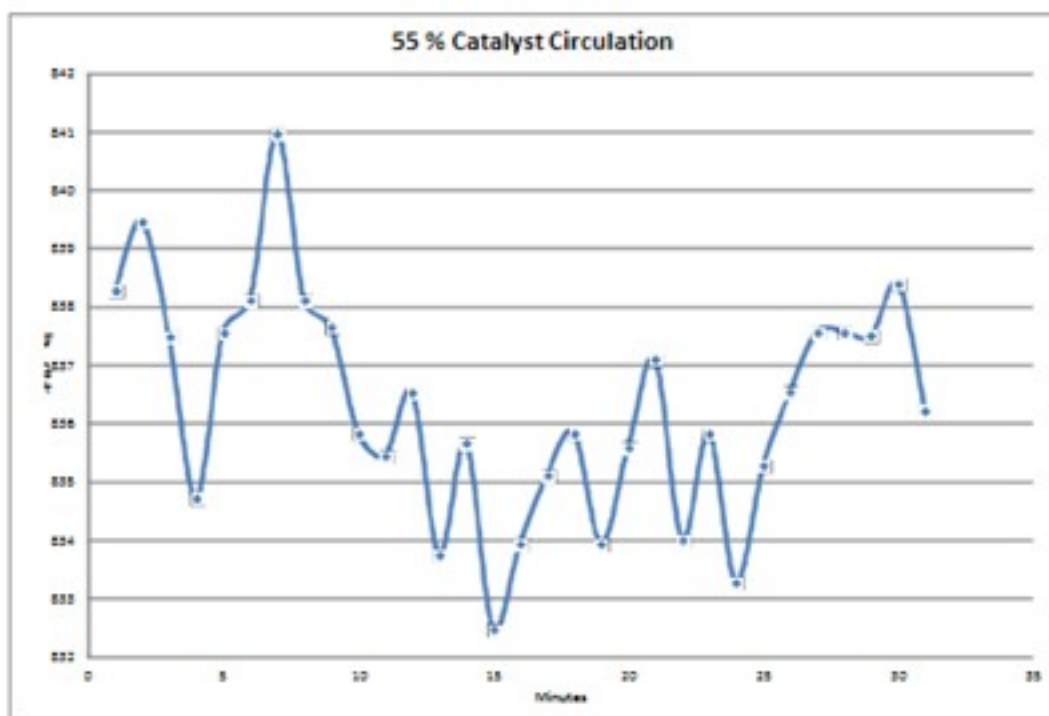
Catalyst circulation rate plays a part in the amplitude of the temperature cycle at the top of the inner screen. Lower catalyst circulation rates lead to larger cycles and increased fatigue. The same is true for shutdowns that occur during normal operation at any catalyst circulation rate.

Table	FCH Load Size	
	25 lbs	
Cat alyst Circulation Rate	Catalyst Unload Time	
100%	60	Seconds
85%	70	
65%	90	
55%	110
