Question 65: Please share experiences in crude tower fouling from organic and/or phosphorous-containing deposits.

2013 Crude/Atm. Distillation & Coking Q&A Session

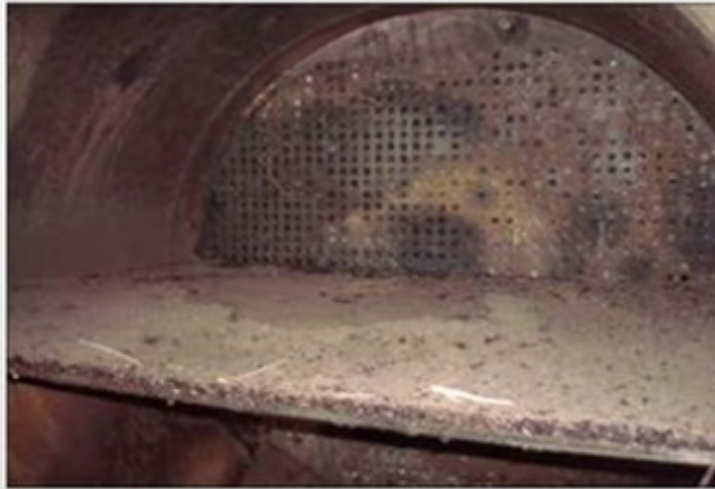
Pumparound Tube Sheet Phosphorous Fouling

On the next slide, you can see how the trays looked when we opened the tower.

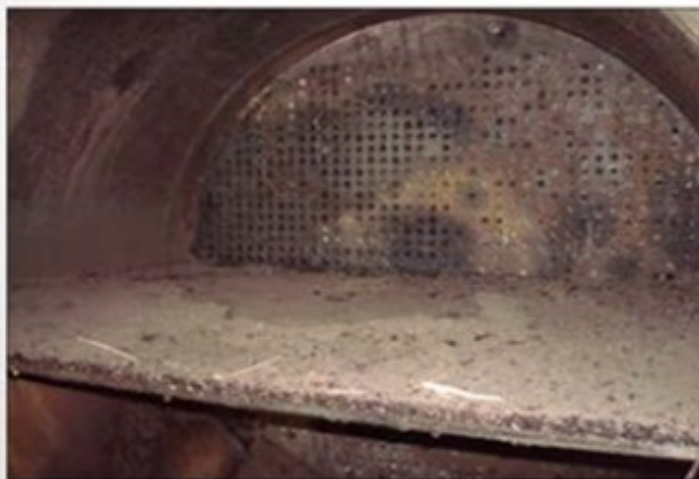
Pumparound Tube Sheet Phosphorous Fouling

The last slide shows fouling in one of the heat exchangers.
