## **Question 95: What failure mechanisms have you observed in cyclone or cyclone support systems? What is the typical time to failure?**

# Failure Mechanisms of Cyclones and Supports

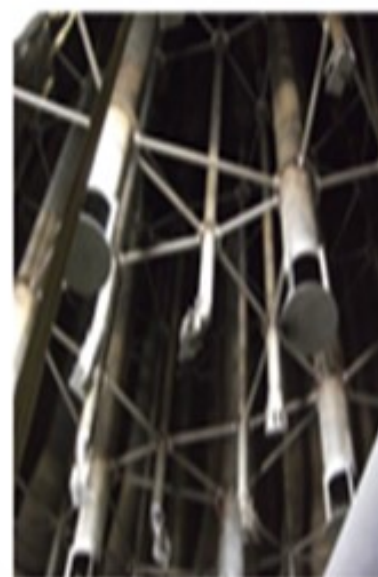
- **Observations**

- Cyclone designs
- Support systems
- Change in feed qualities
- Operation at high vapor and catalyst velocity

- **Time to failure**

- Length of operation within design parameters
- Shutdowns and temperature excursions

- **Support system**
