Question 18: What are your methods to mitigate bed 1 pressure drop without a unit skim? How would your approach be different if the pressure drop developed in a different bed, say bed 3?

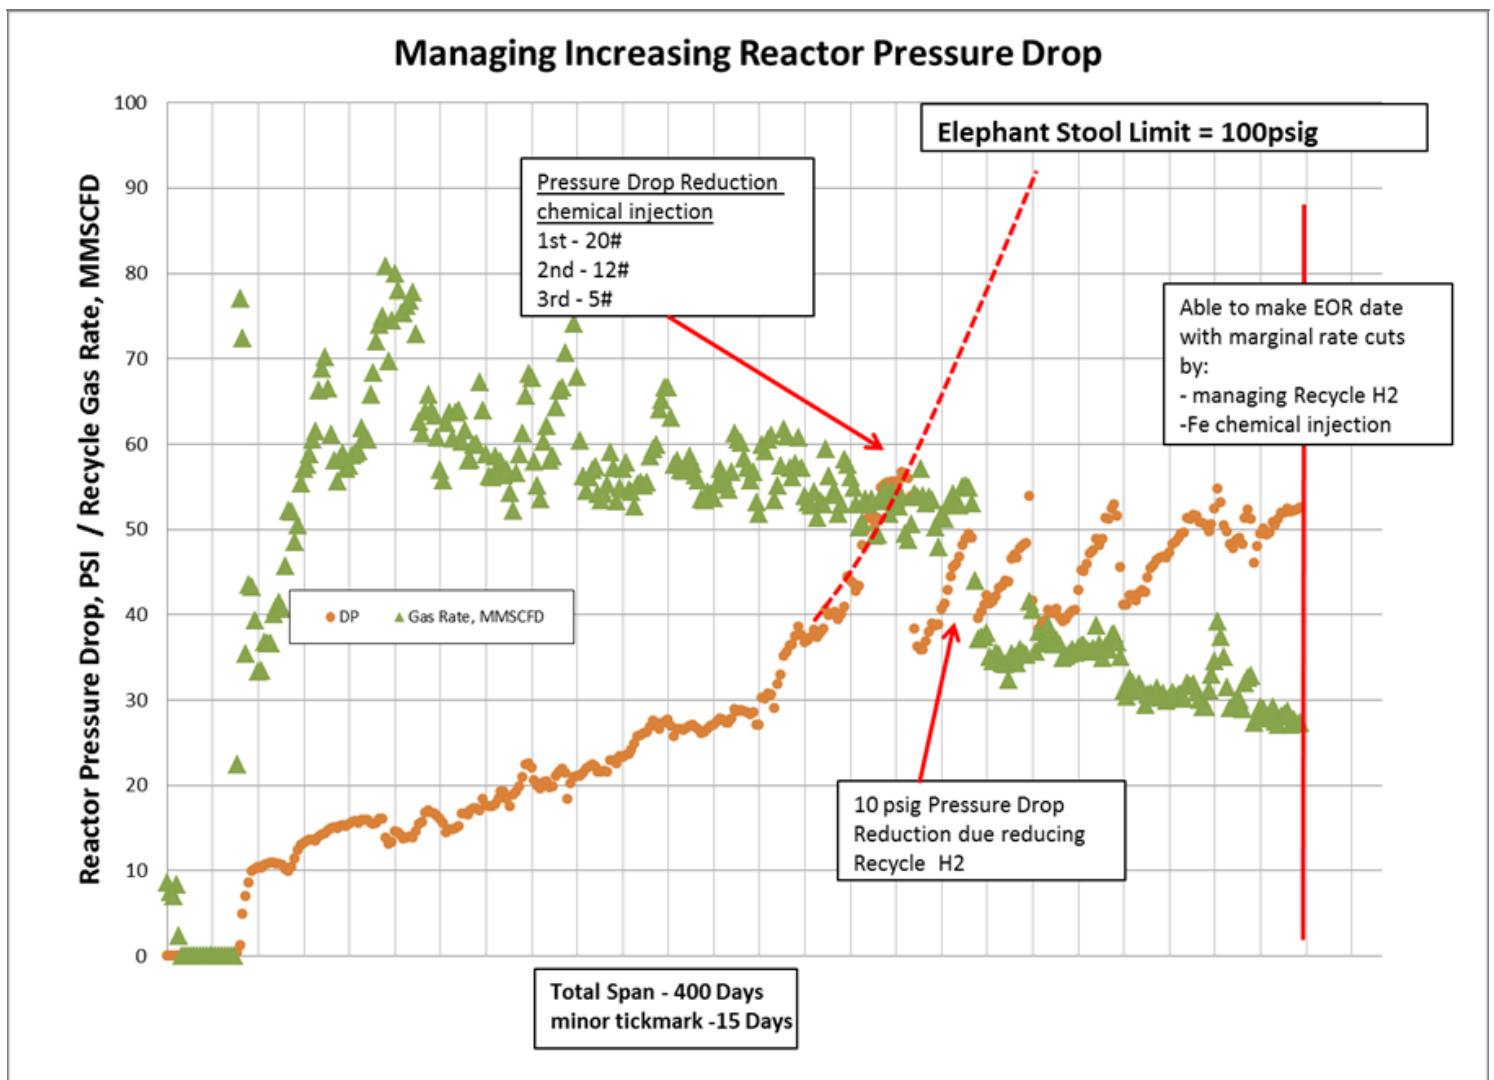
For example in a Naphtha Hydrotreater, both recycle H₂ and Fe Injection agglomerant chemistry was used to extend cycle length. Compressor spillback was used to reduce hydrogen forward flow (caution need to ensure compressor stays away from surge).
