## **Question 2: Iron is one of the most common contaminant metals seen on naphtha reforming catalyst. What is the source, what is the impact to yields and operation, and what can be done to mitigate these effects?**

# Iron – Source Matters

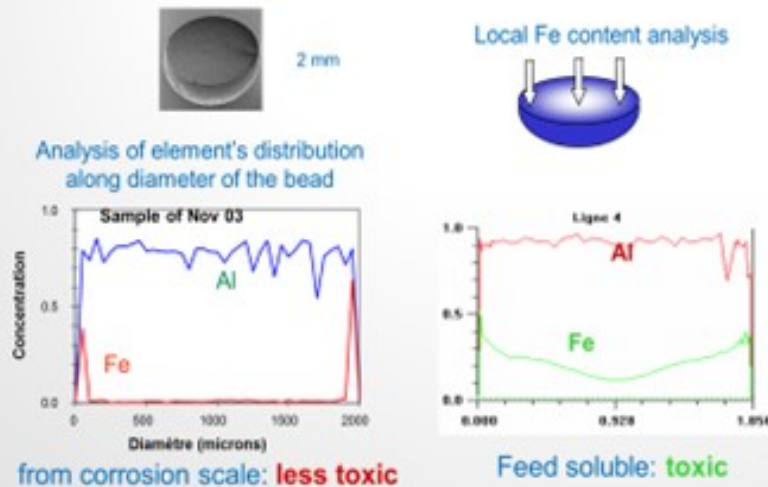
### Electron microprobe delineates iron's location

Few options exist to mitigate iron contamination from the feed as the iron particles present are often in the micron range, which is typically below the trapping range of feed filtration. For metal dusting-derived iron, the use of a sulfur agent injection in the feed is often sufficient to minimize the risk. Corrosion scale type products should not make it past the feed filtration if the filter size mesh in the range of 10microns is used.

While there are three main sources of iron contamination, two of them – namely, naphtha feed-based iron and metal dusting-based iron – have increased impact due to the atomic nature of the iron. Atomic iron is as named: individual atom(s) that are more mobile and able to penetrate deep into the catalyst pores. This atomic iron introduces a significant effect at lower concentrations than the corrosion scale iron which deposits on the outer surface of the catalyst.
