Question 2: Iron is one of the most common contaminant metals seen on naphtha reforming catalyst. What is the source, what is the impact to yields and operation, and what can be done to mitigate these effects?

2017 Summit Gasoline Processes Q&A

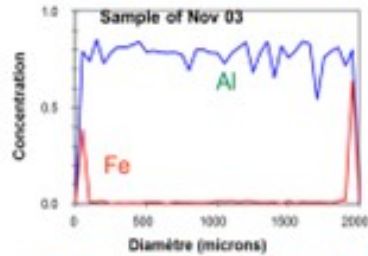
Iron – Source Matters

Electron microprobe delineates iron's location

Local Fe content analysis

Analysis of element's distribution along diameter of the bead

from corrosion scale: **less toxic**

Feed soluble: **toxic**

As mentioned, the first of the two types of iron we see is what we call atomic iron, which is based off metal content or due to heater tubes. It is a smaller iron particle. With atomic iron, we see a much higher penetration of iron into the center of the bead. This slide shows an electron microprobe of a catalyst. We would envision it this way with the left side being one side of the catalyst bead; the right side is the far edge with the center being the middle of the catalyst. What we see with atomic iron is that the iron penetrates much further into the core of the catalyst and is much more detrimental to the performances. Corrosion byproduct-based iron peaks on the left and right edges, which is equivalent to staying on the surface of the catalyst. So, this iron is less detrimental and not as impactful. It also has the impact of being iron from a corrosion byproduct. You can tolerate a much higher level of impurities – maybe up to 5,000 parts per million by weight (ppmw) – versus atomic iron where you see significant yield penalties starting at 1500 ppmw. So, the type of iron and the quantity of iron do make a big difference.

While there are three main sources of iron contamination, two of them – namely, naphtha feed-based iron and metal dusting-based iron – have increased impact due to the atomic nature of the iron. Atomic iron is as named: individual atom(s) that are more mobile and able to penetrate deep into the catalyst pores. This atomic iron introduces a significant effect at lower concentrations than the corrosion scale iron which deposits on the outer surface of the catalyst.

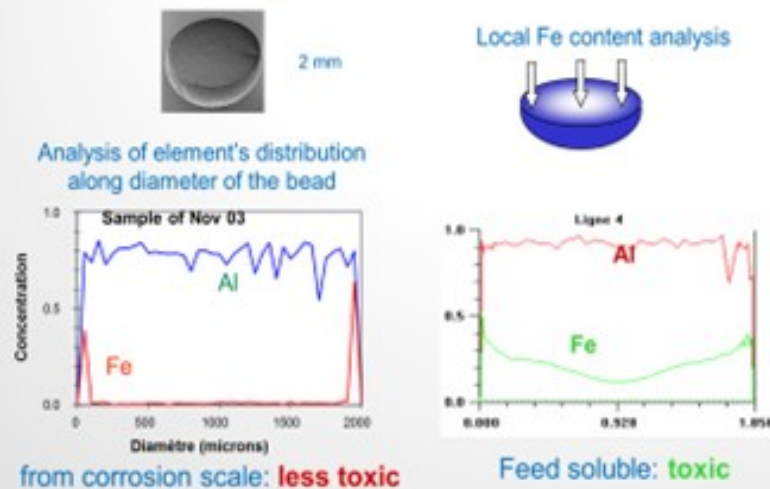
Electron microprobe delineates iron's location

Impacts of iron contamination, as noted previously, are highly dependent on the type of iron and how it deposits on or within the catalyst. For surface iron derived from corrosion scale, concentrations as high of 5,000 ppmw have been observed with minor impacts on performance. Much lower concentrations of atomic iron, derived from metal dusting or feed sources, has been observed to cause performance and yield impacts at concentrations as low as 1500 ppmw.
