Question 63: Please explain the phenomenon known as "coke ratcheting" in the FCC reactor where equipment exposed to coking services elongates over time and heat cycles. Please provide details of actual examples of where this occurred and the impact to equipment operations and reliability.

### **Coke Ratcheting**

2017 Summit FCC Q&A

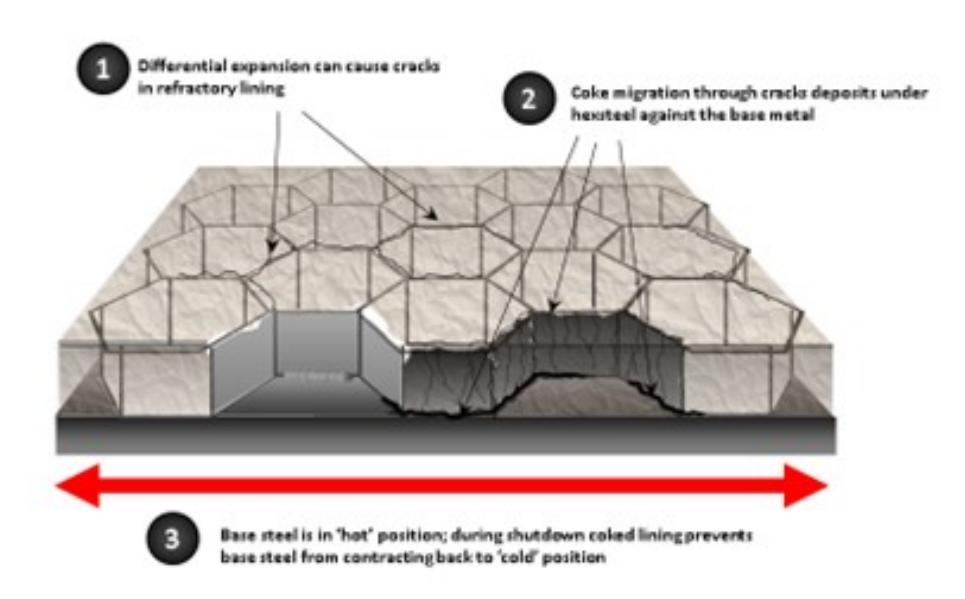
Coke ratcheting is a phenomenon that occurs in hot wall refractory line equipment in the FCC reactor service. It impacts refractory linings with hex steel-type anchors and can occur with a variety of base metals, including carbon steel and alloy steel. The basic mechanism is illustrated here with some pictures. The differential expansion causes some cracks in the refractory, and that provides a pathway for hydrocarbons to get back underneath the refractory. Then, coke sets up in that annular space between the hex and the base steel, all while the unit is running in 'hot' position. When you go through a thermal cycle, the coke setup in that space restricts the base material from contracting all the way back to its normal cold position.

Coke ratcheting occurs on hotwall refractory-lined equipment in FCCU reactor service. It impacts refractory linings with hex [hexagonal] steel anchors and can occur with a variety of base metals, including carbon and alloy steel. Whilst in the hot condition, differential expansion can loosen the refractor biscuits and provide a pathway for hydrocarbons to migrate beneath the lining and form coke in the annular space between the base metal and the hex steel. During a shutdown, this coke can prevent

the base metal from contracting back to its cold position. This process, when repeated over multiple thermal cycles, can cause the effective lengthening of reactor internals. Further evidence of what is occurring is often seen as the premature failure of the lining on this equipment. As the coke is built up overtime on the surface of the steel, it will separate the lining system away from the base metal often seen as the loosening and loss of the refractor biscuits. One method used to prevent coke ratcheting is to utilize a 100% anchor weld of the hex steel to the base steel, which reduces the area beneath the anchor for coke formation to occur. Carbon diffusion into the base metal grain structure is not believed to be a significantly contributing factor. Although this phenomenon is a possibility, it only occurs in environments with temperature greater than 1100°F, and the result is the embrittlement of the base metal.

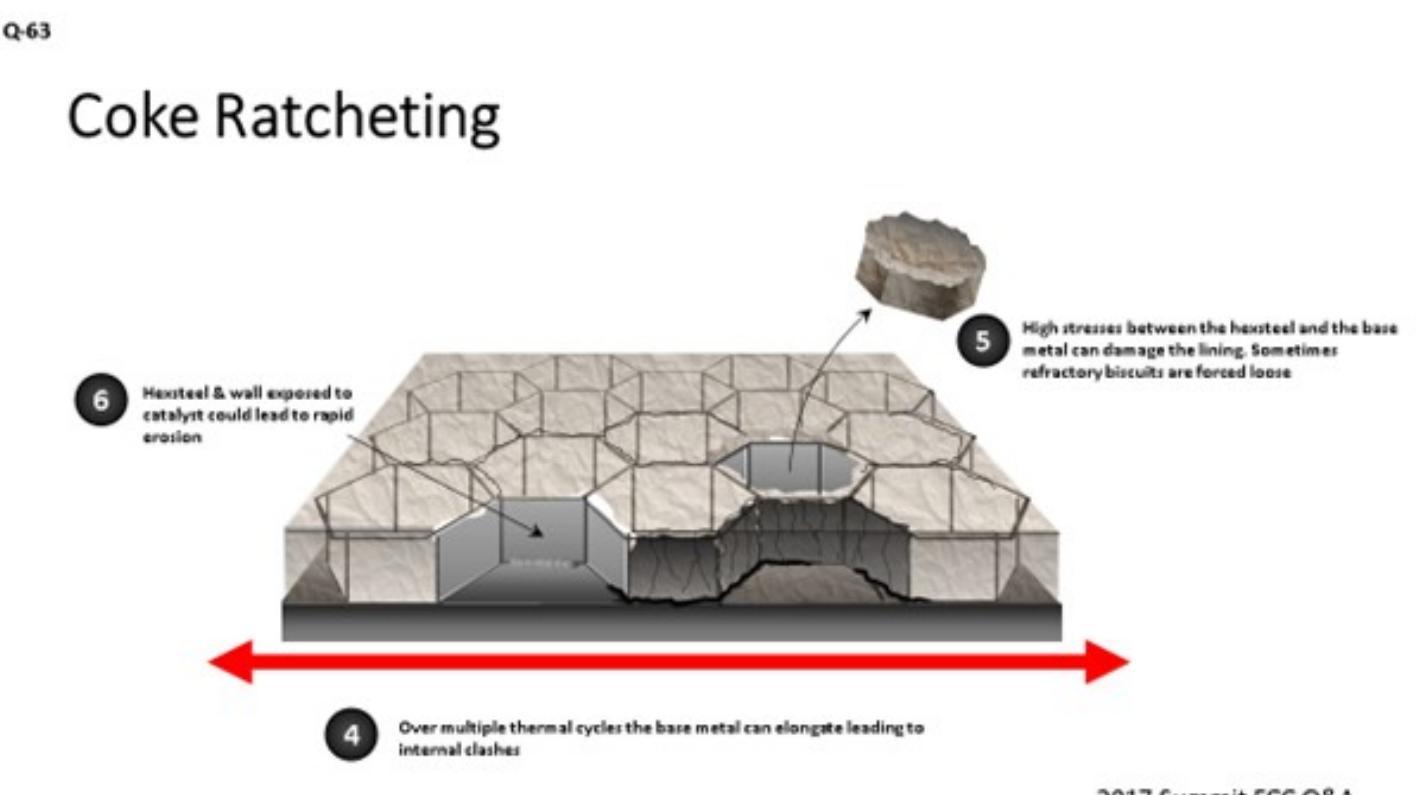
During your next thermal cycle, when the material returns to the 'hot' position, it may be slightly longer. The stresses there between the hex and the base metal then get worse, as do the cracks. Over many, many thermal cycles like this, you can eventually actually extend the base material. We have seen it in riser termination devices and in some areas of cyclones, such as in the crossover areas. What may also happen before you even see the elongation of the base material is that the coke will separate the hex from the base metal. You might see refractory biscuits popping out; and where there is bare metal exposed, you will then see some severe erosion.

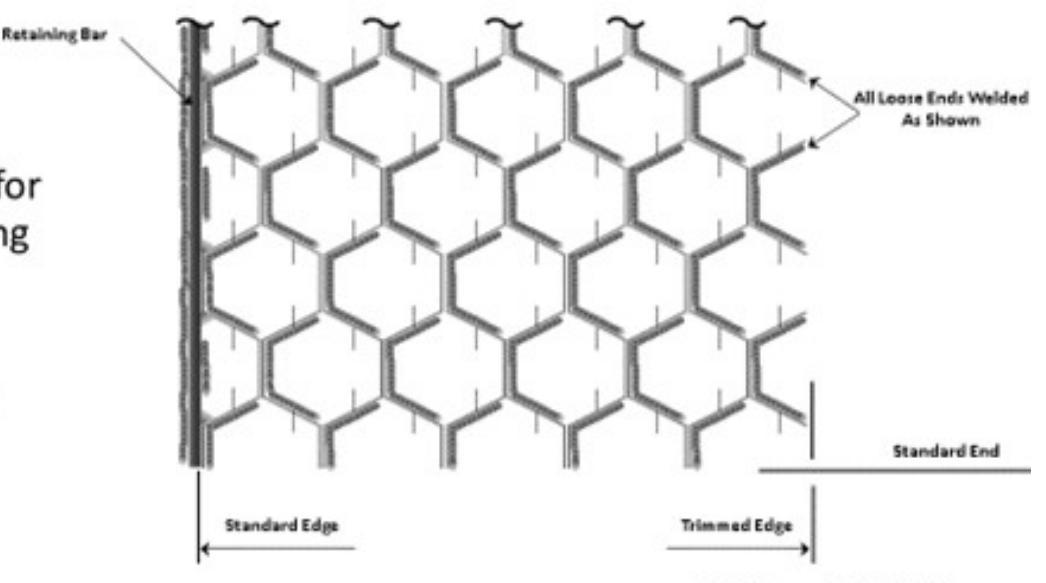
At TechnipFMC, we recommend that all hex in the reactor service be 100% welded pattern to the base material to minimize the amount of annular space available for the coke to settle. We also recommend the type of hex steel that has punched tabs to help hold the biscuits in place.

TechnipFMC recommends:

- 100% weld pattern for the hexsteel in coking service
- Hex steel with punchtabs to retain refractory biscuits

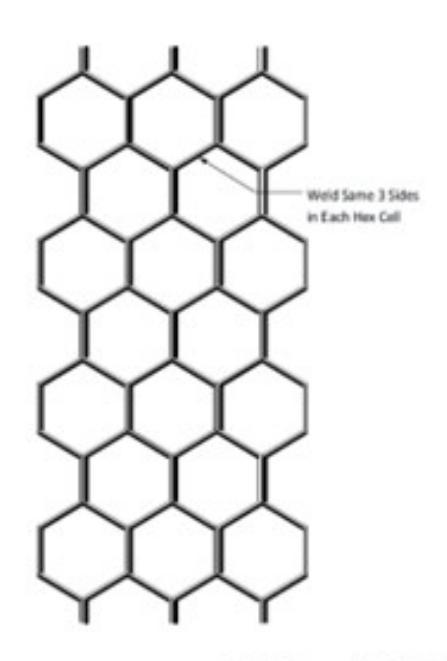
Since 2005, we have gone to the standard where we weld every hex mesh. Prior to that, we did see some lining failures due to the stresses in the cold condition. Since we started welding everything, we have had good performance.

- High stresses in the cold condition can lead to failure of hex mesh at the attachment welds to the parent metal
- Since 2005 we have welded the full length of every hex in coking service and had good performance

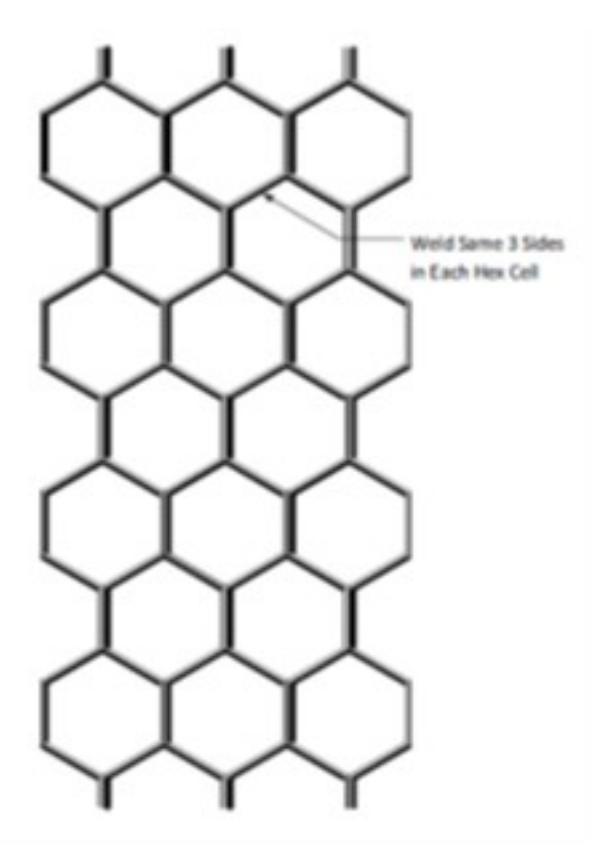
Figure 1: Hex Mesh Welding Diagram in Severe (Coking) Service

We have seen some liner failures due to coke ratcheting in our reactor/riser systems. For this reason, on abrasion resistant linings in coking service, our standard is to weld the full length of every hex mesh bar, as shown in Figure 1. By welding the same three sides in each hex, every bar receives an attachment weld to the base metal. Since we implemented this practice in 2005, we have had good lining performance in coking service.

When the system is cooled down, the coke impregnated lining does not return to its original shape causing the parent metal to yield and elongate. In the cold condition, high stresses are present in the attachment welds between the hex mesh and the parent metal. This situation can lead to lining failures.
