Question 70: Electrostatic precipitator (ESP) fines handling is often complicated by fluidization and mechanical integrity issues. How often do you experience these types of fines handling issues, and what are some of your Best Practices to successfully mitigate these issues? What are your Best Practices for safe fines withdrawal from the ESP?

2017 Summit FCC Q&A

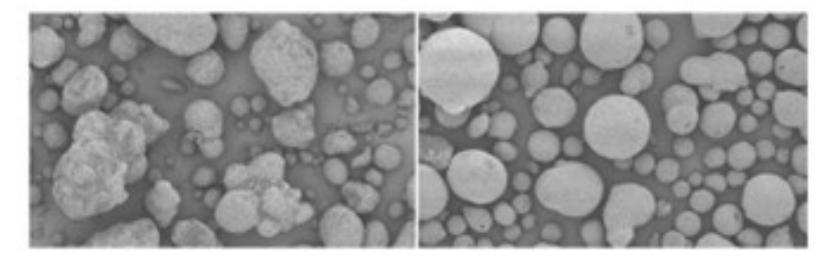
Catalyst PSD and Morphology

"Bad Morphology"

"Good Morphology"

The morphology and PSD profiles of the ESP fines will have a strong impact on the fine's withdrawal efficiency. Cyclone performance within the regenerator plays a major role in ESP performance and the corresponding fluidization properties of the ESP fines. Healthy cyclone operation typically results in average particle sizes (APS) in the range of 15 to 30 microns, depending on the regenerator design and overall hydraulic profile. Adequate cyclone performance helps maintain a manageable particulate loading to the ESP while sustaining a healthy PSD profile for the ESP fines. Excessive loadings to the ESP, over an extended duration, can have the following impacts:

Excessive attrition within the reactor-regenerator system or the regenerator flue gas train can significantly reduce the APS of the fines, essentially increasing the concentration of microfines and fractured particles. These microfines and fractured particles tend to agglomerate, preventing smooth flow of the ESP fines into the collection hoppers. This type of fluidization issue is more prevalent once the APS of the fines drops below 15 microns. The jagged edges caused by catalyst fracturing can be identified by SEM analyses of the ESP fines samples. Even with a healthy PSD profile in the fines, agglomeration can occur due to other flue gas system failures, such as a flue gas cooler leak. The steam and boiler feed water in contact with catalyst fines can quickly lead to undesired catalyst agglomeration. Further, in extreme cases, acid dew point corrosion may be observed. These types of flue gas cooler leaks can be detected through sudden increases in the process-side pressure and much higher metals deposits on the ESP fines than those of the circulating e-cat inventory. The affected flue gas cooler tubes, or banks, should be isolated as quickly as possible to mitigate further erosion and downstream issues.
