Question 35: What are possible causes do you see of high product nitrogen in a naphtha hydrotreater processing coker naphtha? Please include monitoring, identification, and troubleshooting techniques, inside and outside battery limit considerations, and mitigation options.

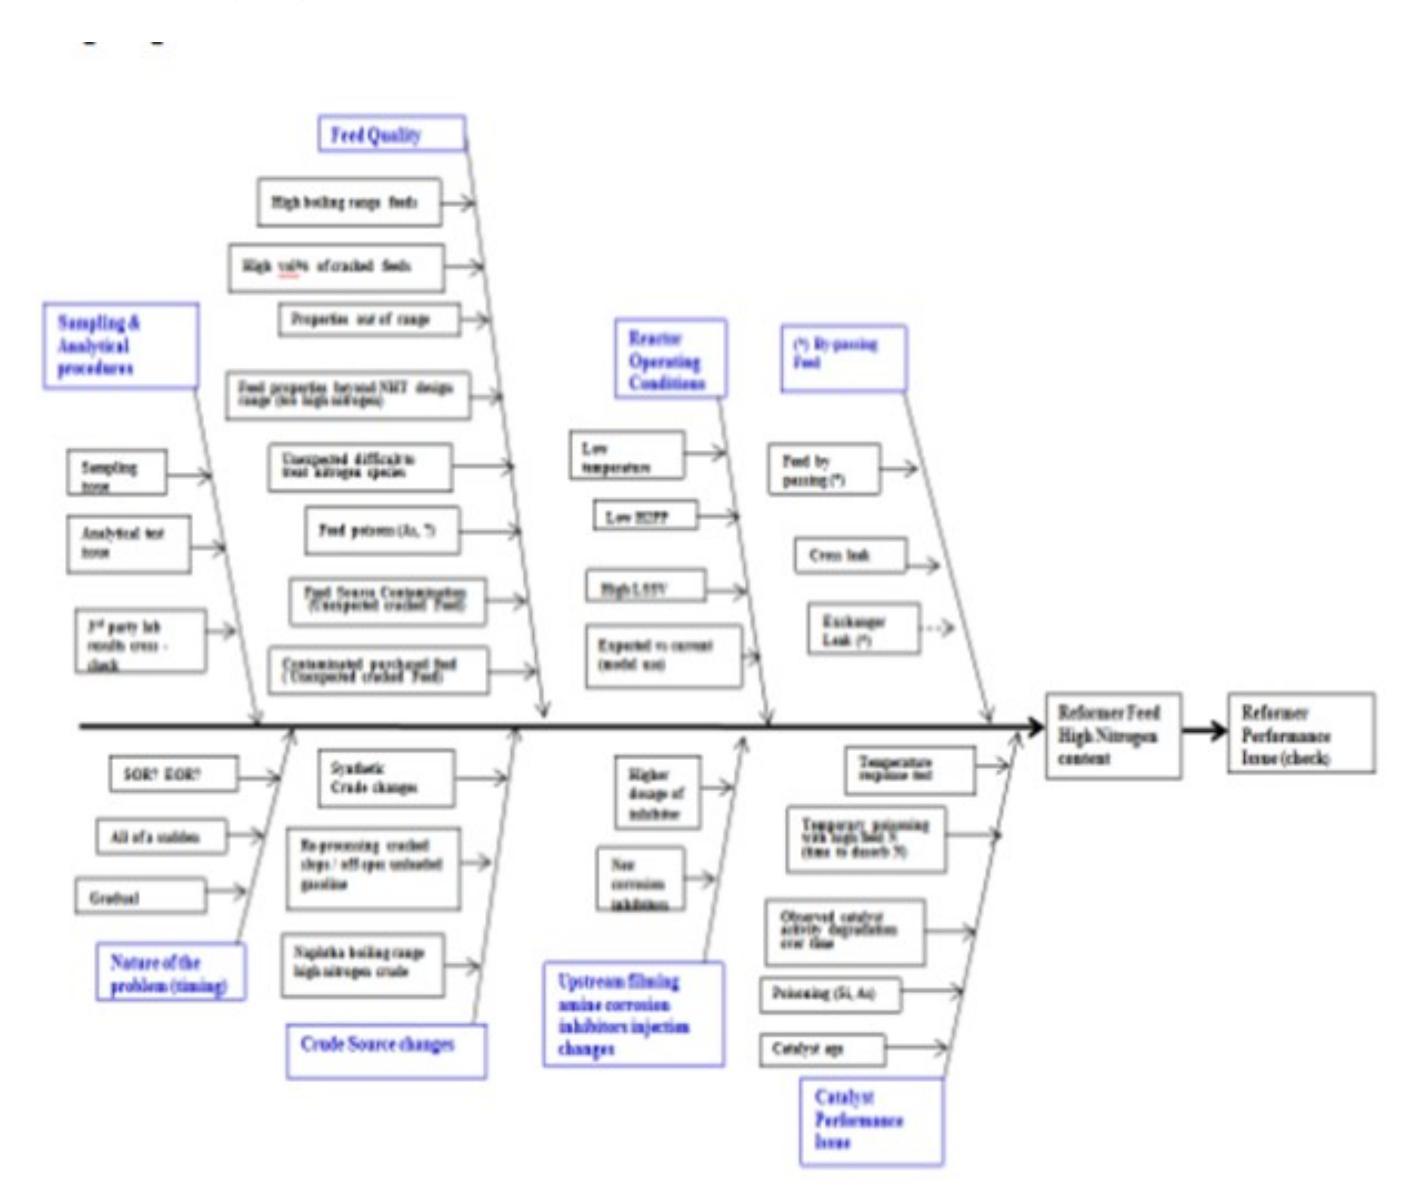
High product nitrogen from a naphtha hydrotreater (NHT) processing some coker naphtha and providing feed to a catalytic reformer is of concern since nitrogen affects the performance of high value reforming catalyst. The naphtha hydrotreater product specifications are typically less than 0.5 ppm sulfur and nitrogen in the feed to the reformer. When higher product nitrogen is measured, it is critical to identify and correct the issue as quickly as possible. When product nitrogen is high, there are many possible causes. The fishbone diagram below describes many of these causes that need to be reviewed in order to narrow down the potential reasons. Coker naphtha specifically lowers the feed quality with cracked components and brings higher level of contaminants.
