Question 36: Which refinery water sources do you accept for hydrotreater water wash (e.g., stripped fractionator overhead water, stripper sour water, etc.)? What are typical water quality guidelines?

JEFFREY MUELLER (Marathon Petroleum Company)

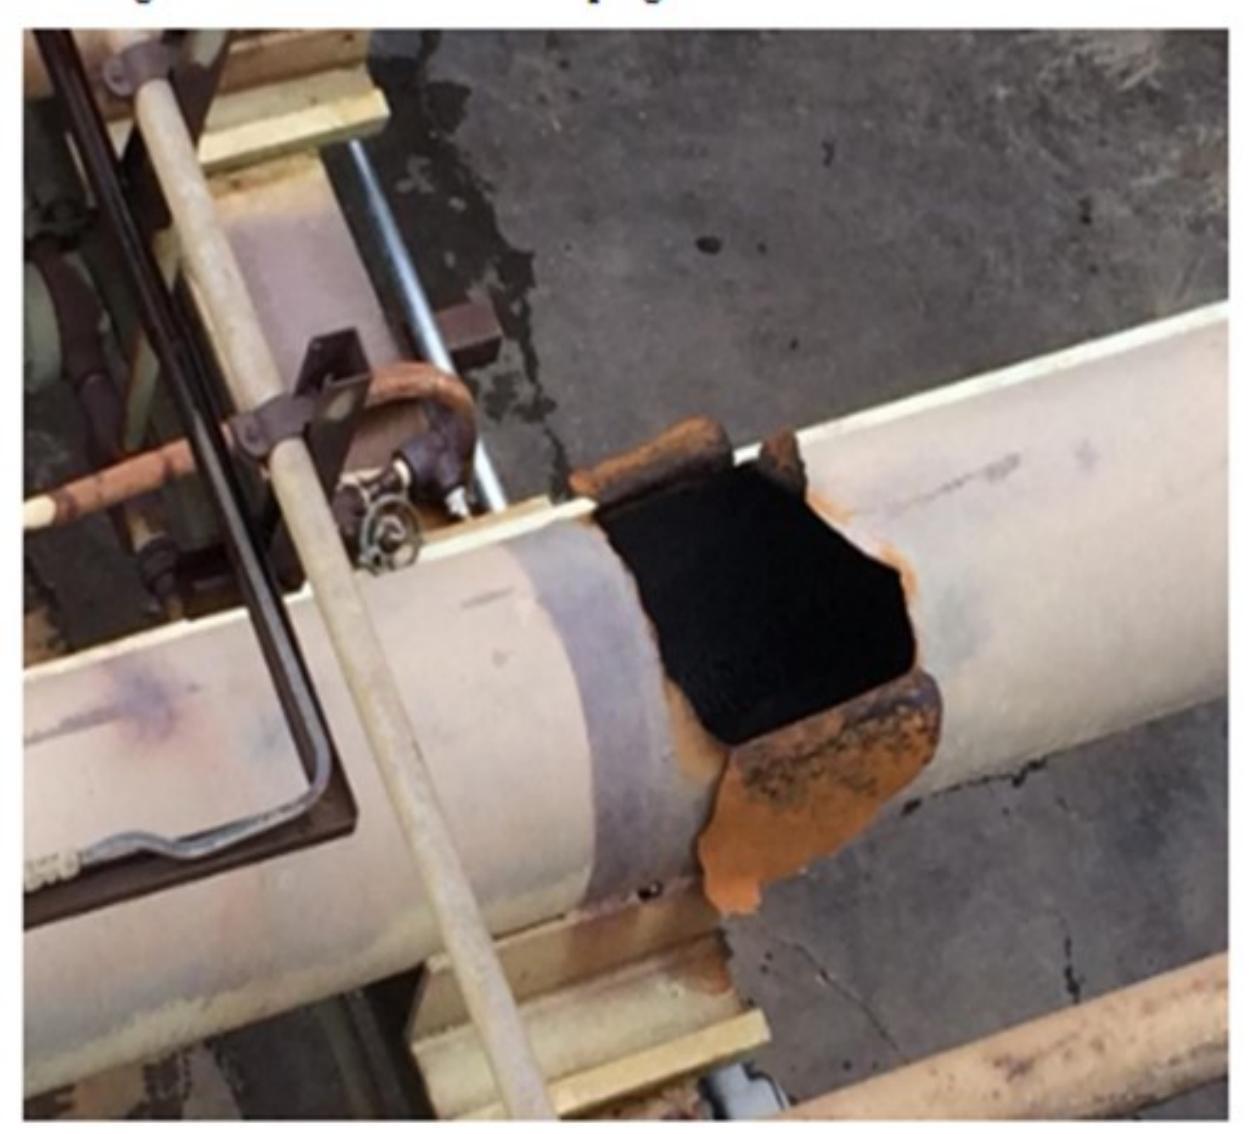
Figure 1. Reactor Effluent Piping Failure at MPC NHT

On April 9, 2015, a failure occurred on the top of a horizontal section of reactor effluent piping of a naphtha hydrotreater. The escaping stream of hydrocarbon was estimated to be 70 to 80feet high, and the sound of liquid hydrocarbon release made communications in the immediate area difficult. Fortunately, the unit operators were able to shut down the heaters without incident. Figure 1 illustrates the piping failure associated with this incident.

The piece of piping that failed was located directly downstream of the feed/effluent exchangers and a continuous waterwash injection point, upstream of the reactor effluent air coolers. The systemoperated at 320 psig and 280°F, with no prior history of leaks. The process, at this point, contained 0.2 mol% H2S, 0.001 mol% NH3, and 0 to 4 ppm chloride in the makeup hydrogen. These conditions are not severe by hydrotreater standards.

The failure was internal corrosion due to the condensation of HCI on the vapor space of the pipe. Some of the causal factors in this incident relate to the waterwash design (though this was not the exclusive cause). The presence of water with inadequate mixing created an extremely corrosive condition in the vapor space of the horizontal pipe. A couple physical factors related to the waterwash contributed to this inadequate mixing:

*The water was injected through low velocity quills.

*Water was injected upstream of a non-freedraining low point with long horizontal line.

*Typically, waterwash is injected immediately upstream of the REACs. In this case, there was a long horizontal run of piping immediately downstream of the injection that does not allow for adequate mixing.
