Question 9: What do the possible causes of high pressure drop in lower beds of HT (hydrotreater) and HC (hydrocracker) units? What techniques are used to diagnose the causes prior to shut down? Are there any mitigation techniques or strategies to extend the cycle?

Causes of High Pressure Drop

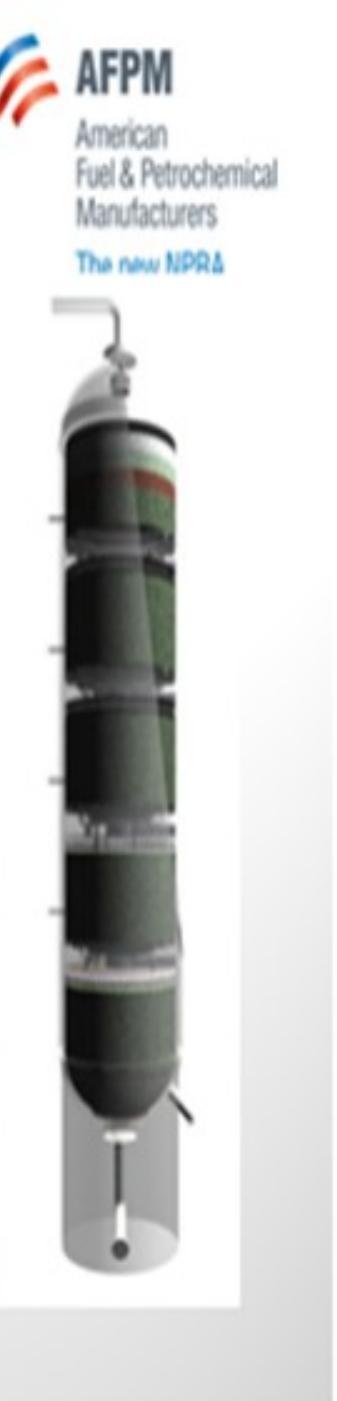
- Discussed in 2007 Q&A
- Examined 13 recent reactor ∆P incidents from 2007 to 2011
 - 10 of 13 incidents had high ∆P in lower reactor beds
 - Only 3 "classic" incidents with ∆P in top bed

The topic of the causes of high-pressure drop was discussed in the 2007 Q&A, so you may want to refer to that transcript for additional information. At Chevron, we had a string of 13 reactor ?P (pressure differential) incidents between 2007 and 2011. Ten of these occurred in lower reactor beds with only three of them being classic top bed ?P incidents.

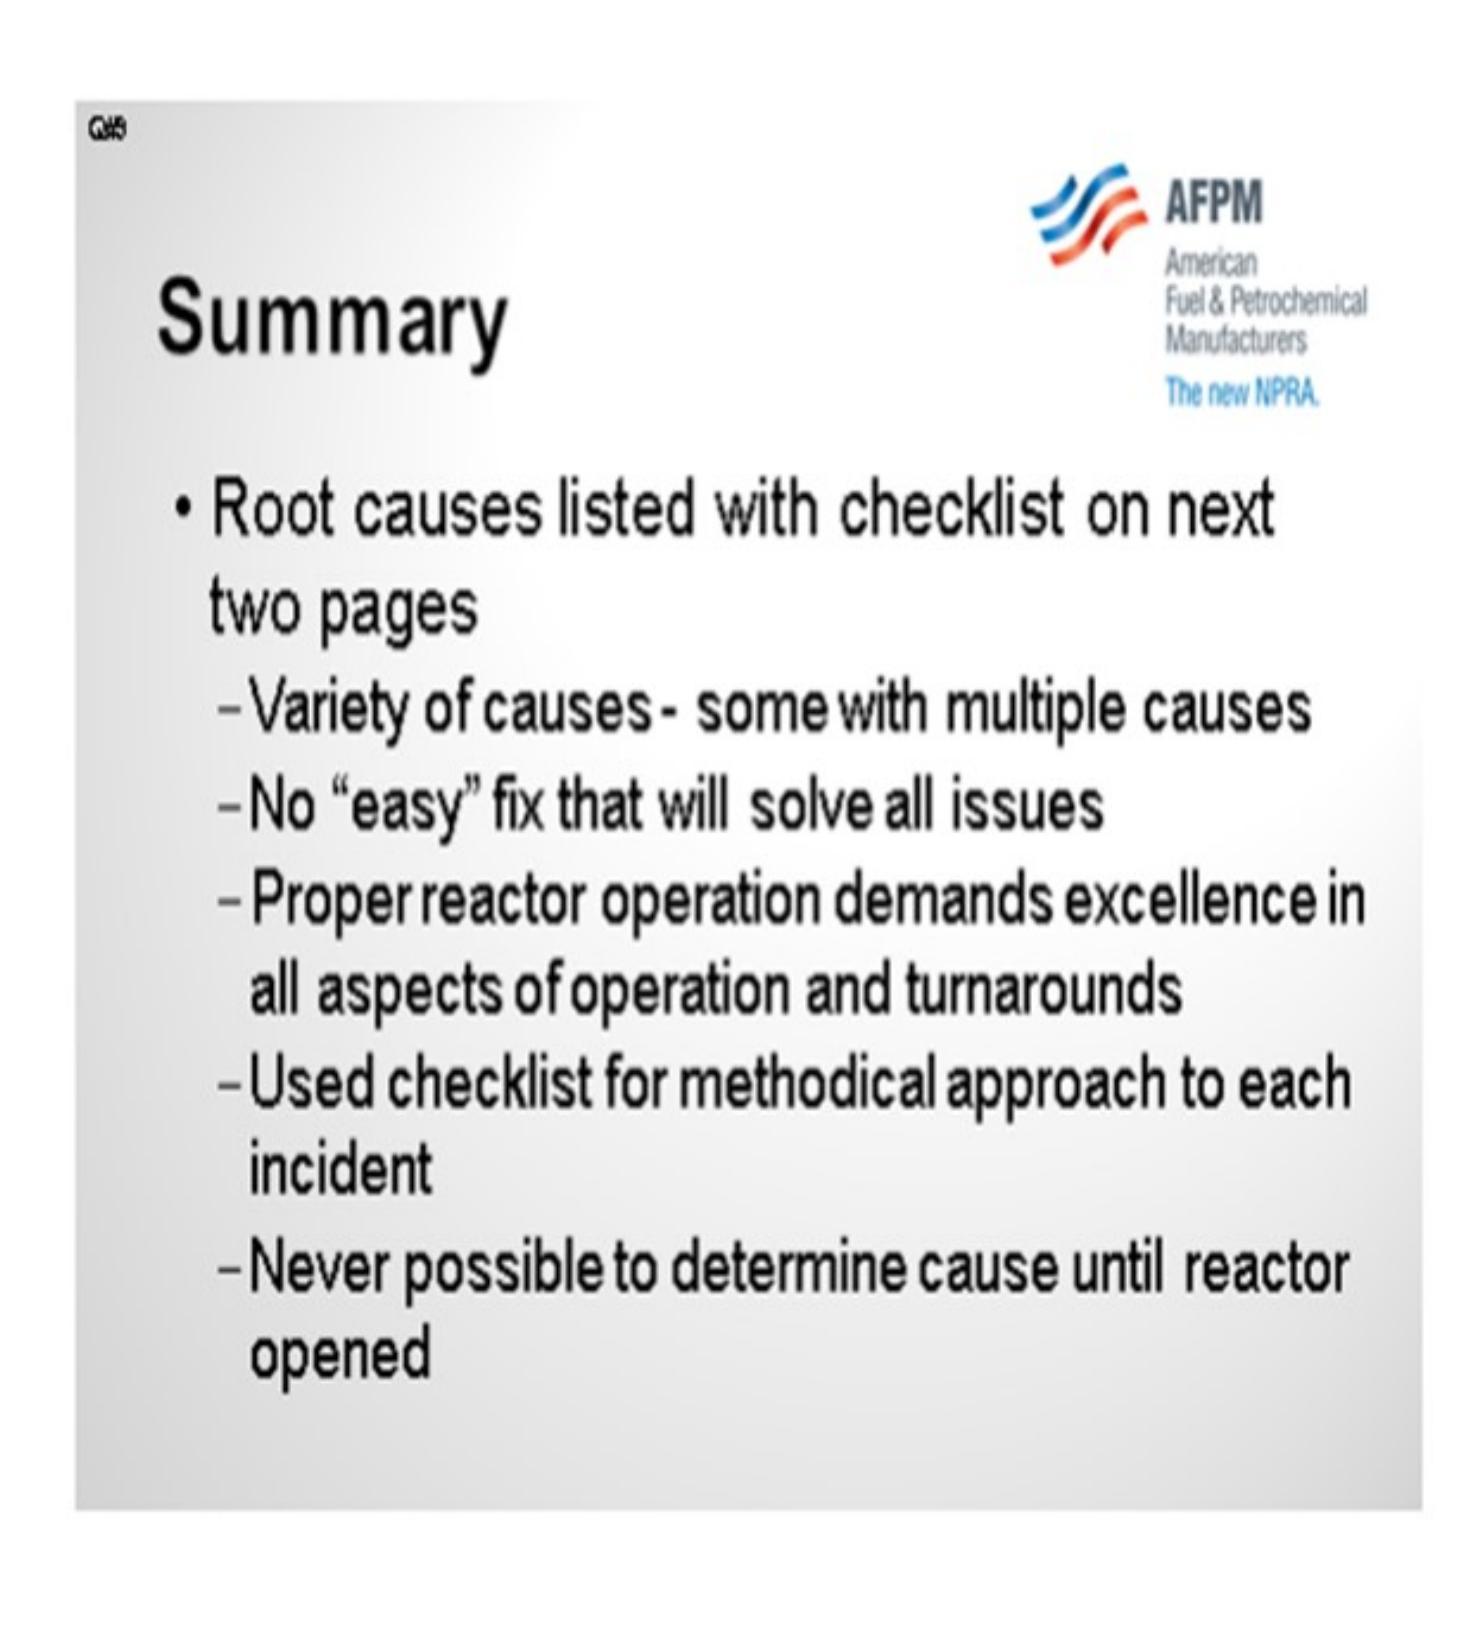
Reactor Page 1 of 2 (F	P Checklist Red Indicates Incident Cause)	American Fuel & Petrochemics Manufacturers The new NPRA.
Feed Contamination	 Particulates and corrosion products 	
	Gums/olefins	
	 Gross contamination 	
Catalyst Quality	 Physical strength (poor attrition, crush stren 	gth, or fines)
	 Excessive short material or mixture of sizes (L/D) 	
	 Dimensions (diameter and shape) 	
Catalyst Loading	 Insufficient cleaning (plugged screens and or 	lebris)
	 Improper loading and layering of different sized catalysts 	
	 Catalyst migration (tray gaps and dump pipe issues) 	
	 Catalyst fluidization and attrition (high veloci chimneys or dump pipes) 	ty from
	 Particulates from quench piping 	
	 Catalyst breakage from mishandling

Fortunately, we have had good crime scene investigation capability that has allowed us to generate this checklist of possibilities. When performing any incident investigation, it is important to think about all of the possible causes. The following slide summarize our findings. The causes highlighted in red are ones that were actual root causes of an incident. Among them are classic feed contamination in the upper beds, catalyst quality issues with strength, and loading catalyst of the wrong dimensions. The process of catalyst loading is also critical. In the table below, we found four different root causes attributed to catalyst loading. Making sure that the catalyst loaders are properly trained and supervised is critical.

We have also seen mechanical failures in the reactors cause excessive pressure drop. In one case, a screen failure resulted in catalyst migration into the reactor internals. In another case, a quench pipe developed a leak, which then pulverized the surrounding catalyst to a powder.

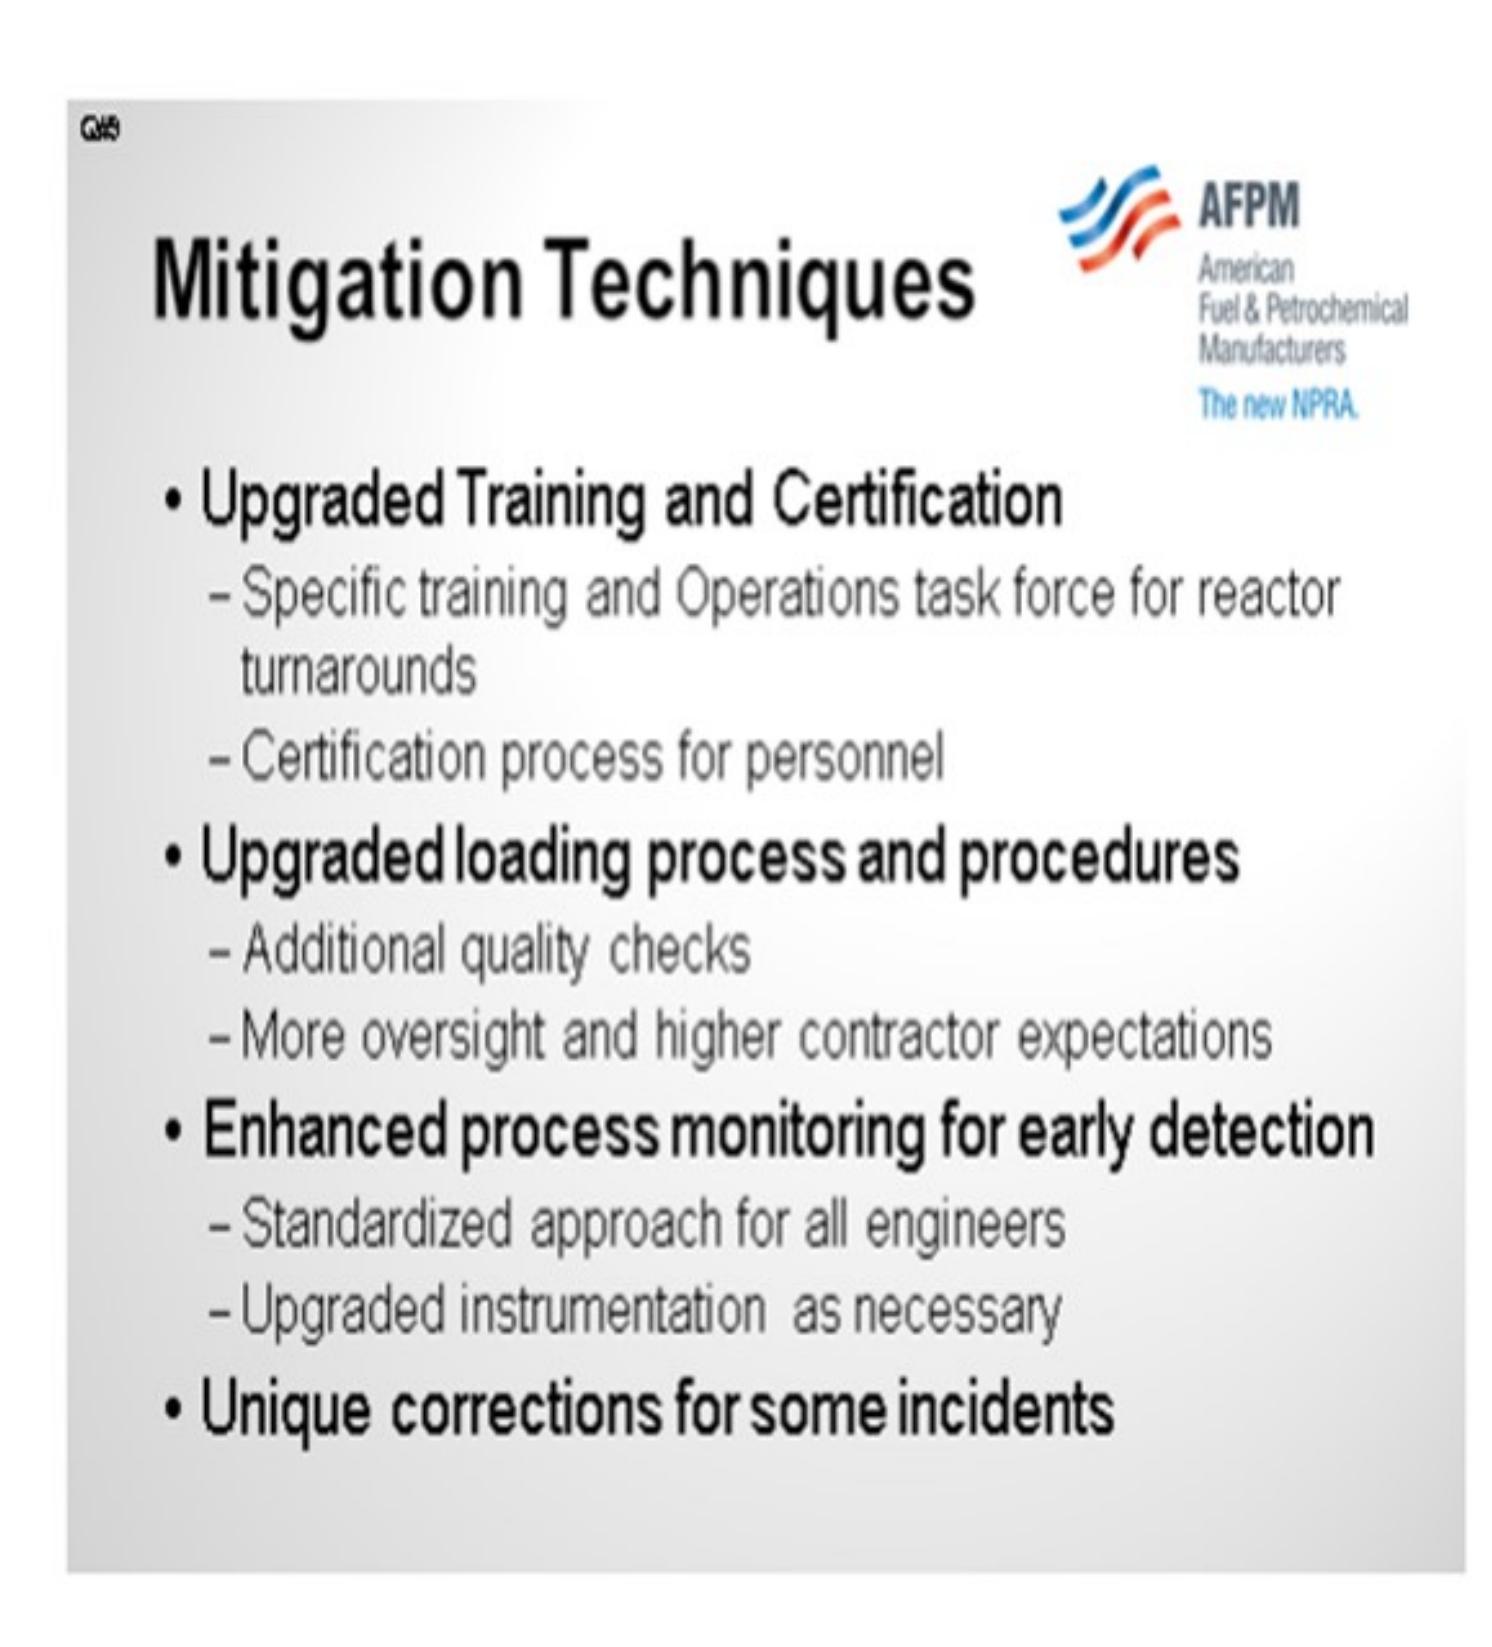
Reactor $\triangle P$ Checklist

Mechanical Failure	 Catalyst migration (screen failures)
	 Catalyst fluidization and attrition (internal quench pipe failures)
	 Inadequate design
Operational Issues	 Catalyst coking (heavy feed, low H2 partial pressure, excursion)
	 Improper dryout (catalyst popcorning)
	 Liquid in quench system
Instrumentation (Not a cause, but contributed to monitoring and troubleshooting problems)	 Liquid or blockage in △P legs
	 Not correcting measured △P for quench flows
	 Poor calibration
	 Using absolute pressures instead of △P

Operational issues, such as loss of recycle, have been observed as a culprit of increased ?P. We have also listed instrumentation as a category, even though it is not really a root cause, because it is critical to validate pressure drop issues and predict the point in time when the maximum allowable pressure drop will be reached.
