# Question 31: What is the panel's experience with temperature excursions (regeneration and otherwise) leading to the catalyst or equipment damage in reforming and isomerization units?

## Temperature Excursions

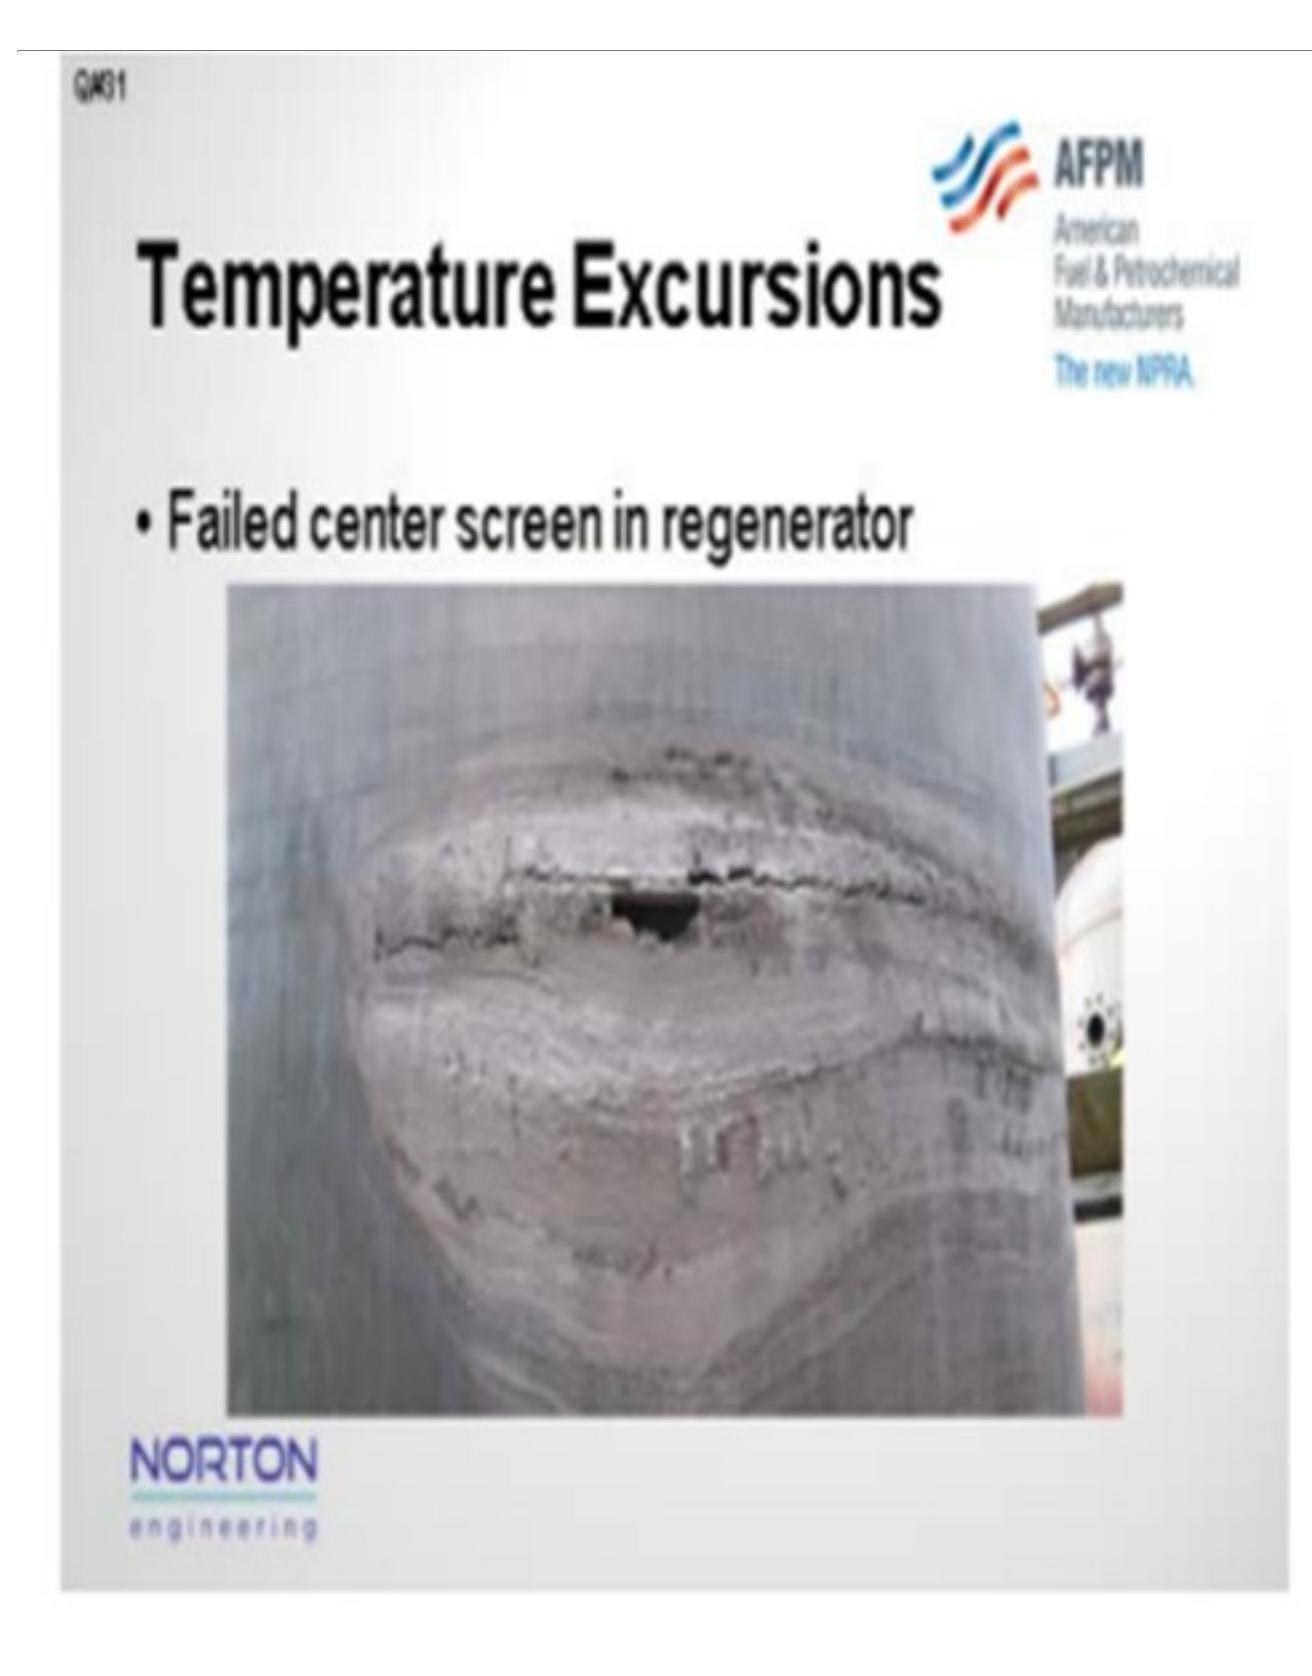
QH31

- Severe temperature excursion in chlorination zone of regenerator for moving bed reforming unit.
- Unit put back in "white burn" sooner than what would normally be recommended.
- Drying zone thermocouple indicated temperature spike over 2000°F – believe temperatures exceeded 3600°F.

Upon inspection, it was found that the center screen had failed, as shown on the slide.

In a refinery where I used to work, our moving-bed reformer experienced a severe temperature excursion in the chlorination zone of the regenerator. After a prolonged outage on the regenerator, the unit was put back into white burns sooner than would have been recommended. On introduction of air/oxygen into the chlorination zone, temperature indicators in the drying zone spiked over 2,000°F, and one of the temperature indicators burned out. Although operation was attempted for a few days beyond the temperature excursion, the unit eventually had to be shut down and the regenerator inspected.

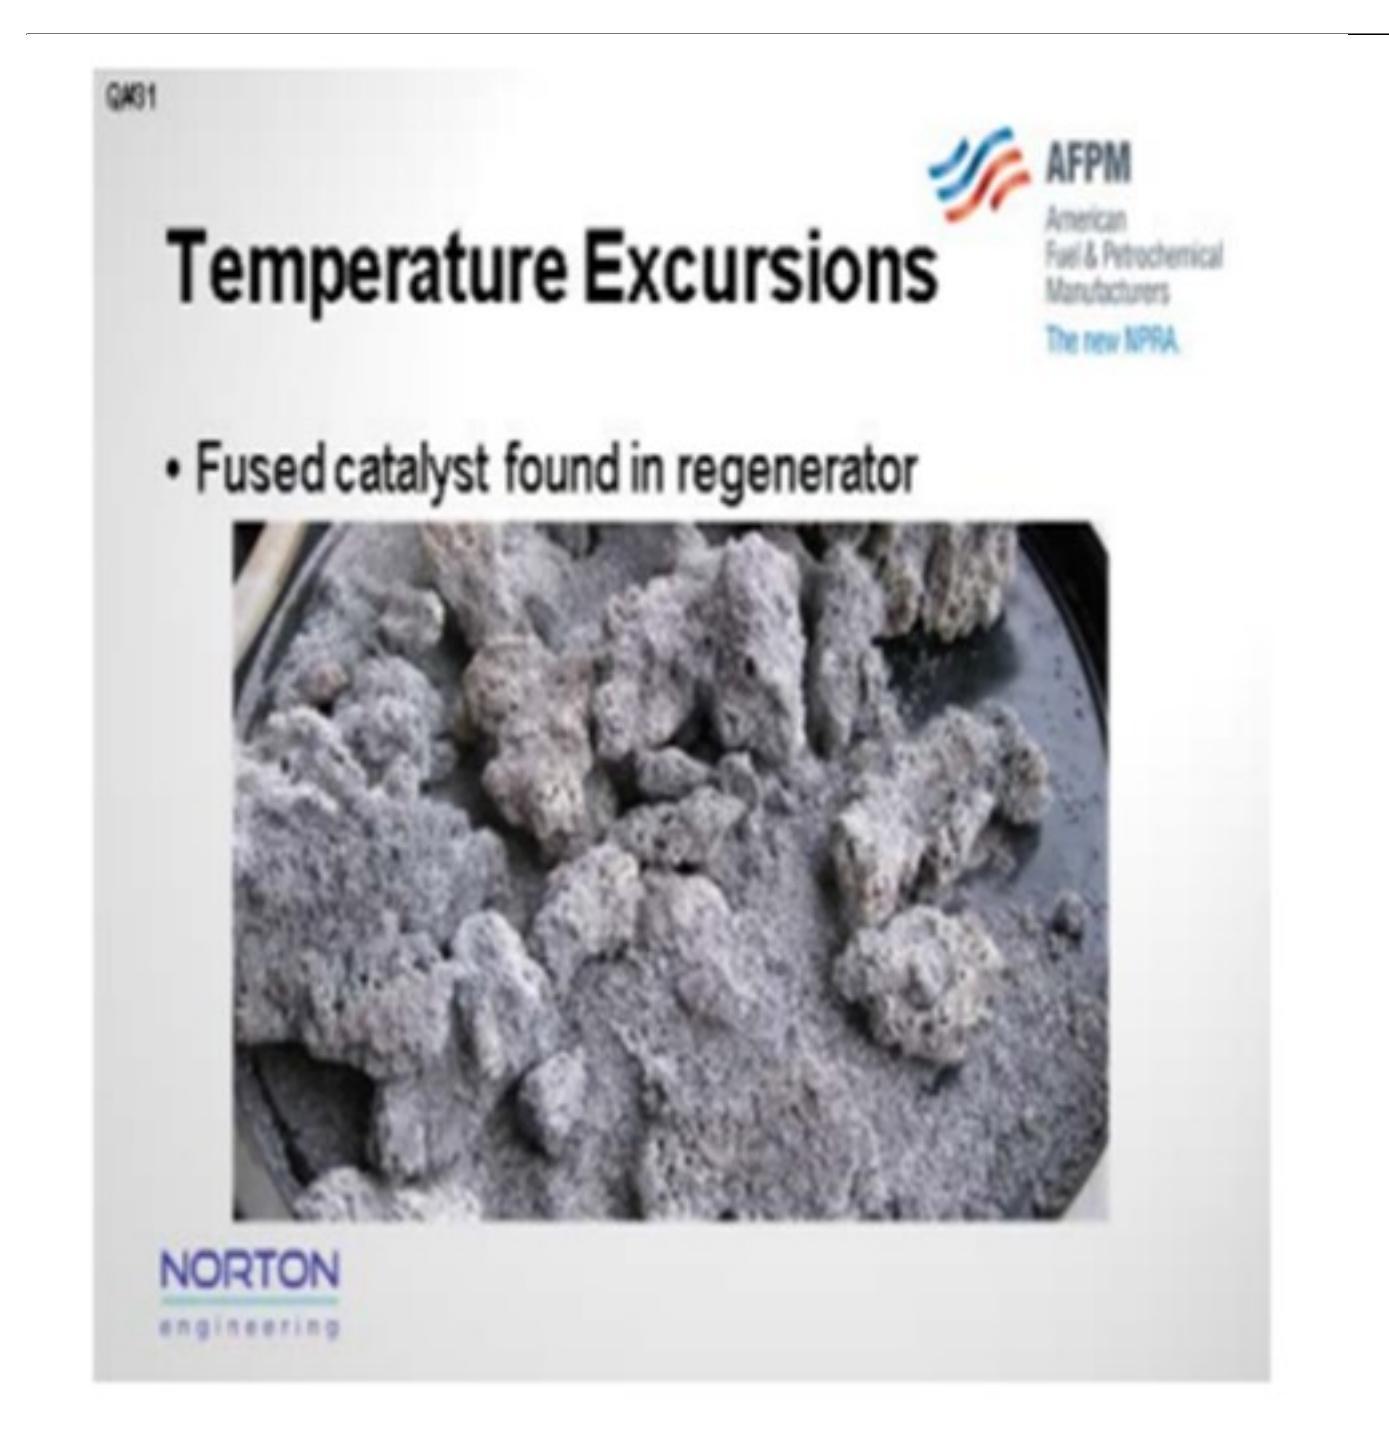
Also, fused catalyst was discovered in the unit. It is believed that temperatures exceeded 3,600°F during the excursion.
