Question 42: In your experience, what are the typical causes of damage to the top of the regenerator inner screen?

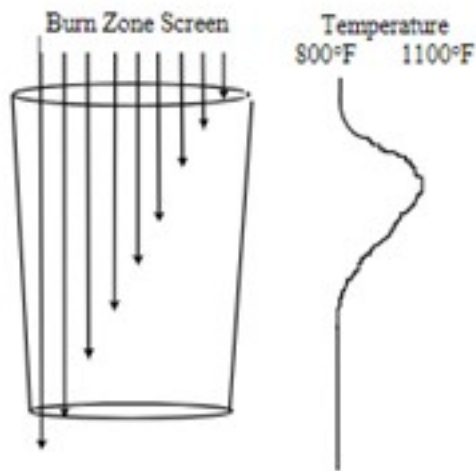
Typical Burn Zone Temperature profile

TI	Normal Range of temperature
TI-1	800-950°F
TI-2	920-1100°F
TI-3	920-1100°F
TI-4	915-1040°F
TI-5	915-940°F
TI-6	915-940°F
TI-7	915-940°F
TI-8	895-930°F
TI-9	895-930°F

The typical cause for damage in the top 2-3 ft of inner screen is metal fatigue due to thermal cycling. This is common to all CCR designs, but more critical in early pressurized designs. Catalyst entering the regenerator from the vessel above is relatively cool, from the catalyst lift and elutriation. The cold catalyst enters the regenerator and the regeneration gas at the top of the screen will cool as it passes through this top section of catalyst, then in turn the gas will cool the inner screen.

As the carbon burn begins, catalyst temperature will increase thereby causing the inner screen temperature to rise. Each time catalyst cycles, a thermal cycle at the top of the regenerator inner screen will occur.
