Question 30: What are common mechanical defects that occur to the weld overlay material in hydroprocessing reactors? What are the most common locations for defects, and does the location play a factor in the mechanical integrity of the equipment? How do you detect and repair the defects? How often do you conduct Remaining Life Analysis (RLA) and/or Fit For Service (FFS) Assessment on critical equipment?

AL-FUDHAIL (Saudi Aramco)

2017 Summit Hydroprocessing Q&A Session

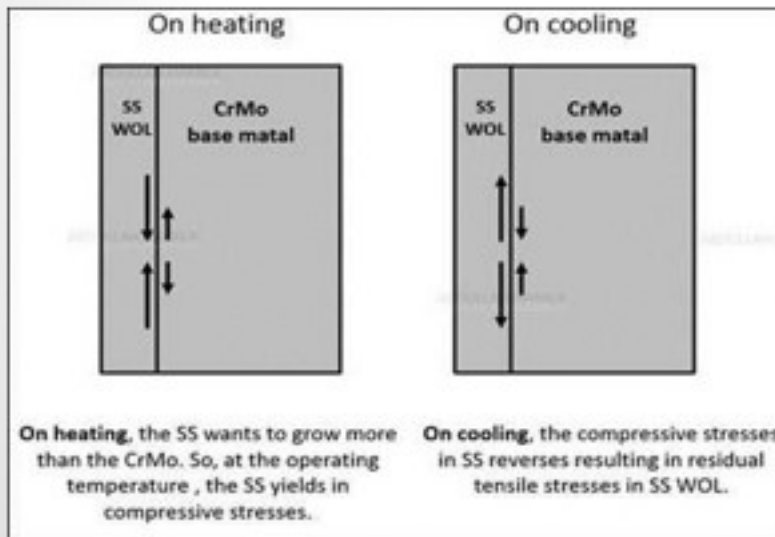
Mechanical Defects on Weld Overlay

Second, low cycle fatigue cracking thermal grading during startup and shutdown cycles: Thermal stresses and residual hydrogen concentration drive weld overlay cracking, as well as the disbonding mechanism, i.e., cracking along weld overlay, which is a chrome-moly-based metal interface. During heating and cooling cycles, the coefficient of thermal expansion mismatch between the stainless-steel weld overlay and base metal generates excessive stresses at the interface for an embrittled transition layer. This cycling of temperatures aggravates the situation, as you can see shown on the slide.

Now the first question is: What are common mechanical defects that occur to the weld overlay material in hydroprocessing reactors? First, microstructure changes or sigma-phase embrittlement. This damage can occur either during original fabrication and post-weld heat treatment or during operation. Therefore, the weld overlay conditions during a fabrication govern the susceptibility to hydrogen disbonding. Higher traveling speeds and welding currents result in good resistance as they generate fine microstructure without, of course, planar grains at the interface. Therefore, the fabrication stage is a crucial step and requires dedicated attention to avoid inherent damage.

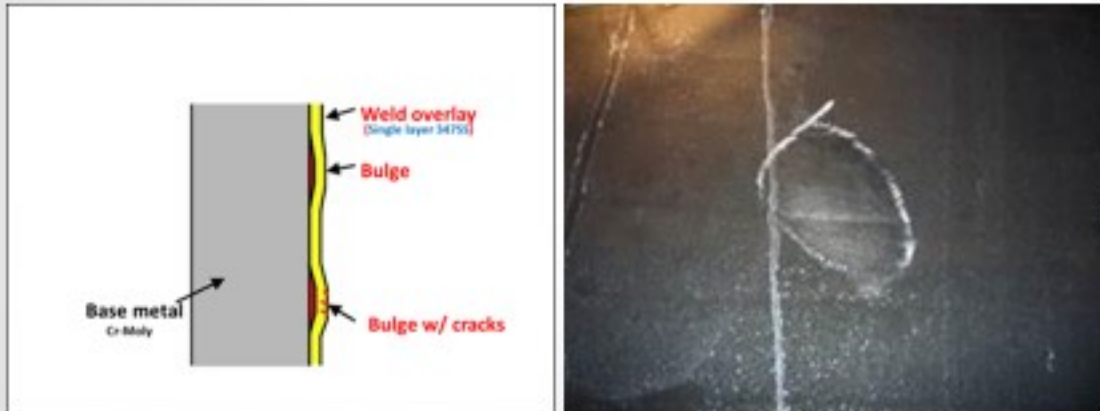
3. WOL Dis-bonding:

Third, weld overlay disbonding: High concentration of hydrogen remains in the reactor even after shutdown. Such hydrogen – in excess of 4 ppm – at ambient temperature is considered beyond equilibrium concentration and can cause hydrogen embrittlement of transition zone, which is the more sensitive zone. Hydrogen disbonding is purely a hydrogen distribution issue. The best way to slow down this problem is to control the amount of hydrogen dissolved in the weld overlay and base metal. This resolution can be achieved by utilizing a lower operating temperature, lower operating pressure, and smooth shutdown procedure. Also, the microstructure at the interface – being a primary factor – can be improved to govern the resistance to disbonding.

WOL Dis-Bonding

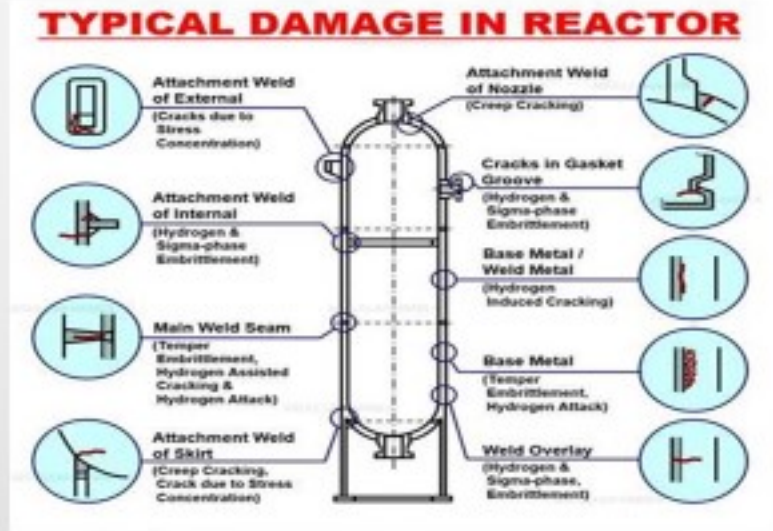
Damage in the Reactor

The second question is: What are the most common locations for defects, and does the location play a factor in the mechanical integrity of the equipment? As you can see on the slide, the most critical areas where damage can occur are at structure welds. These areas require periodic inspection of specific parts of the equipment such as hands-to-shell junction, nozzle details, internal supports, and skirted vessel joints. Finding a defect in these areas can affect the mechanical integrity of the equipment.

What are the most common locations for defects, and does the location play a factor in the mechanical integrity of the equipment?
