Question 36: Which refinery water sources do you accept for hydrotreater water wash (e.g., stripped fractionator overhead water, stripper sour water, etc.)? What are typical water quality guidelines?

JEFFREY MUELLER (Marathon Petroleum Company)

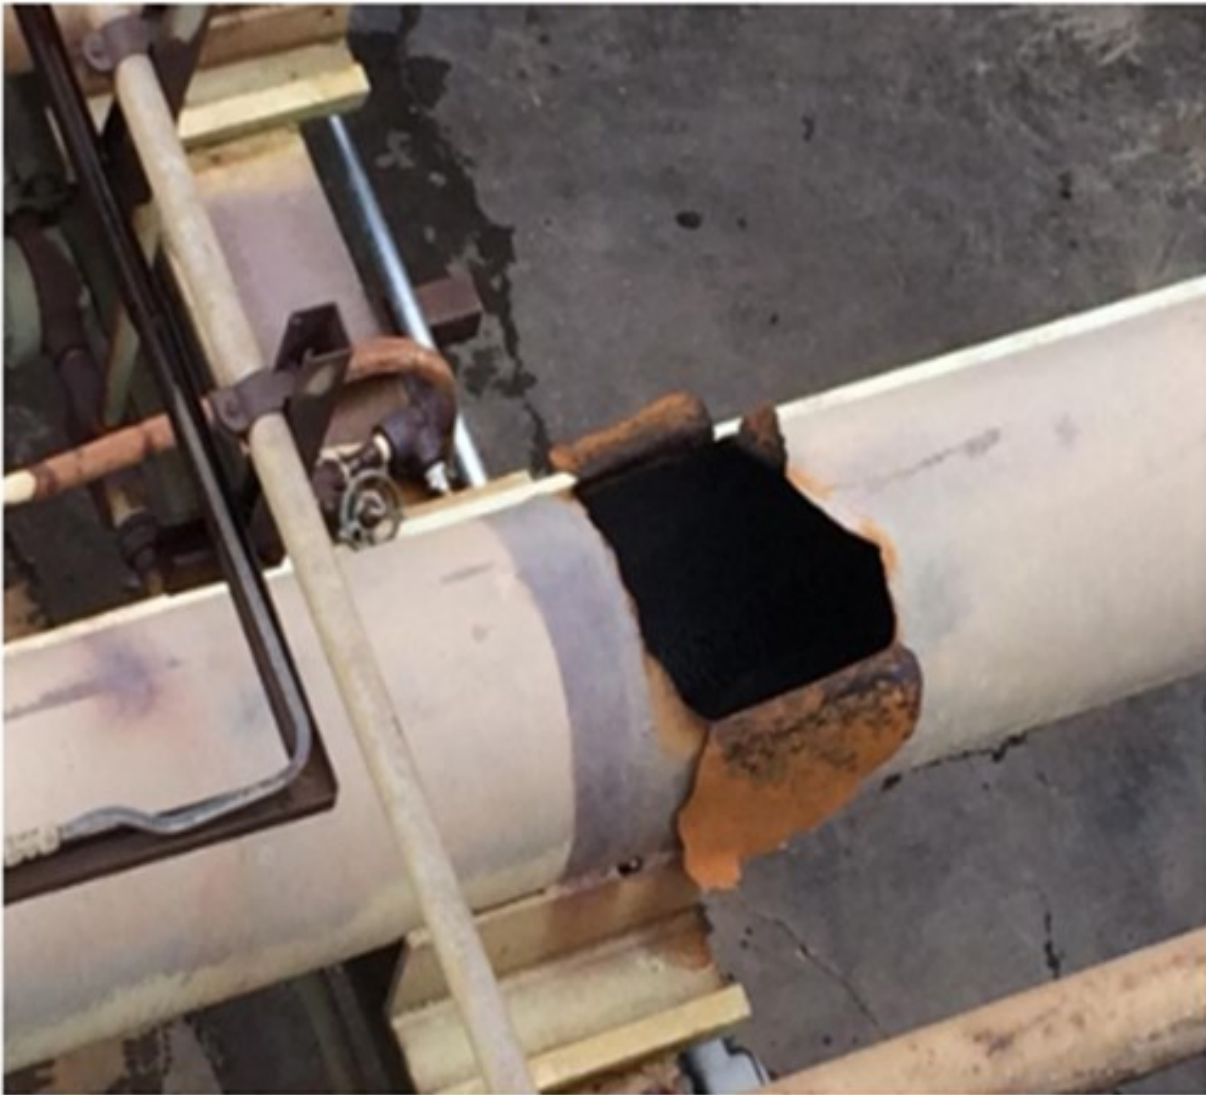
Figure 1. Reactor Effluent Piping Failure at MPC NHT

On April 9, 2015, a failure occurred on the top of a horizontal section of reactor effluent piping of a naphtha hydrotreater. The escaping stream of hydrocarbon was estimated to be 70 to 80 feet high, and the sound of liquid hydrocarbon release made communications in the immediate area difficult. Fortunately, the unit operators were able to shut down the heaters without incident. Figure 1 illustrates the piping failure associated with this incident.

The piece of piping that failed was located directly downstream of the feed/effluent exchangers and a continuous waterwash injection point, upstream of the reactor effluent air coolers. The system operated at 320 psig and 280°F, with no prior history of leaks. The process, at this point, contained 0.2 mol% H₂S, 0.001 mol% NH₃, and 0 to 4 ppm chloride in the makeup hydrogen. These conditions are not severe by hydrotreater standards.

The failure was internal corrosion due to the condensation of HCl on the vapor space of the pipe. Some of the causal factors in this incident relate to the waterwash design (though this was not the exclusive cause). The presence of water with inadequate mixing created an extremely corrosive condition in the vapor space of the horizontal pipe. A couple physical factors related to the waterwash contributed to this inadequate mixing:

*The water was injected through low velocity quills.

*Water was injected upstream of a non-freedraining low point with long horizontal line.

*Typically, waterwash is injected immediately upstream of the REACs. In this case, there was a long horizontal run of piping immediately downstream of the injection that does not allow for adequate mixing.
