**Question 60: Please describe your experience with the occurrence of phosphorus and barium fouling in the distillate section of the crude tower. What steps have you taken to identify and mitigate the problem?**

2015 Crude & Vacuum Q&A Session

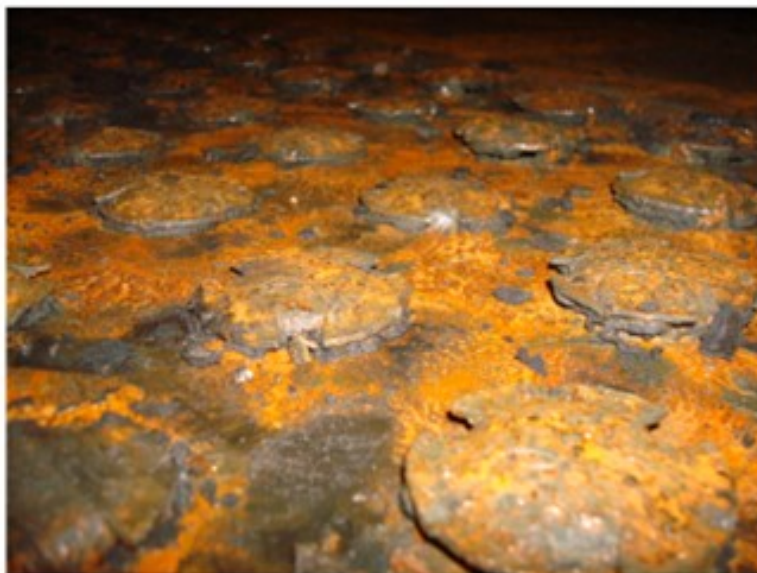
We have had some practical experience. The picture here shows phosphorus fouling of one of our crude towers. This is in the kerosene section again. The first time we experienced it in 2011, we went into a tower for turnaround and found fouling in the kero section, with none above or below. It had not caused an operational problem, and we actually did not analyze foulant that was on the tray at that time.

## Example of Phosphorous Fouling in Crude Tower Kero Section

A similar incident occurred at a third refinery. One of the remedies we have implemented is the installation of fouling-resistant, fixed-valve trays in the kero section. In refineries that still have floating valve trays, we try to keep vapor traffic up in the kerosene section. We have found occasions where the valves were found stuck open; but fortunately, they did not cause an operational issue. It is when we got lower rates and lower velocities that the valves became stuck closed and caused flooding problems. We have also had experience with barium fouling in the wash section of the crude tower. This picture shows an example of that problem. The solution for this issue was also to install foul resistant, fixed-valve trays.

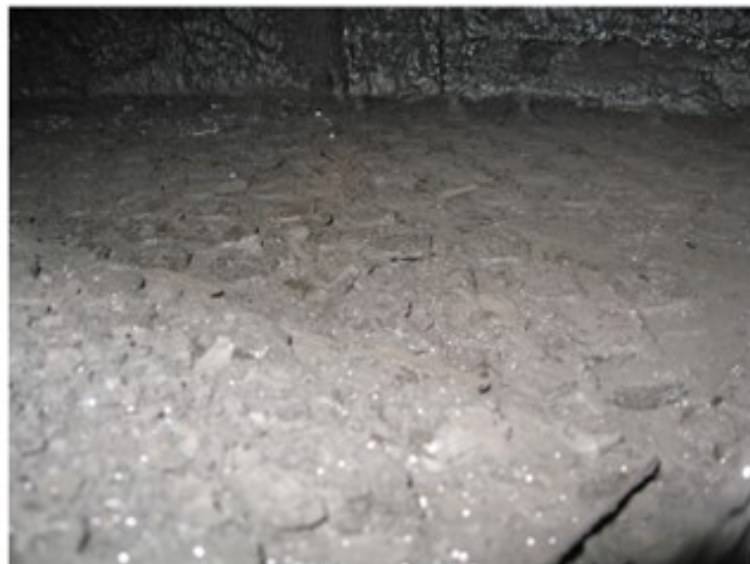
## Example of Barium Fouling in Crude Tower Wash Section

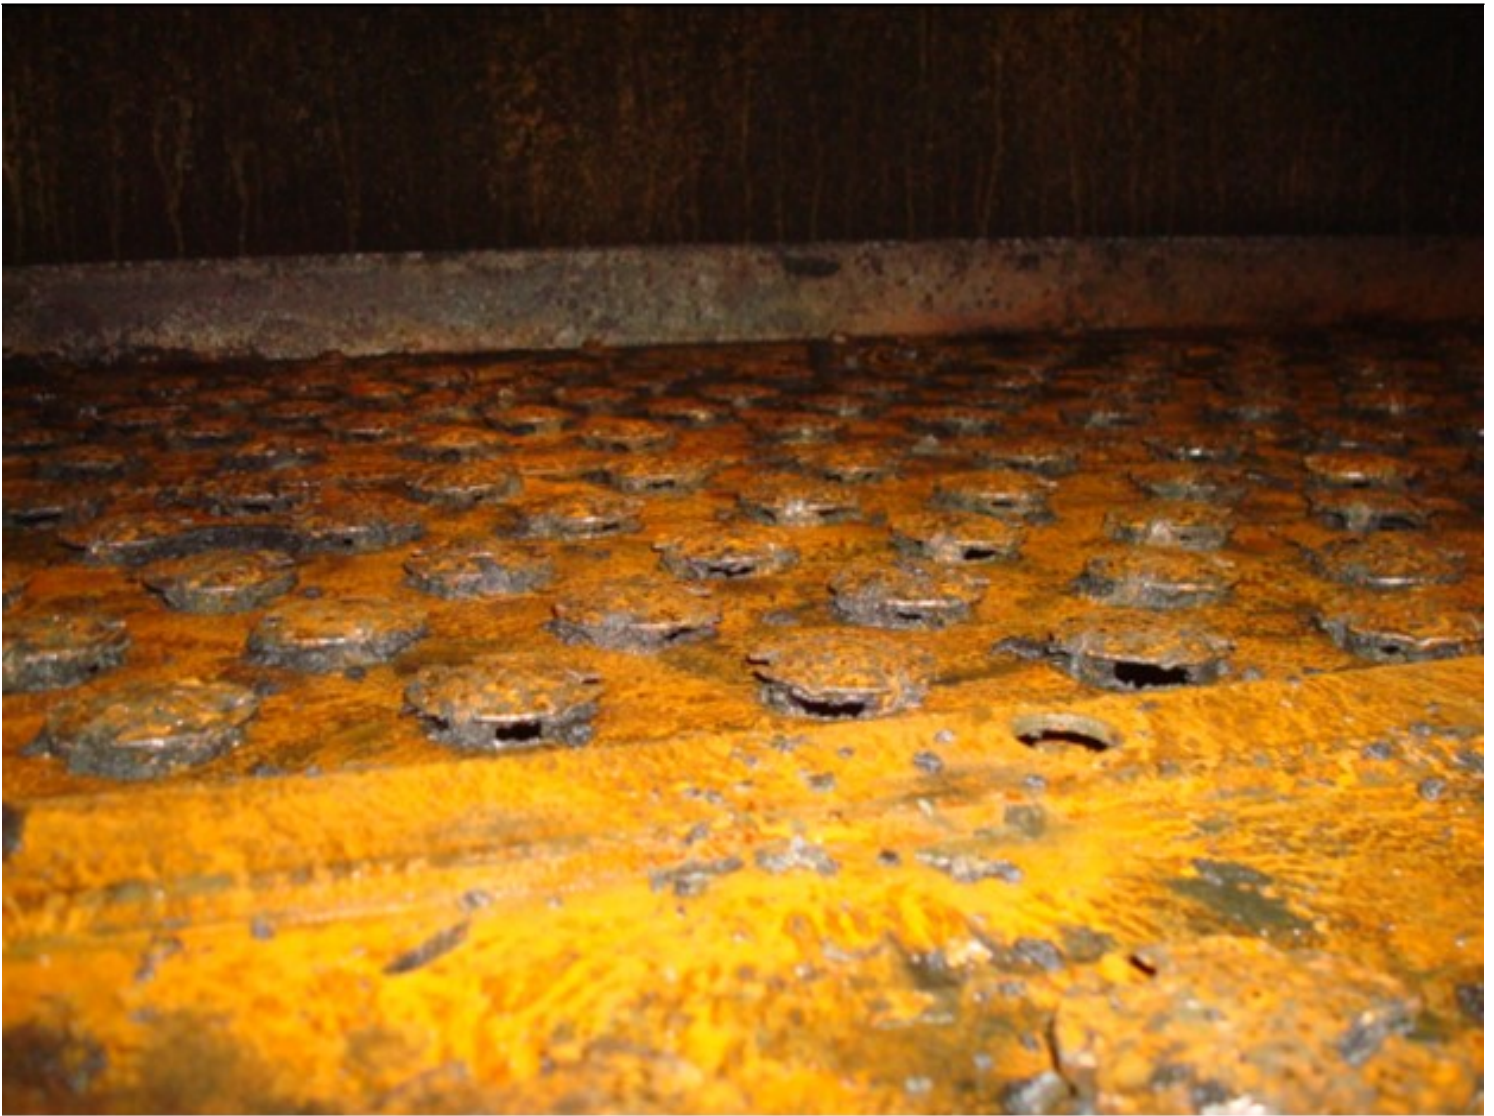
Figure 1. Example of phosphorous-induced tray fouling in crude unit kerosene section

MPC has experienced fouling in the kerosene section of crude units at multiple refineries which has been attributed to phosphorous. The first documented occurrence was found in 2011 during inspection of the tower during a unit turnaround. A light crusty scale was found on the trays in the kerosene section with no fouling in the sections above or below. Although this scale was not analyzed, subsequent incidents support phosphorous as the culprit.

A second occurrence followed an extended rate reduction at another refinery. When the refinery attempted to return to maximum rates, they were limited by flooding in the kerosene section. The MPC Crude Quality Manager at the time had heard of similar issues and referred the crude technologist to the Canadian Crude Quality Technical Association (CCQTA). The CCQTA representative suggested phosphorous fouling as the potential problem based on experience with other refineries. An attempt to remove phosphorous with online chemical treatment showed some effectiveness, but the unit was ultimately taken down to clean out the fractionator concurrent with a planned turnaround. The valves on several trays in the kerosene section were found to be stuck closed, which caused the flooding issues in the tower (See Figure 1). Analysis confirmed phosphorous as a major component of the foulant. Similar fouling has been found in one other refinery on inspection, however the valves were stuck open versus closed and did not impact operation.

MPC has switched to fouling-resistant, fixed-valve trays in crude towers where phosphorous fouling is thought to be an issue. In addition, at a refinery where we have not been able to replace trays yet, efforts are made to keep traffic high in the kerosene section in the event of a rate reduction.

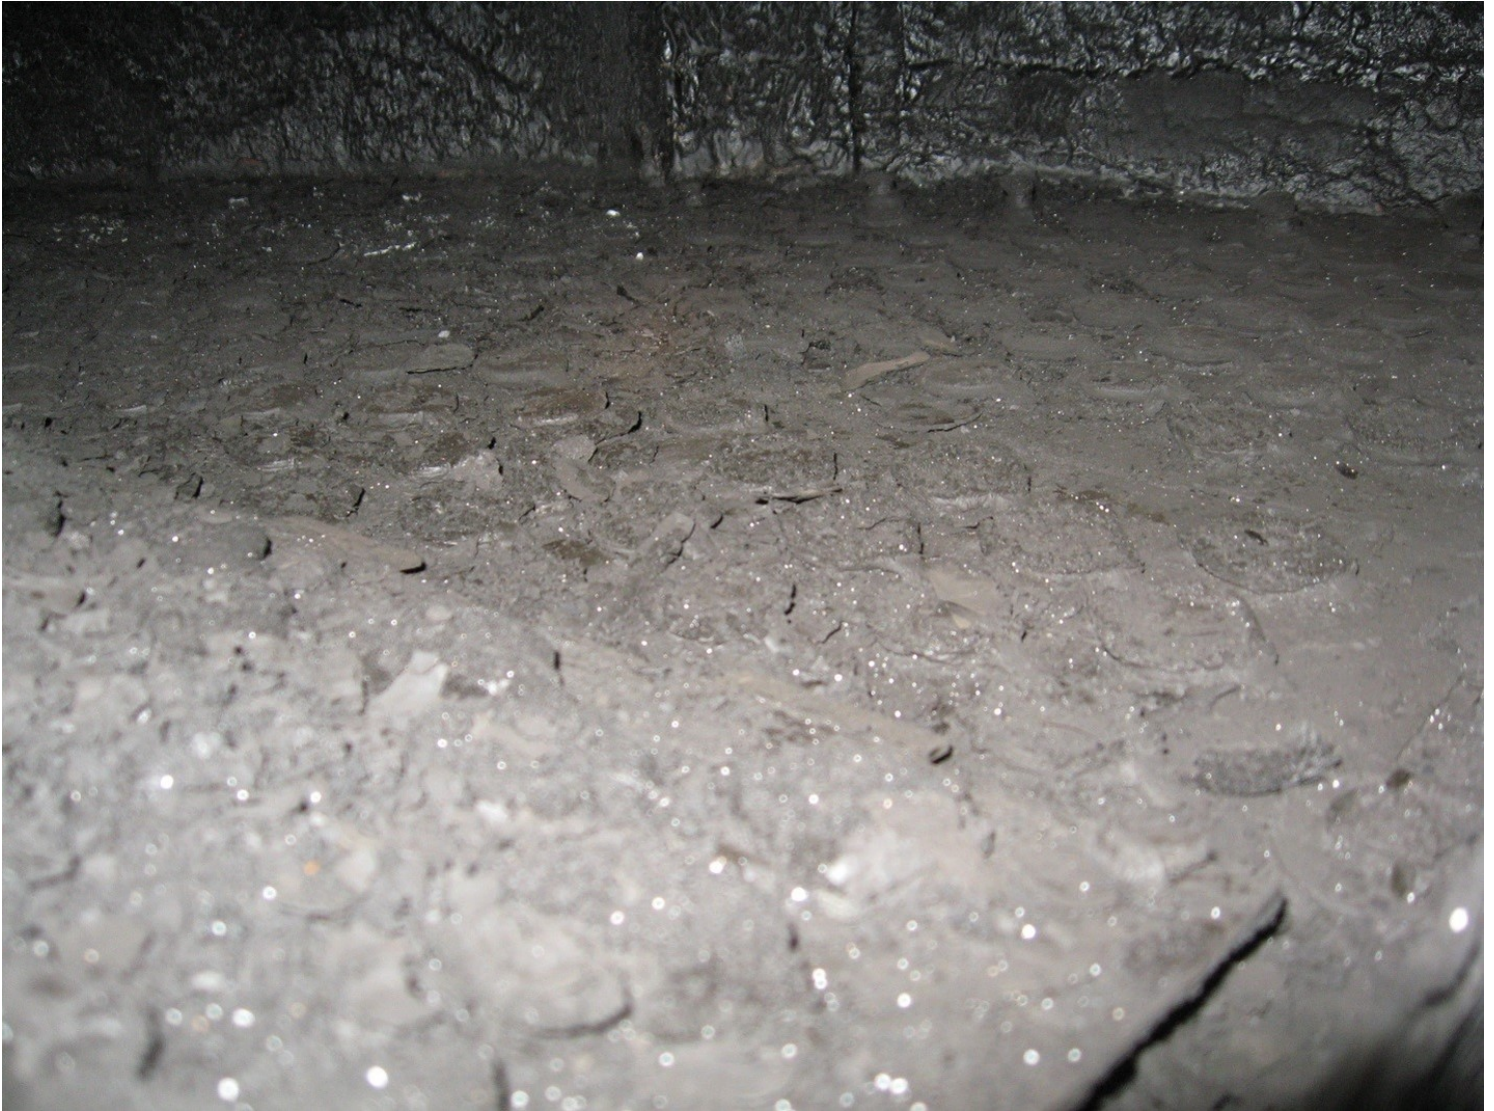
Figure 2. Barium fouling in wash section of atmospheric crude tower

MPC has also experienced fouling attributed to barium at one refinery in the wash section of the crude tower (Figure 2). Fouling-resistant trays were installed to minimize fouling rate and extend time between

cleanouts.
