Question 60: Please describe your experience with the occurrence of phosphorus and barium fouling in the distillate section of the crude tower. What steps have you taken to identify and mitigate the problem?

2015 Crude & Vacuum Q&A Session

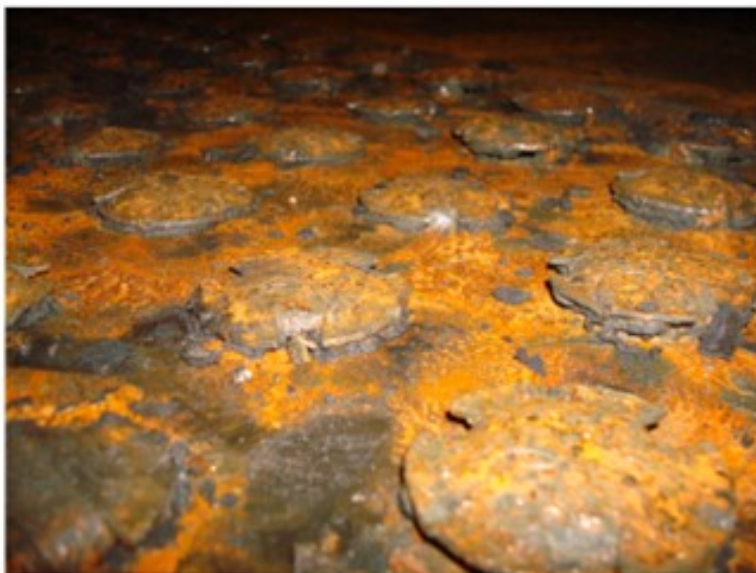
We have had some practical experience. The picture here shows phosphorus fouling of one of our crude towers. This is in the kerosene section again. The first time we experienced it in 2011, we went into a tower for turnaround and found fouling in the kero section, with none above or below. It had not caused an operational problem, and we actually did not analyze foulant that was on the tray at that time.

Example of Phosphorous Fouling in Crude Tower Kero Section

MPC has experienced fouling in the kerosene section of crude units at multiple refineries which has been attributed to phosphorous. The first documented occurrence was found in 2011 during inspection of the tower during a unit turnaround. A light crusty scale was found on the trays in the kerosene section with no fouling in the sections above or below. Although this scale was not analyzed, subsequent incidents support phosphorous as the culprit.

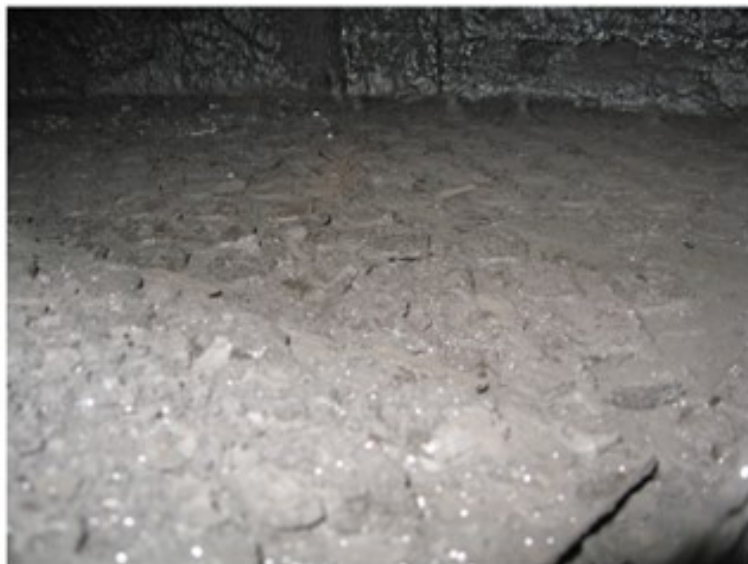
A similar incident occurred at a third refinery. One of the remedies we have implemented is the installation of fouling-resistant, fixed-valve trays in the kero section. In refineries that still have floating valve trays, we try to keep vapor traffic up in the kerosene section. We have found occasions where the valves were found stuck open; but fortunately, they did not cause an operational issue. It is when we got lower rates and lower velocities that the valves became stuck closed and caused flooding problems. We have also had experience with barium fouling in the wash section of the crude tower. This picture shows an example of that problem. The solution for this issue was also to install foul resistant, fixed-valve trays.

Example of Barium Fouling in Crude Tower Wash Section

MPC has also experienced fouling attributed to barium at one refinery in the wash section of the crude tower (Figure 2). Fouling-resistant trays were installed to minimize fouling rate and extend time between

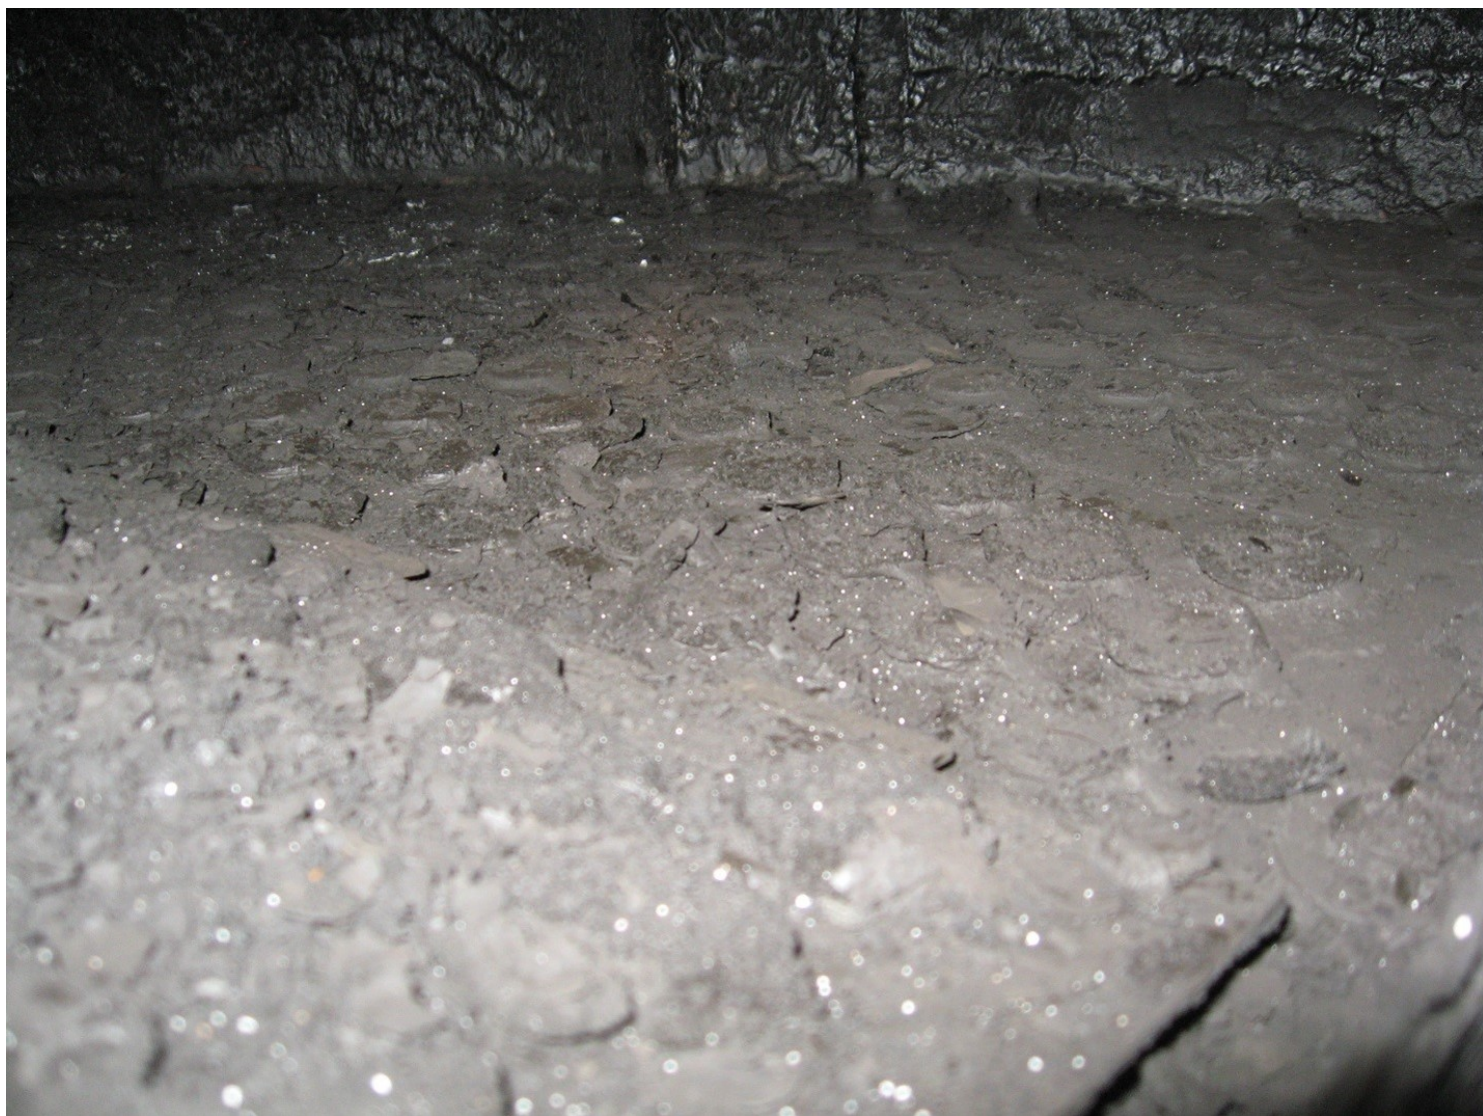
Figure 2. Barium fouling in wash section of atmospheric crude tower
