Question 60: Please describe your experience with the occurrence of phosphorus and barium fouling in the distillate section of the crude tower. What steps have you taken to identify and mitigate the problem?

2015 Crude & Vacuum Q&A Session

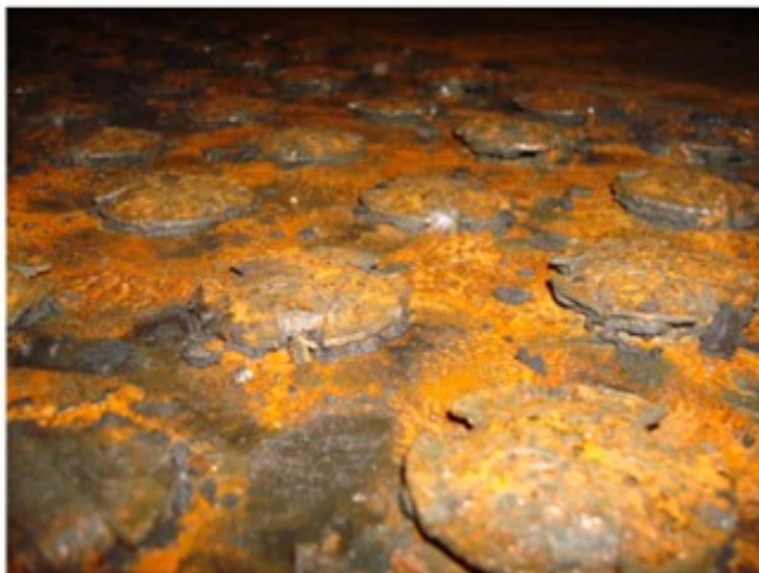
Example of Phosphorous Fouling in Crude Tower Kero Section

We have had some practical experience. The picture here shows phosphorus fouling of one of our crude towers. This is in the kerosene section again. The first time we experienced it in 2011, we went into a tower for turnaround and found fouling in the kero section, with none above or below. It had not caused an operational problem, and we actually did not analyze foulant that was on the tray at that time.

A similar incident occurred at a third refinery. One of the remedies we have implemented is the installation of fouling-resistant, fixed-valve trays in the kero section. In refineries that still have floating valve trays, we try to keep vapor traffic up in the kerosene section. We have found occasions where the valves were found stuck open; but fortunately, they did not cause an operational issue. It is when we got lower rates and lower velocities that the valves became stuck closed and caused flooding problems. We have also had experience with barium fouling in the wash section of the crude tower. This picture shows an example of that problem. The solution for this issue was also to install foul resistant, fixed-valve trays.
