Question 76: The check valve on the air blower discharge line is designed to protect the blower from hot catalyst that backs into it when the blower fails. What type of valve is used in this service, where is it located, and what is done to ensure that it closes properly?

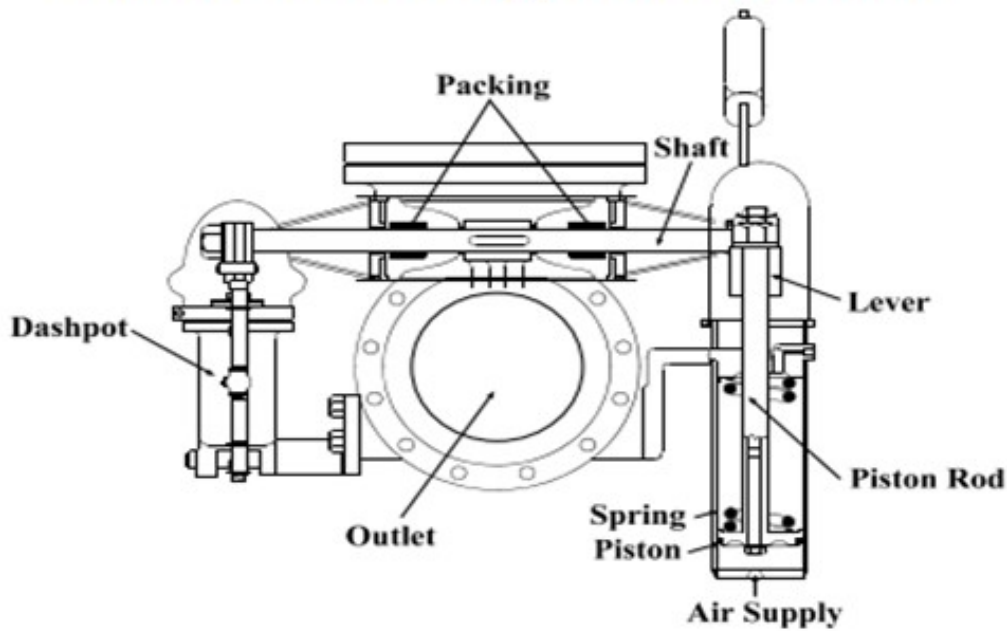
Blower Discharge Check Valve

the blower. The main air blower discharge special check valve helps protect the blower during surges. Fluidized catalyst can easily flow back through the air heater if pressure is lost. The regenerator inlet air special check valve helps to prevent backflow of catalyst to the blower. Figure 1 and Figure 2 show the check valve and its associated equipment.

The special check valve is a swing style check valve with a spring-loaded air cylinder that provides spring force assisted closing. An oil filled dashpot provides a damping action on opening to prevent hammering and damage. Construction is of heavy wall steel, to resist temperature and pressure stresses, with 11% Cr (chrome) to 13% Cr or stainless trim. The stainless-steel shaft is supported by hardened stainless steel bushings with GRAFOIL® packing used to prevent leakage. The shaft is connected to the dashpot and to a lever arm that has counterweights. The counterweights support 75% of the disc weight to minimize the pressure drop through the valve. The counterweight should never hold the disc open when there is no air flow. The lever arm is usually cut to the proper length in the factory, and the weights are set in the field.

The air cylinder consists of a small piston opposed by a spring. Under normal conditions, air is supplied to the piston, which moves up to compress the spring. The piston rod moves freely between two small lever arms attached to the check valve shaft. As the piston rod rises, the valve is free to open. Air flow from the blower forces the valve open. The air to the piston is supplied through a three-way valve that will vent off cylinder pressure when actuated. For new units that have venturi meters on the blower discharge line, a low flow signal will alert the valve to cut off the air supply to the special check valve. Instrument air failure will also vent off pressure from the cylinder. Upon initial venting, the spring provides a sharp thump to the valve shaft to help free the disc in the event that it has become slightly stuck in the open position. The force of the spring is not enough to close against the normal operating air flow from the main air blower.

A manually operated air test valve is provided which permits equalization of the pressure on both sides of the air cylinder piston so that the spring force moves the piston downward and exercises the valve during operation.
