Question 76: The check valve on the air blower discharge line is designed to protect the blower from hot catalyst that backs into it when the blower fails. What type of valve is used in this service, where is it located, and what is done to ensure that it closes properly?

GH76

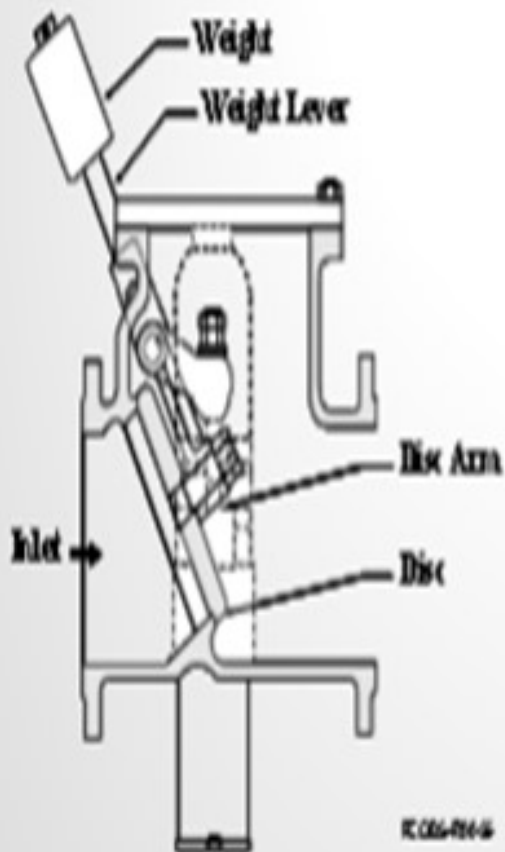
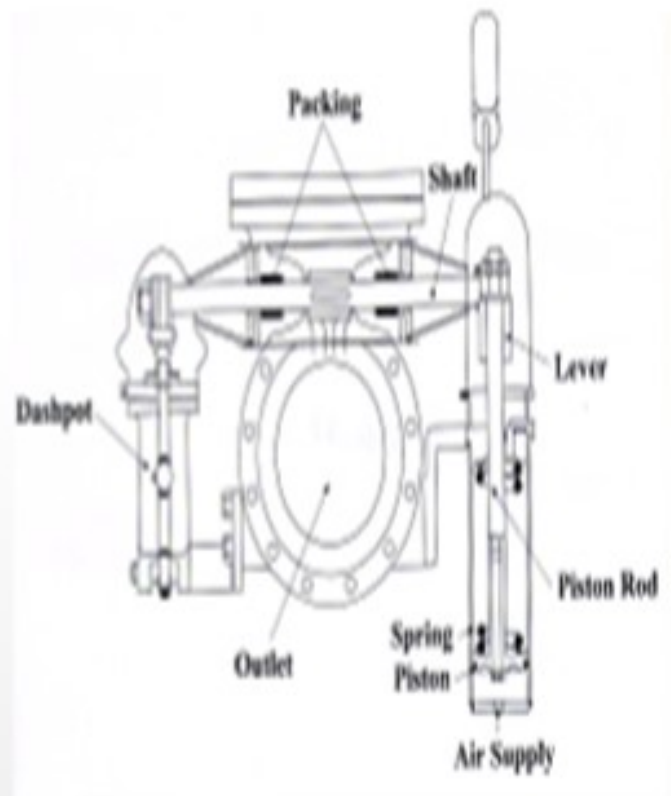
Blower Check Valve

- Iso-Check Valve (at least one)
 - Internal Disc with external counterweight to open
 - External spring assist to close
 - Air assist to close using hydraulic cylinder

- One Iso-Check min. distance from air heater
 - 300# flange rating for temperature conditions
- One Iso-Check min. distance from air blower
 - 150# flange rating
 - Provides additional blower protection
 - Only adds an additional ½ psi pressure drop to system

KBR typically installs at least one ISO check valve in the air blower's discharge line. The ISO check consists of an internal disc with external counter weight to help hold the valve open during normal operations and a spring assist to help close the valve in the event that air blower operations are interrupted. Some refiners use an air-assist ISO check instead of the spring to fully close the valve during emergency situations. Here air applies pressure to a hydraulic piston that closes the valve when the low flow alarm is triggered.

In cases where the distance from the air blower to the regenerator is excessive, KBR recommends an additional ISO check within the system. One ISO check is located at a minimum distance from the blower (downstream of the anti-surge vent valve), and a second ISO check valve is at minimum distance from the air heater. The check at the air heater is to prevent catalyst back flow from the unit if air is lost. The additional check valve near the blower serves two basic purposes. First, in the event that the second check does not seal properly, this check valve provides an additional level of protection for the blower. Also, as the check valve closest to the air heater closes, the higher pressure air volume trapped upstream of the check valve does not reverse-flow through the anti-surge valve against the blowers discharge as it is relieving. KBR believes that the additional check valve is well warranted as the additional valve typically only provides an additional pressure drop of ½ psi (pounds per square inch) to the system at normal flow rate. The check near the blower is 150-pound rated, and the check near the air heater is 300- pound rated because of the potential high temperature.

To ensure that the valve is properly closed, we recommend that Operations visually verify its closure with the valve position indicator while applying pressure to the counterweight lever in the direction to ensure the check valve is completely closed.
